COLORADO CULTURAL RESOURCE SURVEY

Architectural Inventory Form

- 1. Resource number: **5PE.5660**
- 2. Temporary resource number:
- 3. County: **Pueblo**
- 4. City: **Pueblo**
- 5. Historic building name: **Warden, H.C., House**
- 6. Current building name: **Carlino, Anthony J., House**
- 7. Building address: **716 W 13th Street**
- 8. Owner name: **Anthony J. Carlino**
- Owner organization:
- Owner address: **716 W 13th St.  
Pueblo, CO 81003**

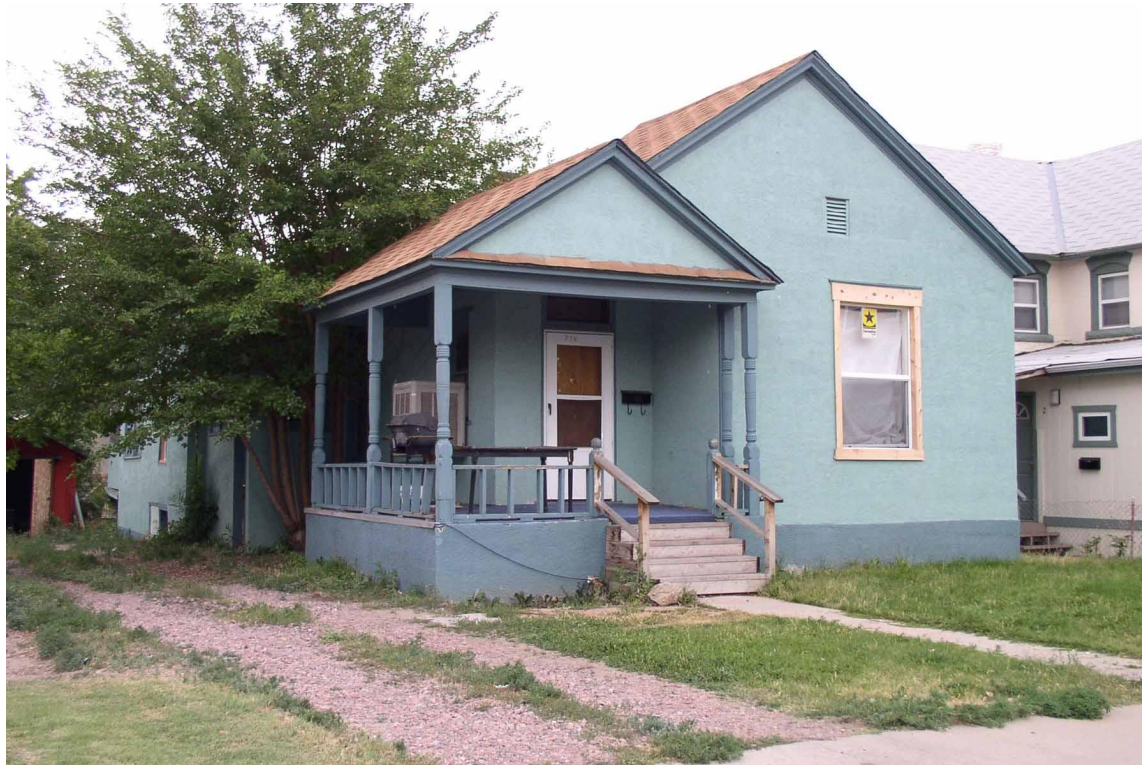
**Oriented to the north, this house rests on a concrete foundation, almost entirely concealed behind blue-tinted stucco. Basement windows are single-light hopper. Blue-green-tinted stucco clads the exterior walls. Windows are generally 1-over-1-light, double-hung sash, with blue-painted wood frames and entablatures, with projecting cornices. A white vinyl-frame window of this kind opens in the west side of the front (north) facade. Its wood surround is unpainted. A pair of 6-light hopper windows appears near the center of the east elevation. A pedimented, front-gabled porch wraps around the northeast corner of the house. It has a concrete floor; blue-painted, turned wood supports; and simple wood balustrade. Four wood steps approach the porch on the west end of its north elevation, approaching the principal doorway. This doorway hosts a wood slab door, opening behind a white, aluminum-frame storm door. A 2-panel, blue-painted wood door opens near the center of the east elevation. A shed-roofed porch is cantilevered off the east half of the rear (south) elevation. Blue-green-painted plywood and wire-mesh screens enclose the porch. Wood steps, with most of the treads missing, approach the porch at its center. The porch provides access to a doorway opening in the east end of the rear elevation. It hosts a 4-panel, blue-painted wood door. Brown asphalt shingles cover the front-gabled main roof and all other roof surfaces. Blue-painted wood soffit and fascia, with projecting cornice, box the shallowly overhanging eaves. A brick chimney protrudes from the south end of the east-west-oriented roof ridge.**

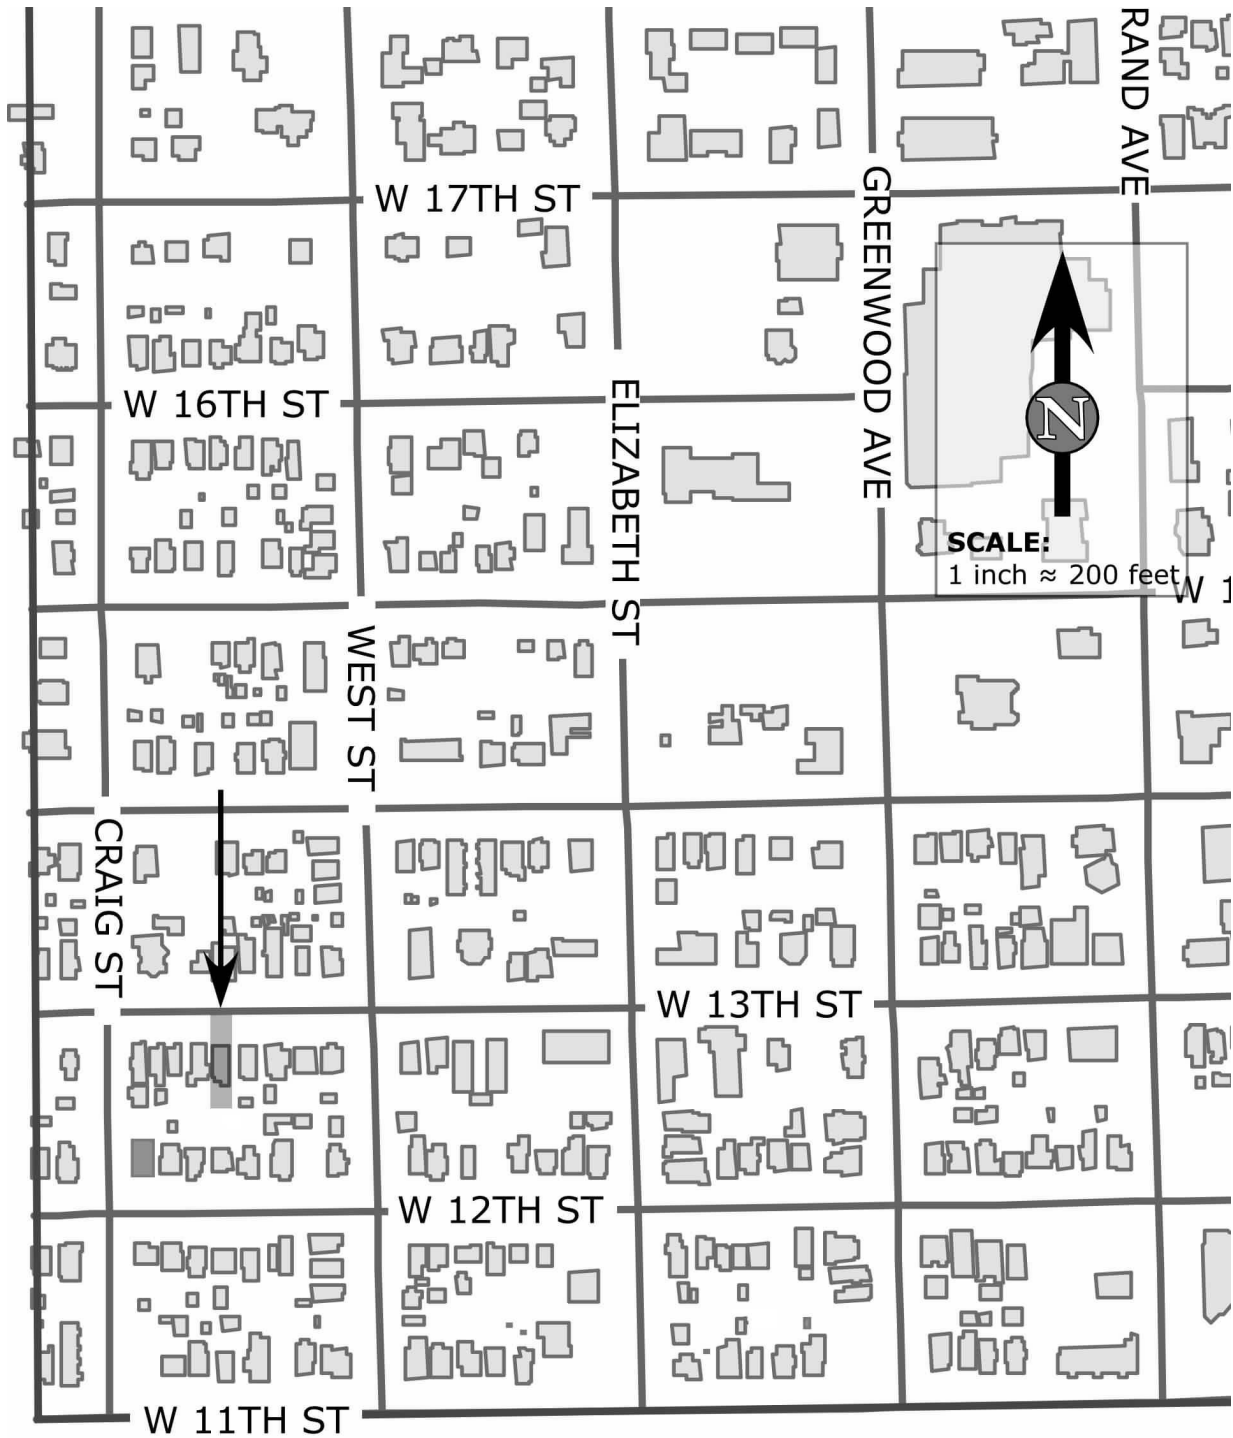
SITE SKETCH MAP

**This property is located on terrain sloping downward from north to south, with an elevation of around 4,700 feet above mean sea level. The neighborhood features modest, one- and two-story houses and commercial buildings. Setbacks from West 13th Street, the busy, principal east-west thoroughfare through this area, are generally the same on this block. This property is situated on the south side of West 13th Street, between 714 West 13th Street to the east and 722 West 13th Street to the west. Gravel covers the strip separating the sidewalk from the street. A planted-grass yard, lacking landscaping, covers the lot. However, a tree grows in a small recess along the east elevation. A two-track gravel driveway runs along the east side of the house, connecting the street to a garage southeast of the dwelling.**

Describe: **A single-car garage is located immediately southeast of the house. Oriented to the north, the building appears to lack a formal foundation. Sheets of mainly red-painted, corrugated metal clad the exterior walls. Dominating the front (north) elevation are paired doors of unpainted flakeboard construction, opening on metal strap hinges. Opening west on center in the rear (south) elevation is a 4-light hopper or awning window, lacking glazing and boarded shut from the inside. Sheets of corrugated metal cover the front-gabled roof, and the rafter ends are exposed.**
