COLORADO CULTURAL RESOURCE SURVEY

Architectural Inventory Form

- 1. Resource number: **5PE.5662** Parcel number(s):
- 2. Temporary resource number: **093** **525311004**
- 3. County: **Pueblo**
- 4. City: **Pueblo**
- 5. Historic building name: **Cleghorn, John, House**
- 6. Current building name: **722 West 13th Street**
- 7. Building address: **722 W 13th Street**
- 8. Owner name: **JP Morgan Chase Bank (Trustee)**
- Owner organization:
- Owner address: **9350 Waxie Way**
San Diego, CA 92123

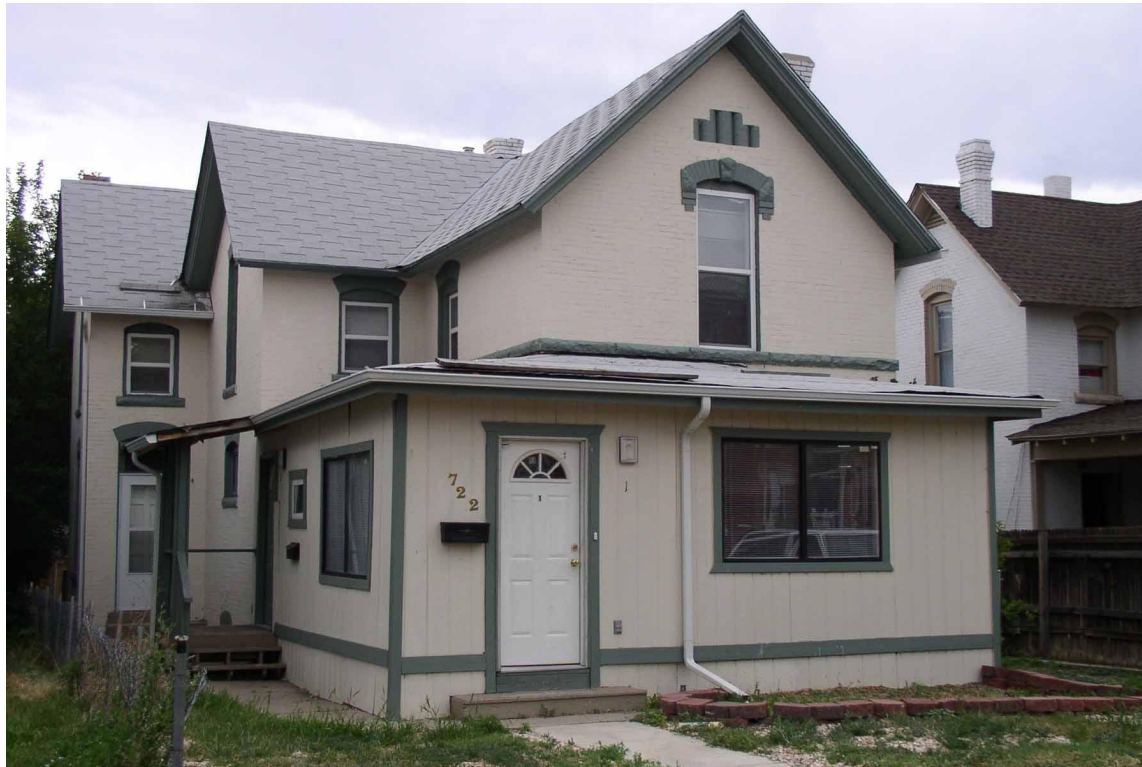
21. General architectural description:
Oriented to the north, this house rests on a buff-colored, rock-faced sandstone foundation arranged as coursed ashlar. The walls consist of cream-painted brick. Plywood sheets, pressed into a vertical-plank pattern, cover the exterior walls of an enclosed porch wrapping around the house's northeast corner. The plywood is painted cream, with green-painted cornerboards. Windows are generally 1-over-1-light, double-hung sash, with white vinyl frames. These windows open between green-painted, rock-faced sandstone sills and segmental arches. The segmental arch above the window opening in the second story of the front (north) elevation, beneath the gable, has a sandstone keystone and springers. Above it, in the gable, is a corbelled pattern of rounded bricks. The enclosed porch hosts 1-beside-1-light, sliding-sash windows, with brown aluminum frames. Near the center of the east elevation's first floor is a stained-glass hopper window. A pair of doorways opens into the porch, on the east side of the north elevation and the south side of the east elevation. Both host 4-panel, metal doors, with fanlights. The door in the north elevation is white, approached by a single concrete step. The door in the east elevation is

painted green and is approached by a two-step wood stoop, sheltered beneath a shed roof. Another doorway opens in the north elevation of a gabled wing protruding from the south end of the east elevation. It hosts a 6-panel, white-painted wood door, opening behind a white, aluminum-frame storm door. Approaching it are 2 concrete steps. A doorway opens near the center of the rear (south) elevation. It hosts a 2-panel, 1-light, white-painted metal door, opening behind an aluminum-frame storm door. Approaching it is a small, uncovered wood deck, with simple wood balustrade. A shed-roofed, 1-car garage is attached to the southwest corner of the house. A gravel driveway approaches it from West 13th Street. Dominating its front (south) elevation are paired, three-panel wood doors, painted cream. A 16-panel, white, steel, overhead retractable garage door consumes the rear (south) elevation of the garage. Gray, interlocking asphalt shingles cover the cross-gabled roof, and green-painted wood soffit and fascia, with protruding cornice, boxes the eaves. A white-painted, corbelled brick chimney protrudes near the northwest corner of the house and another emerges at the junction of the roof ridges.
