COLORADO CULTURAL RESOURCE SURVEY

Architectural Inventory Form

I. IDENTIFICATION

48. Report title: Pueblo North Side Neighborhood Survey

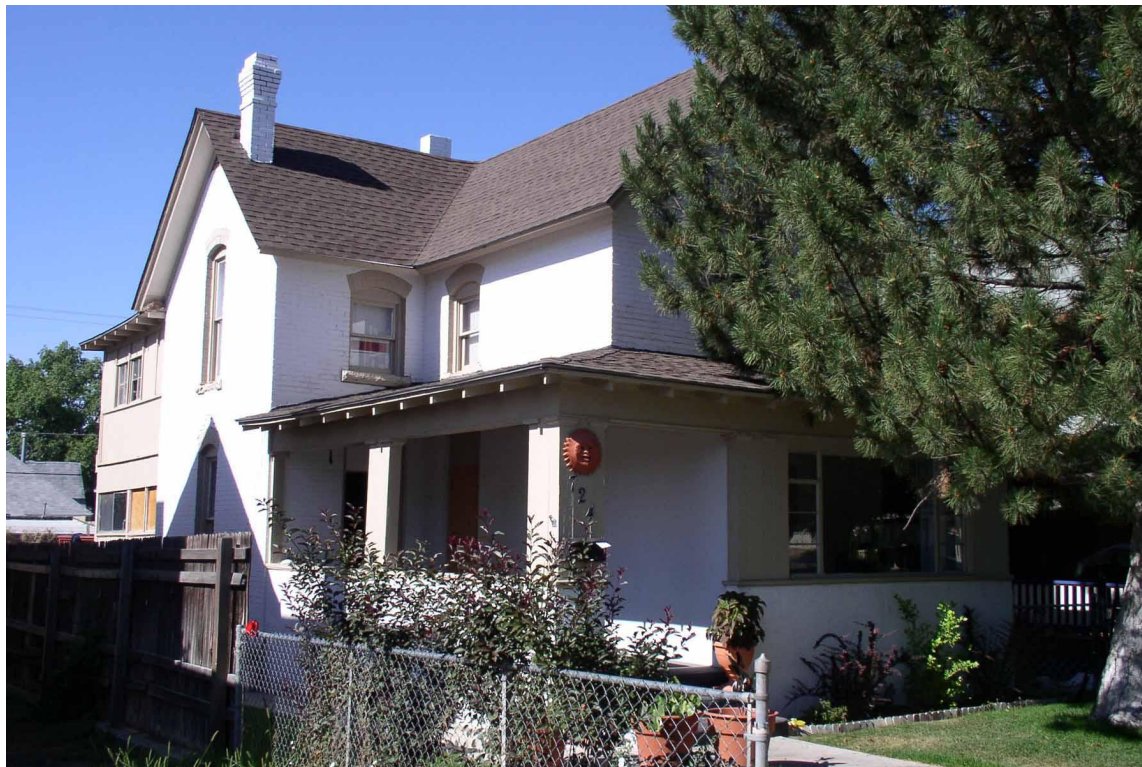
19. Primary external roof material: **Asphalt Roof/Composition Roof**
Other roof materials:
20. Special features:
Fence
Chimney
Porch
Window/Segmental Arch
21. General architectural description:
Oriented to the north, this house rests on a buff-colored, rock-faced sandstone foundation arranged as coursed ashlar. The walls consist of white-painted brick. White-painted stucco covers the enclosed, western portion of the porch and its kneewall. A combination of beadboard and plywood encloses a two-story, shed-roofed porch situated within the southeast corner. Windows are generally 1-over-1-light, double-hung sash, with tan-painted wood frames. They open between tan-painted, rough-faced sandstone sills and segmental arches, also highlighted in tan paint. The window opening beneath the front- (north-) facing gable has a projecting archivolt. Above it, higher in the gable, is a band of corbelled bricks. Dominating the front (north) elevation of the enclosed porch is a tripartite picture window, with tan-painted steel frames. The window consists of a central fixed frame flanked by 3-light casements. Above the casements are small transoms. Enclosing the porch off the southeast corner are 1-beside-1-light, sliding-sash windows in the first story, and 4-light hopper, awning, or casements in the second story. A single-story, 3-sided, canted bay window protrudes near the center of the west elevation. It hosts 1-over-1-light windows, with the upper sashes hosting cottage-style glazing. A small window opening above this bay has been boarded shut. A hipped-roof porch wraps around the northeast corner of the house. The portion running along the east elevation remains open and has a stucco-covered kneewall. Resting on the kneewall are paired, square wood supports, with the voids between

them subsequently filled. The porch provides access to the principal doorway, which opens in the north face of the inside (northeast-facing) corner. A doorway opens in south elevation of the porch along the southeast corner. It hosts a 4-panel, wood door, with white-painted rails and tan panels. It provides access to a red-painted wood deck. Another doorway in the east face has been boarded shut. Brown asphalt shingles cover the cross-gabled roof. Tan-painted wood fascia and soffit box the eaves. Rafter ends are exposed beneath the porch roofs. An engaged hearth and fireplace protrudes from the north end of the west elevation, and features an elaborately corbelled hearth and cap. Other brick chimneys emerge at the northeast corner of the house and at the junction of the roof ridges.

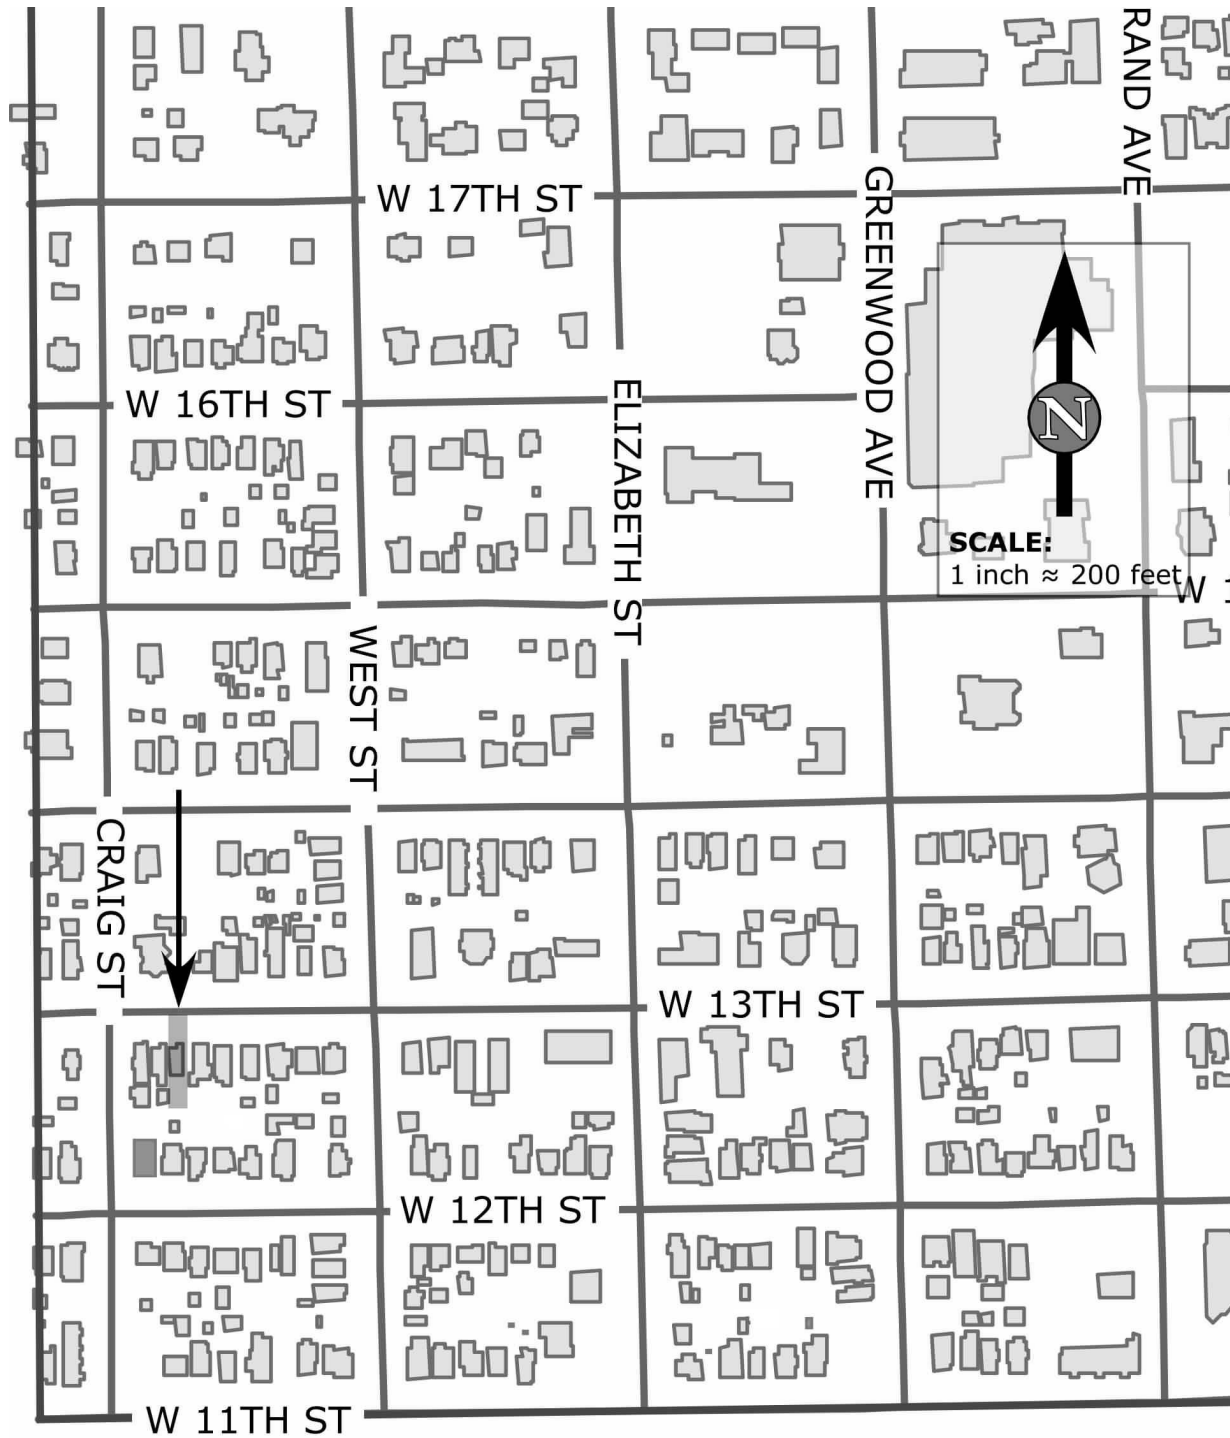
SITE SKETCH MAP

This property is located on terrain sloping downward from north to south, with an elevation of around 4,700 feet above mean sea level. The neighborhood features modest, one- and two-story houses and commercial buildings. Setbacks from West 13th Street, the busy, principal east-west thoroughfare through this area, are generally the same on this block. This property is situated on the south side of West 13th Street, between 722 West 13th Street to the east and 726 West 13th Street to the west. Grass covers the strip separating the sidewalk from the street. A planted-grass yard, with mature landscaping, covers the lot. Growing in front (north) of the house is a large pine tree. A combination of chain-link and wood privacy fences delimit the east and west edges of the property. Located along the southern edge of the property is a concrete basketball court, encircled by a high, woven-wire fence.

Describe: **A shed is located midway along the eastern property line. Oriented to the west, the building lacks a formal foundation. Wooden composition siding, painted alternatively tan and white, clads the exterior walls. Siding also covers the door opening the middle of the front (east) elevation. Black asphalt shingles cover the front-gabled roof, and the rafter ends are exposed.**
