COLORADO CULTURAL RESOURCE SURVEY

Architectural Inventory Form

- 1. Resource number: **5PE.5680**
- 2. Temporary resource number:
- 3. County: **Pueblo**
- 4. City: **Pueblo**
- 5. Historic building name: **Lucy, Emmett K., House**
- 6. Current building name: **Alvarez, John J., House**
- 7. Building address: **512 W 14th Street**
- 8. Owner name: **John J. Alvarez**
- Owner organization:
- Owner address: **512 W 14th St**
Pueblo, CO 81003

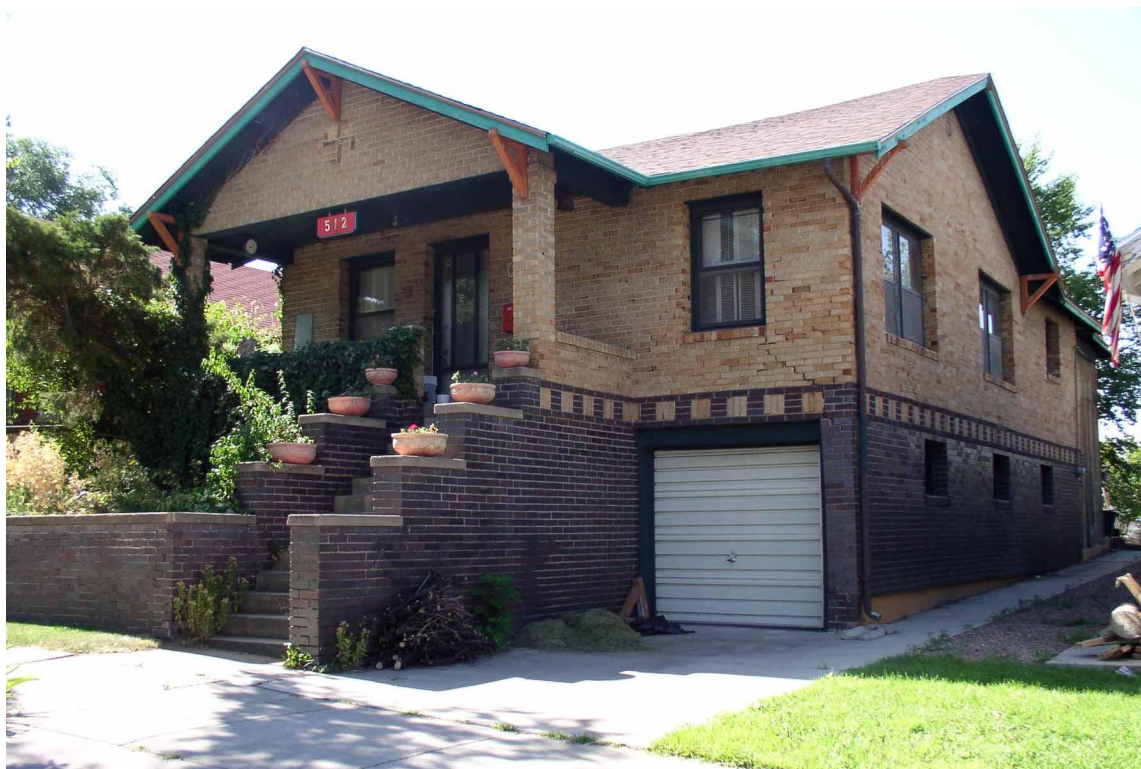
19. Primary external roof material: **Asphalt Roof/Composition Roof**
Other roof materials:
20. Special features:
Fence
Garage/Attached Garage
Chimney
Porch
21. General architectural description:
Oriented to the north, this house rests on a high, concrete foundation, covered in a brown, glazed-brick veneer. An asphalt-covered paper covers a front-gabled addition across the rear elevation. Basement windows are 3-light hopper. A tan, raked-brick veneer clads the exterior walls. Between the foundation and first floor is a watertable of alternating tan and brown brick squares. Windows are generally 1-over-1-light, double-hung sash, with brown aluminum frames. A pair of single-light casement windows flanks an engaged hearth and chimney on the north side of the east elevation. Large, single-light, fixed-frame windows surround the rear addition. A front-gabled porch dominates the eastern two-thirds of the front (north) façade. It has a brick kneewall and supports. Twelve concrete steps approach the porch on the west end of its north elevation. The principal doorway opens onto the porch, offset just east of center. It hosts a 6-light, glass-in-wood-frame door, painted white, opening behind a brown, aluminum-frame storm door. A garage door opens in the foundation, west of the porch. It hosts a white, fiberglass, overhead-retractable garage door. Brown asphalt shingles cover the cross-gabled roof, and the shaped rafter ends are exposed. Knee brackets appear at the apex and corners of the gables.

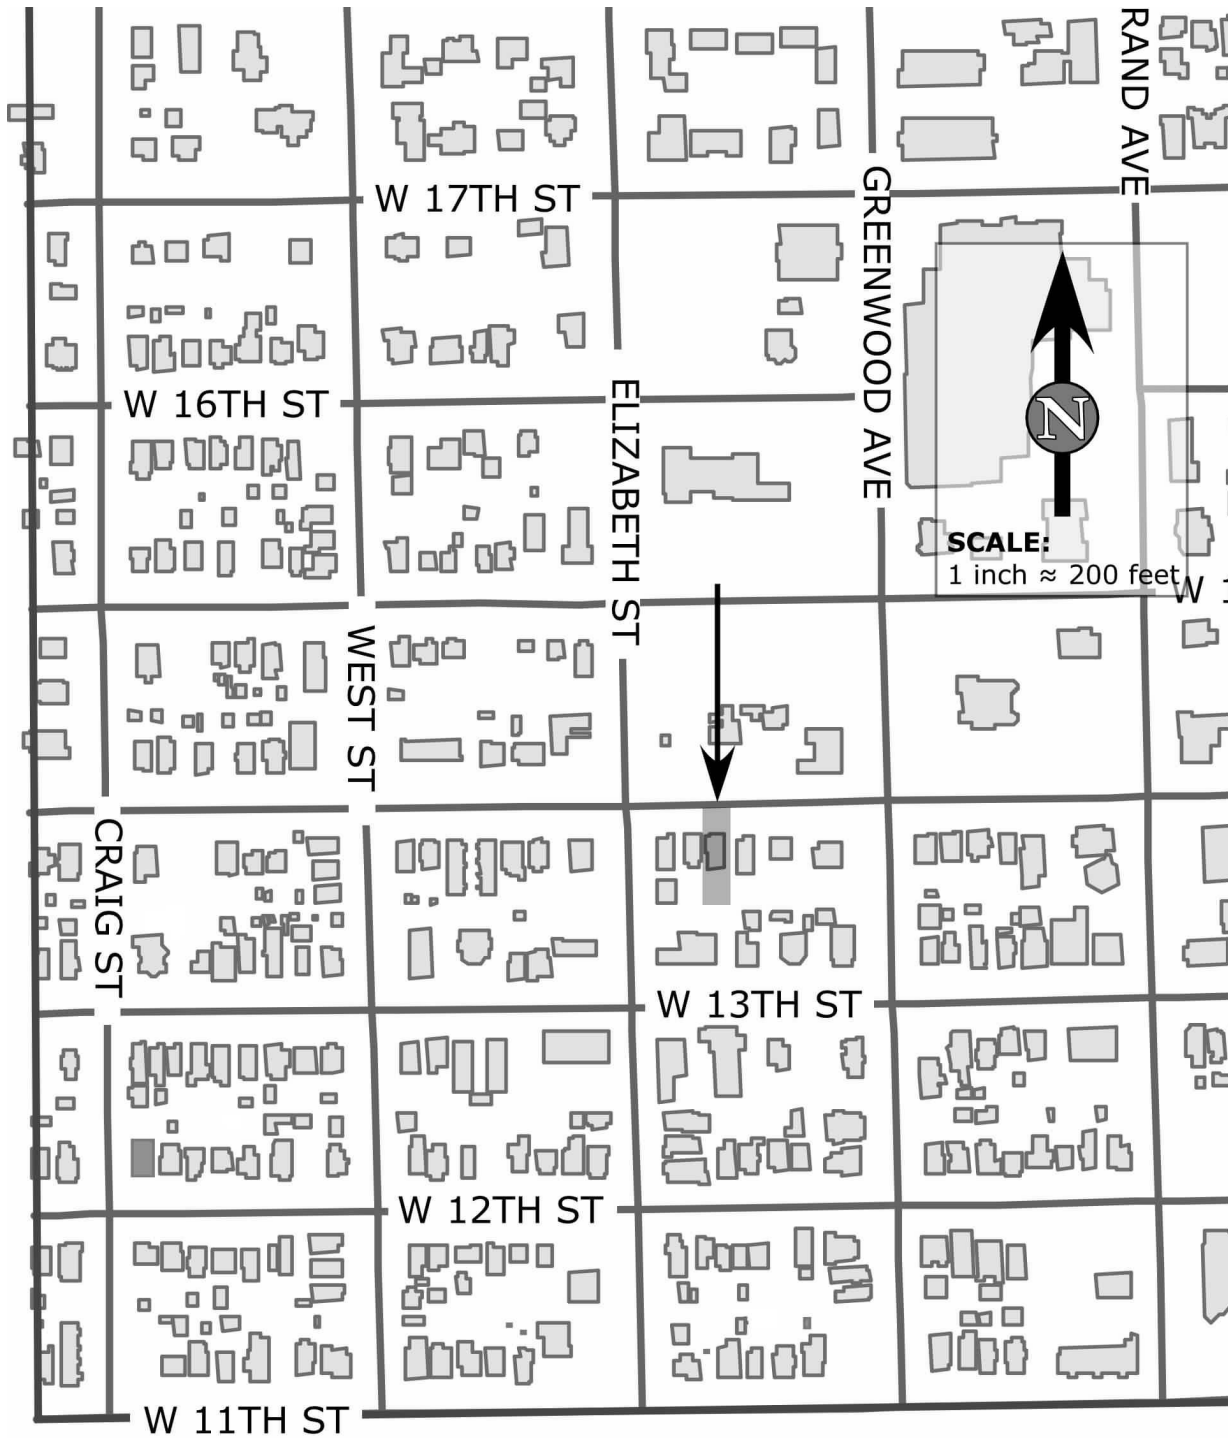
SITE SKETCH MAP

This property is located on terrain sloping downward from northwest to southeast, with an elevation of around 4,700 feet above mean sea level. The neighborhood features a mixture of small and large, one- to three-story houses and commercial buildings, with some residential and medical-related buildings towering many stories above the rest of the landscape. Setbacks from West 14th Street are generally the same on this block. This property is situated on the south side of West 14th Street, between 510 West 14th Street to the east and 514 West 14th Street to west. Grass covers the strip separating the sidewalk from the street. A brown, glazed-brick retaining wall, in turn, separates the sidewalk from the front lawn. A planted-grass yard, with mature landscaping, covers the property. The backyard is terraced and encircled by a chain-link fence.
