COLORADO CULTURAL RESOURCE SURVEY

Architectural Inventory Form

- 1. Resource number: **5PE.5683** Parcel number(s):
- 2. Temporary resource number: **525406002**
- 3. County: **Pueblo**
- 4. City: **Pueblo**
- 5. Historic building name: **Heaton, Wilbur M., House**
- 6. Current building name: **Martinez, Daniel J. and Berlinda, House**
- 7. Building address: **605 W 14th Street**
- 8. Owner name: **Daniel J. and Berlinda Martinez**
- Owner organization:
- Owner address: **605 W 14th St**
Pueblo, CO 81003

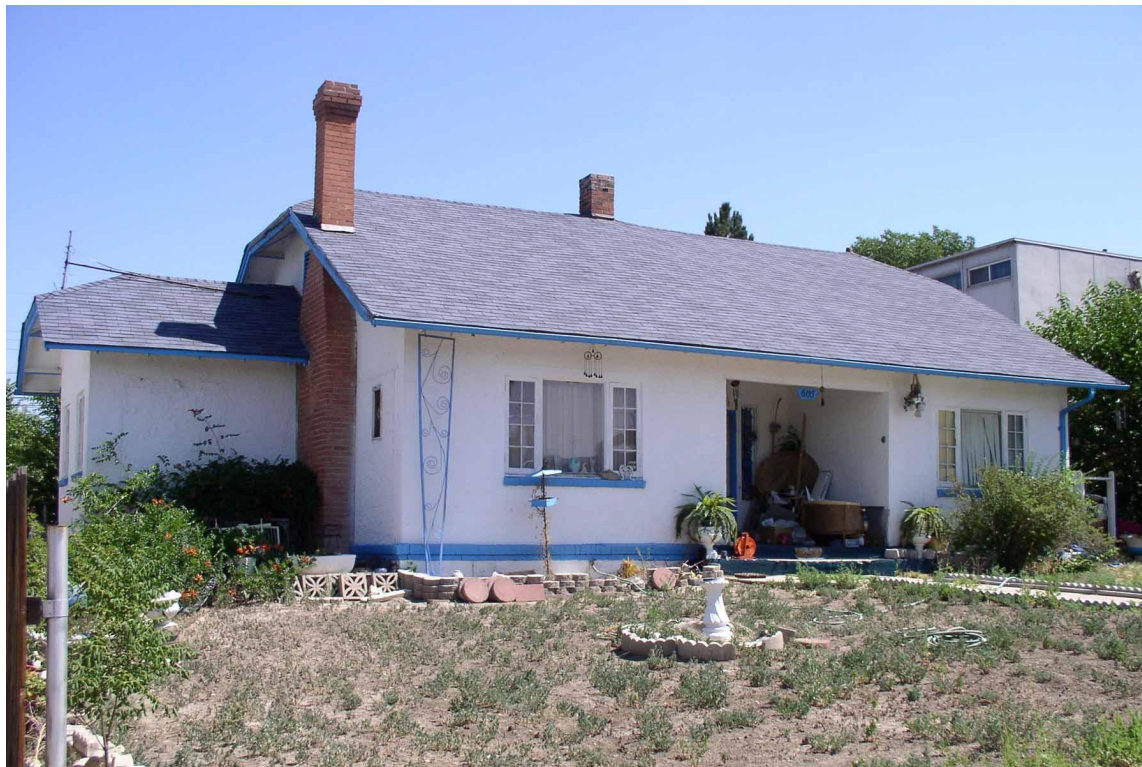
19. Primary external roof material: **Asphalt Roof/Composition Roof**
Other roof materials:
20. Special features:
Fence
Chimney
Porch
Window/Stained Glass
21. General architectural description:
Oriented to the south, this house consists of a rectangular box, with a room protruding from the north half of the west elevation. The building rests on a concrete foundation, covered in white-painted stucco. The same stucco clads the exterior walls. A blue-painted, brick watertable marks the junction of the foundation and the exterior walls. Windows are generally 6- to 8-light casements, with white-painted wood frames and surrounds. Those in the front (south) façade flank single-light picture windows. A stained-glass casement opens in the south end of the west elevation. All windows opening in the east elevation are protected behind blue-painted, wrought-iron grilles. An integral porch dominates the center of the nearly symmetrical façade. It provides access to the principal doorway, which hosts a 1-panel, 1-light wood door, painted white, opening behind a blue-painted, security-type storm door. Flanking it are sidelights. Another doorway opens in the west end of the rear (north) elevation. It hosts a 10-light, glass-in-wood-frame door, painted white. A shallow, front-gabled hood, on knee brackets, protects the doorway. Gray asphalt shingles cover the side-gabled roof and the rafter ends are exposed. The gables are clipped. An engaged, red-brick hearth and chimney protrude from the south end of the west elevation. Another chimney protrudes from the center of the roof ridge.
