COLORADO CULTURAL RESOURCE SURVEY

Architectural Inventory Form

- 1. Resource number: **5PE.5684**
- 2. Temporary resource number:
- 3. County: **Pueblo**
- 4. City: **Pueblo**
- 5. Historic building name: **Carleton, Albert R., House**
- 6. Current building name: **Raley, Nancy C., House**
- 7. Building address: **606 W 14th Street**
- 8. Owner name: **Nancy C. Raley**
- Owner organization:
- Owner address: **606 W 14th St**  
**Pueblo, CO 81003**

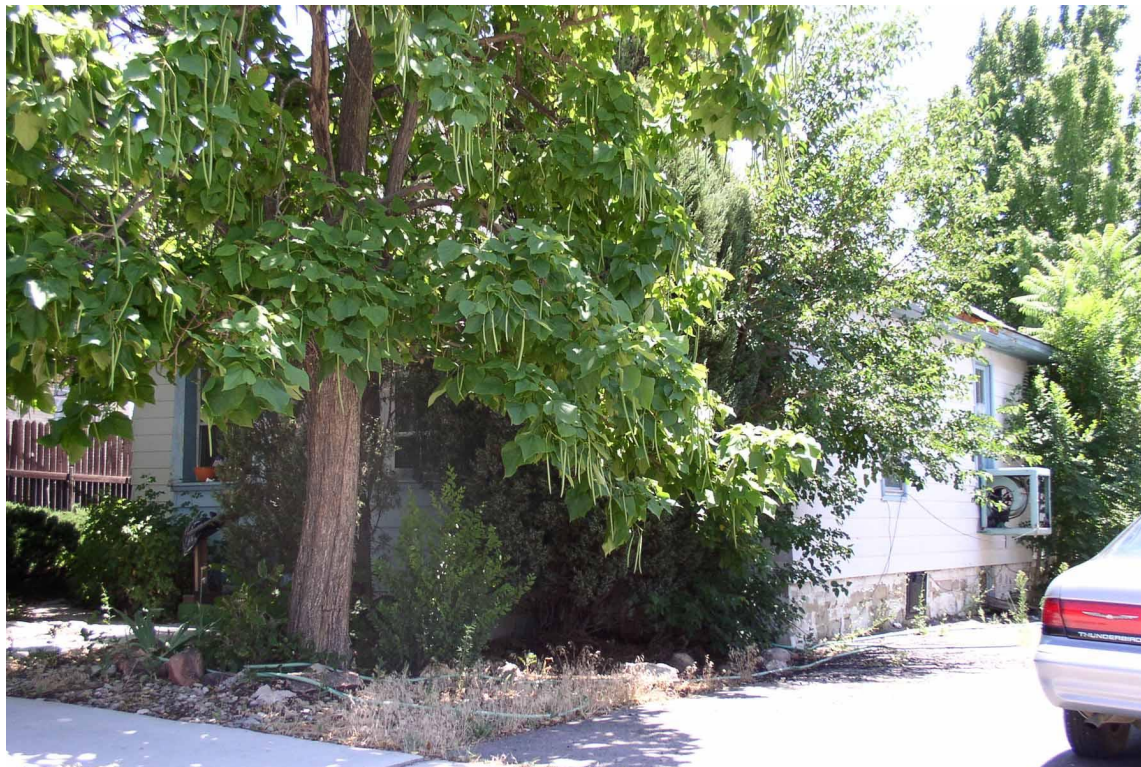
21. General architectural description:  
**Oriented to the north, this house rests on a white-painted sandstone foundation. White aluminum siding clads the exterior walls. Windows are generally 1-over-1-light, double-hung sash, with blue-painted wood frames and surrounds, and aluminum-frame storm windows. Some appear to open beneath segmental arches, and aluminum awnings shade the windows opening in the east elevation. A small, hipped-roof porch protrudes from the center of the front (north) façade. It has a kneewall covered in blue aluminum siding. Tapered, square porch supports rest on the knee wall. The principal doorway opens in the center of the façade, sheltered by the porch. It hosts a white-painted slab door opening behind a white, vinyl-frame storm door. Another doorway opens in the south end of the east elevation. It hosts a 4-panel, 1-light wood door, painted white. Approaching it is a concrete stoop. Yet another doorway opens low in the rear (south) elevation, at the end of small, shed-roofed structure. It has a white-painted slab door, opening behind a vinyl-frame storm door. Gray interlocking asphalt shingles cover the centrally hipped roof. White-painted wood fascia and soffit box the broadly overhanging eaves.**

- NOTE: Due to inaccessibility and dense foliage, not every detail of this house could be recorded from public rights-of-way.**
22. Architectural style: **No Style**  
Other architectural styles:

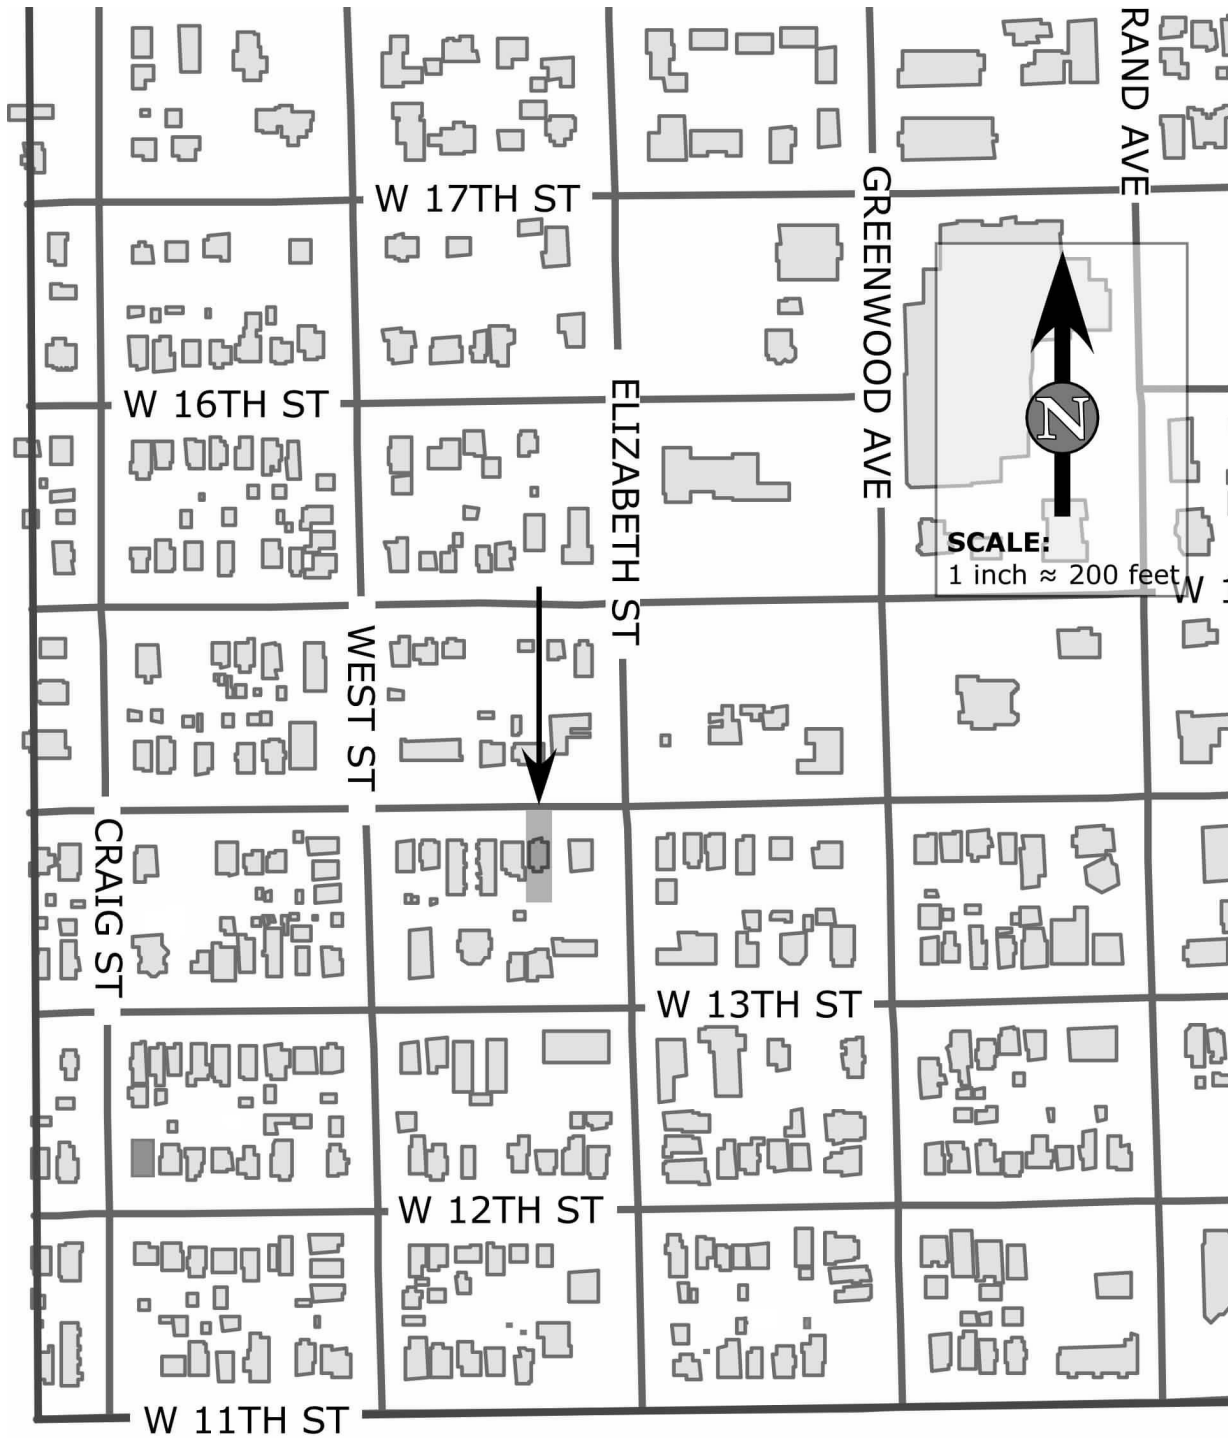
#### SITE SKETCH MAP

This property is located on terrain sloping downward from northwest to southeast, with an elevation of around 4,700 feet above mean sea level. The neighborhood features modest, one- and two-story houses. Setbacks from West 14th Street are generally the same on this block. This property is situated on the south side of West 14th Street, between a vacant lot to the east and 608 West 14th Street to the west. Gravel covers the strip separating the sidewalk from the street. Gravel also covers much of the yard. However, dense foliage, including a pair of large, shady catalpas, largely conceals the house. Lining the east and west sides of the property are wood privacy fences.
