COLORADO CULTURAL RESOURCE SURVEY

Architectural Inventory Form

- 1. Resource number: **5PE.5686**
- 2. Temporary resource number:
- 3. County: **Pueblo**
- 4. City: **Pueblo**
- 5. Historic building name: **609 West 14th Street**
- 6. Current building name: **Pendleton, Rick, House**
- 7. Building address: **609 W 14th Street**
- 8. Owner name: **Rick Pendleton**
- Owner organization:
- Owner address: **609 W 14th St**  
**Pueblo, CO 81003**

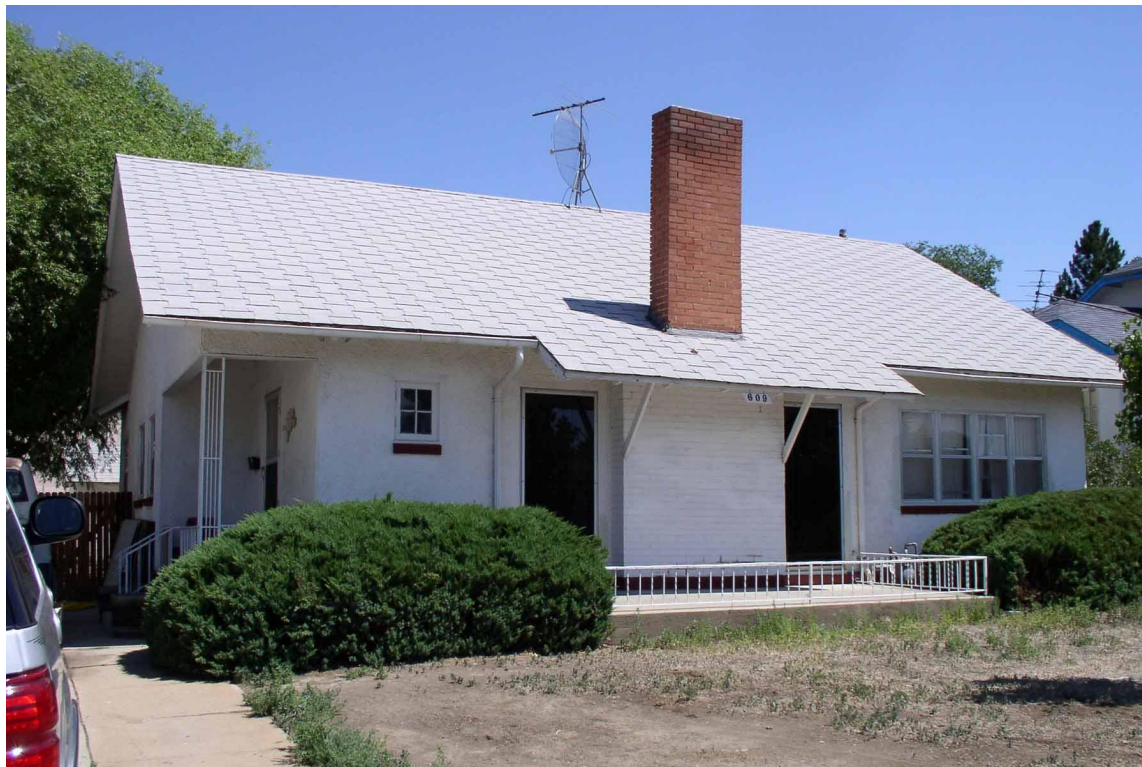
**Oriented to the south, this house consists of a side-gabled, rectangular box, with a front-gabled bay protruding from the west end of the rear (north) elevation. The building rests on a concrete foundation, covered in red-painted stucco. White-painted stucco clads the exterior walls. Marking the junction of the foundation and the exterior walls is a red-painted brick watertable. Windows are generally 1-over-1-light, single-hung sash, with aluminum frames and white-painted wood surrounds. A 4-light casement window, with a white-painted wood frame, opens in the west end of the asymmetrical front (south) façade. A band of 6-light hopper or awning windows line the enclosed, rear porch. An integral porch is situated within the southwest corner of the house. It has a white-painted, wrought-iron railing and support. Approaching the center of the porch's west elevation are two concrete steps. The principal doorway opens in the west face of the inside (southwest-facing) corner. It hosts a wood slab door, opening behind an aluminum-frame storm door. Another doorway opens in an enclosed, shed-roof porch that protrudes from near the center of the rear (north) elevation. It hosts a wood slab door, painted white, approached by two concrete steps. Gray, interlocking asphalt shingles cover the side-gabled roof, and the rafter ends are exposed. A large, engaged, red-brick hearth and chimney protrudes from the center of the facade. The lower portion is painted white. A concrete patio, with low, wrought-iron railing, surrounds the hearth, sheltered beneath a shed-roof on simple knee brackets.**

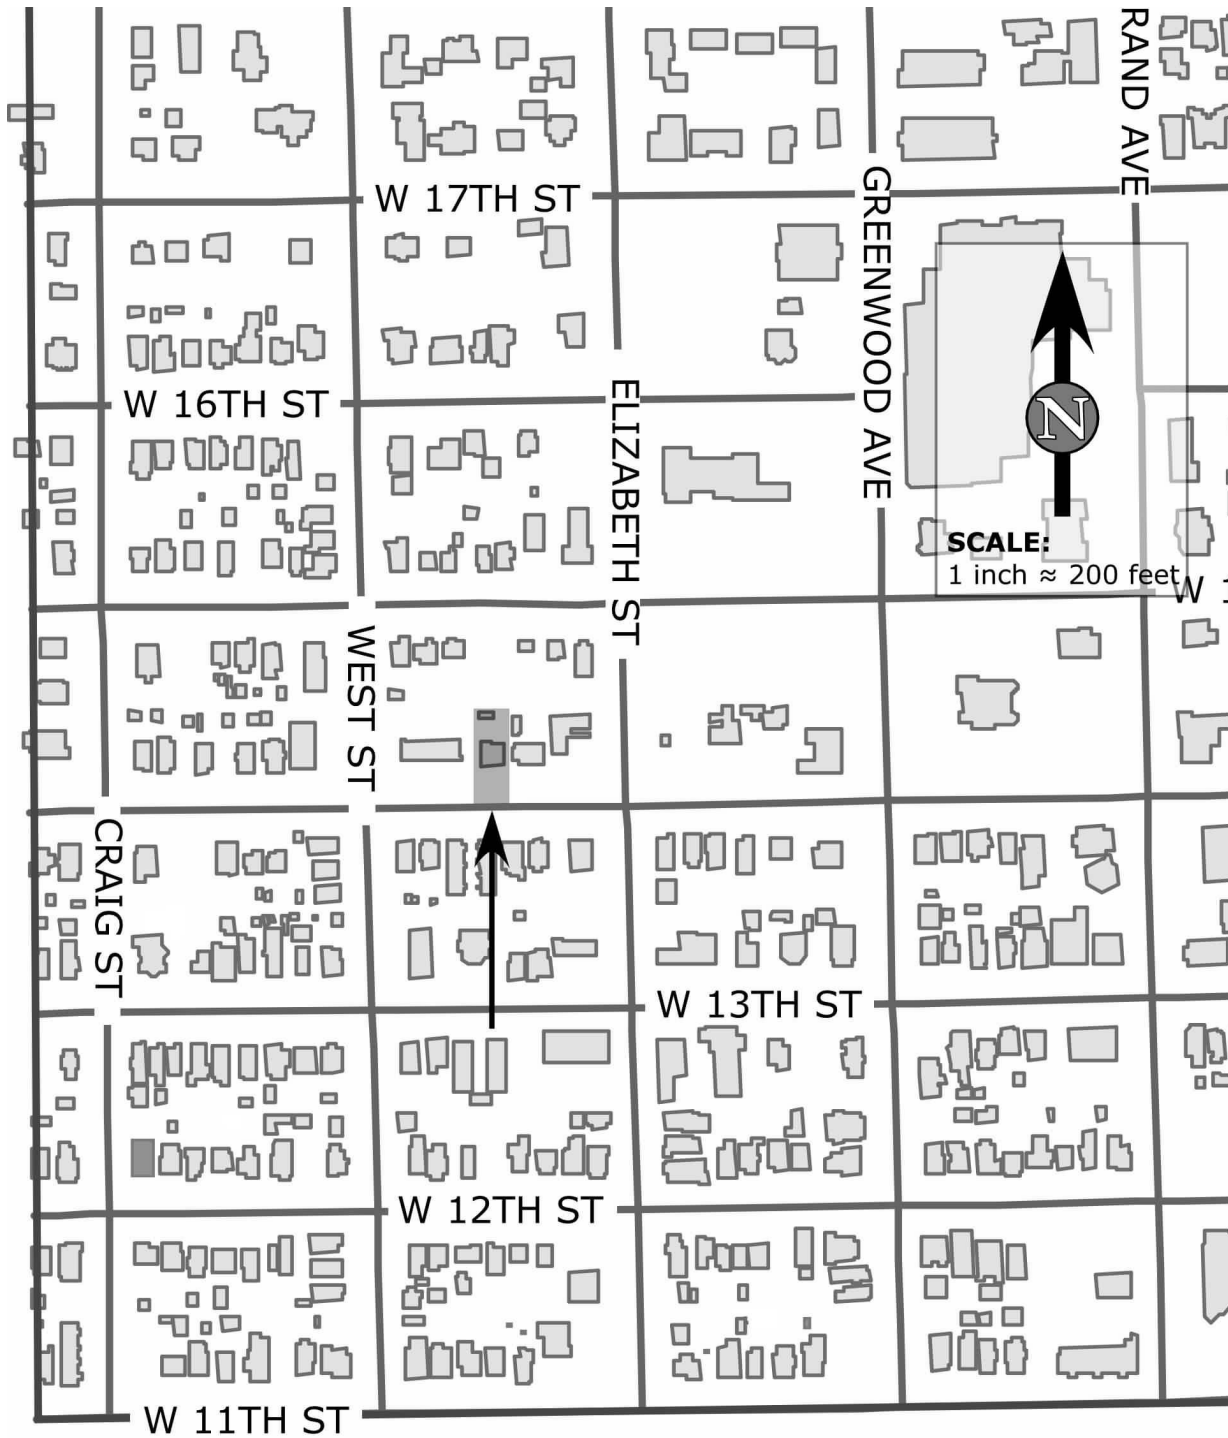
SITE SKETCH MAP

**This property is located on terrain sloping downward from northwest to southeast, with an elevation of around 4,700 feet above mean sea level. The neighborhood features modest, one- and two-story houses. Setbacks from West 14th Street are generally the same on this block. This property is situated on the north side of West 14th Street, between 609 West 14th Street to the east and 625 West 14th Street to west. Grass covers the strip separating the sidewalk from the street. A planted-grass yard, with mature landscaping, covers the lot. Flanking either side of the house are large junipers. A concrete driveway approaches the southwest corner of the house from West 12th Street. Encircling the back yard is a woven-wire fence.**
