COLORADO CULTURAL RESOURCE SURVEY

Architectural Inventory Form

- 1. Resource number: **5PE.5687** Parcel number(s):
- 2. Temporary resource number: **525409003**
- 3. County: **Pueblo**
- 4. City: **Pueblo**
- 5. Historic building name: **610-620 West 14th Street Apartments**
- 6. Current building name: **610-620 West 14th Street Apartments**
- 7. Building address: **616-620 W 14th Street**
- 8. Owner name: **Kamran Atabai**
- Owner organization:
- Owner address: **747 W Abriendo Ave**  
**Pueblo, CO 81004**

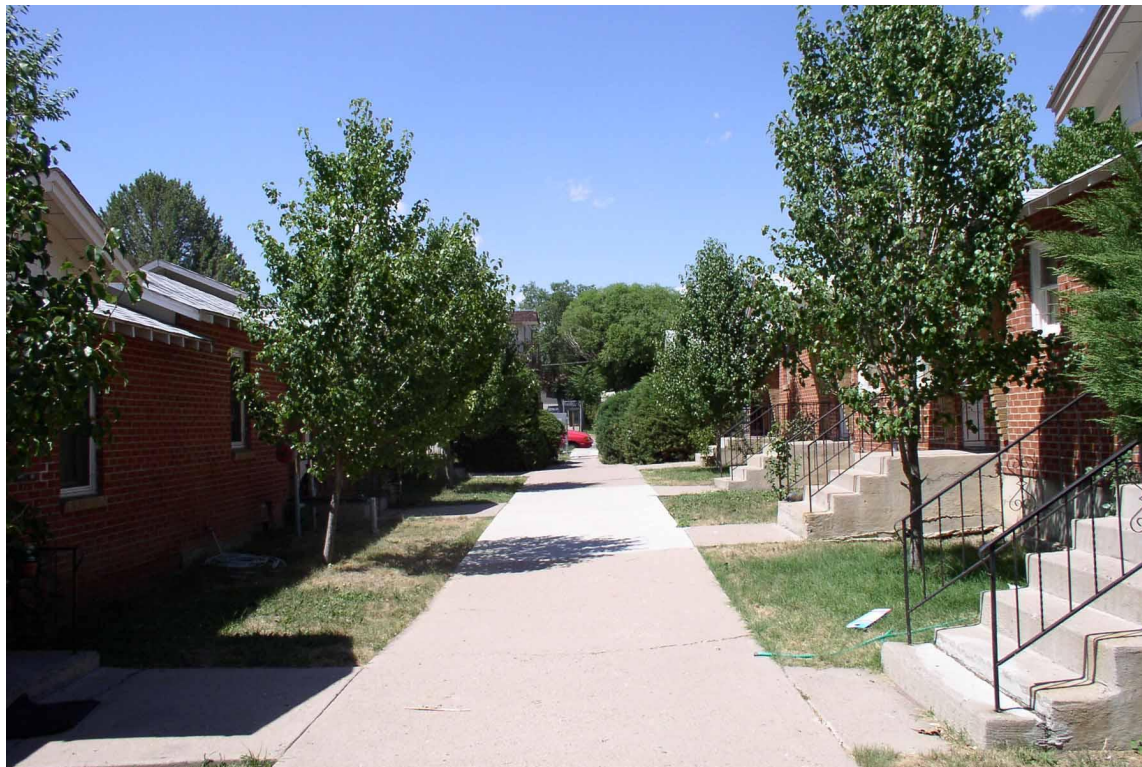
Oriented to the west, this 4-unit apartment building rests on a concrete foundation. A red, raked-brick veneer clads the exterior walls. White-painted, vertical board-and-batten siding covers the gables. Windows are generally 1-over-1-light, double-hung sash, with white-painted wood frames and tan, raked-brick sills. Lining the west elevation are single-light picture windows. The principal doorway into each apartment opens in the front (west) façade. Each hosts a 4-light, 3-panel, glass-in-wood-frame door, painted white, opening behind a wood-frame screen door. A 3-step concrete stoop approaches each doorway. Wrought iron railings flank both sides of the stoops. Front gabled hoods, on corbelled, tan-brick brackets, shelter the stoops. A small, front-gabled structure protrudes from the center of the south elevation. It has walls of beige-painted particleboard. Opening at its center is a 4-panel, white-painted wood door. Gray, interlocking asphalt shingles cover the side-gabled roof. The rafter ends are exposed.

This building is identical to west building except that it is oriented to the east, contains only 3 units, and is terraced to match the slope. It also lacks the gabled-roofed structure protruding from the rear (west) elevation. As well, the units have rear (west) doorways, which are accessed via small concrete stoops.
