COLORADO CULTURAL RESOURCE SURVEY

Architectural Inventory Form

- 1. Resource number: **5PE.5689** Parcel number(s):
- 2. Temporary resource number: **525310001**
- 3. County: **Pueblo**
- 4. City: **Pueblo**
- 5. Historic building name: **Balcom-Phillips House**
- 6. Current building name: **McCluskey House**
- 7. Building address: **710 W 14th Street**
- 8. Owner name: **Sharol J., Michael W., and Jonathan McCluskey**
- Owner organization:
- Owner address: **5 Pedregal Ln**  
**Pueblo, CO 81005**

48. Report title: **Pueblo North Side Neighborhood Survey**

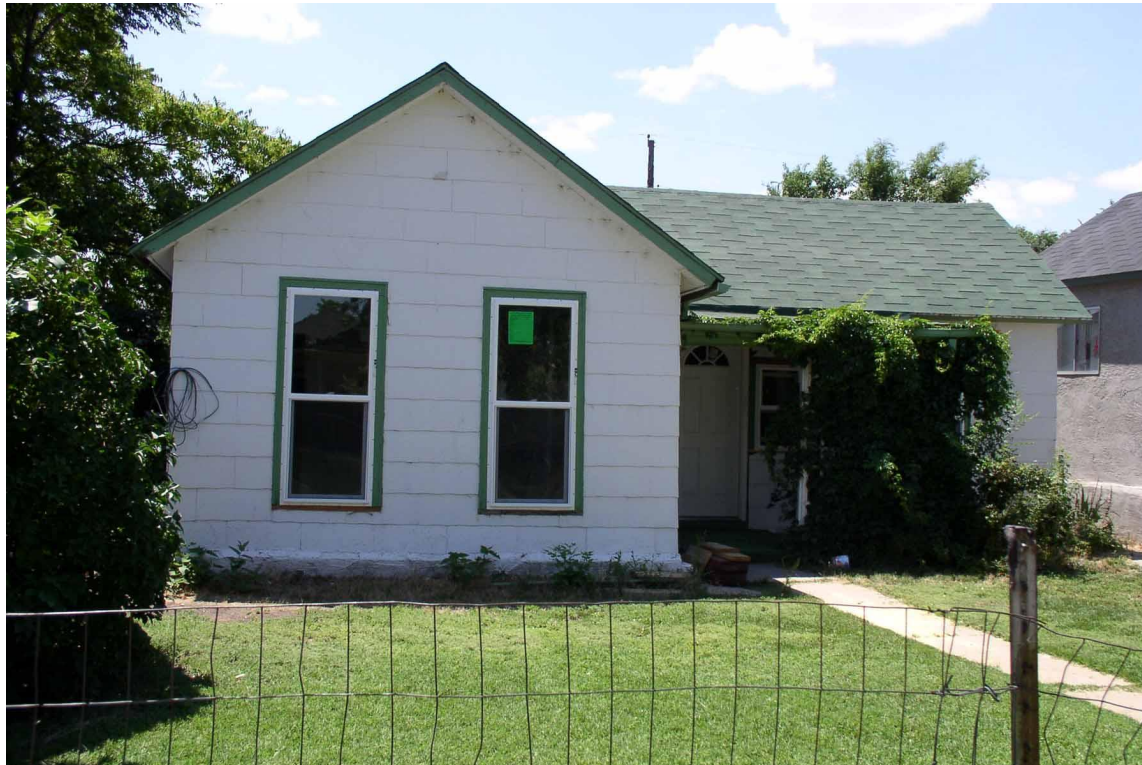
**Oriented to the north, this house rests on a random-coursed sandstone foundation, now almost entirely obscured behind white-painted concrete. Generally, windows are 1-over-1-light, double-hung sash, with white-vinyl frames and green-painted wood surrounds. A shed-roofed addition across the rear elevation has 1-beside-1-light, sliding-sash windows, with white vinyl frames. A small, shed-roofed porch fills the inside (northwest-facing) corner of the asymmetrical front (north) façade. It has a low concrete floor and simple, square, white-painted wood supports. Two doorways, one in each face of the corner, open beneath the porch. The principal doorway opens in the north face and hosts a 6-panel, white-painted metal door, with a fanlight. The other doorway hosts a 3-panel, 2-light, glass-in-wood-frame door, opening behind a wood-frame screen door. Another doorway opens in the east end of the rear (south) elevation. It hosts a 6-panel, gray, metal door. Green, interlocking asphalt shingles cover the cross-gabled roof. White-painted wood soffit and green-painted fascia box the eaves.**
