COLORADO CULTURAL RESOURCE SURVEY

Architectural Inventory Form

- 1. Resource number: **5PE.5690** Parcel number(s):
- 2. Temporary resource number: **525301001**
- 3. County: **Pueblo**
- 4. City: **Pueblo**
- 5. Historic building name: **Christman, Henry R., House**
- 6. Current building name: **Martinez, Manuel M. and Karin S., House**
- 7. Building address: **711 W 14th Street**
- 8. Owner name: **Manuel M. Martinez and Karin S. Martinez**
- Owner organization:
- Owner address: **PO Box 791**
Pueblo, CO 81002

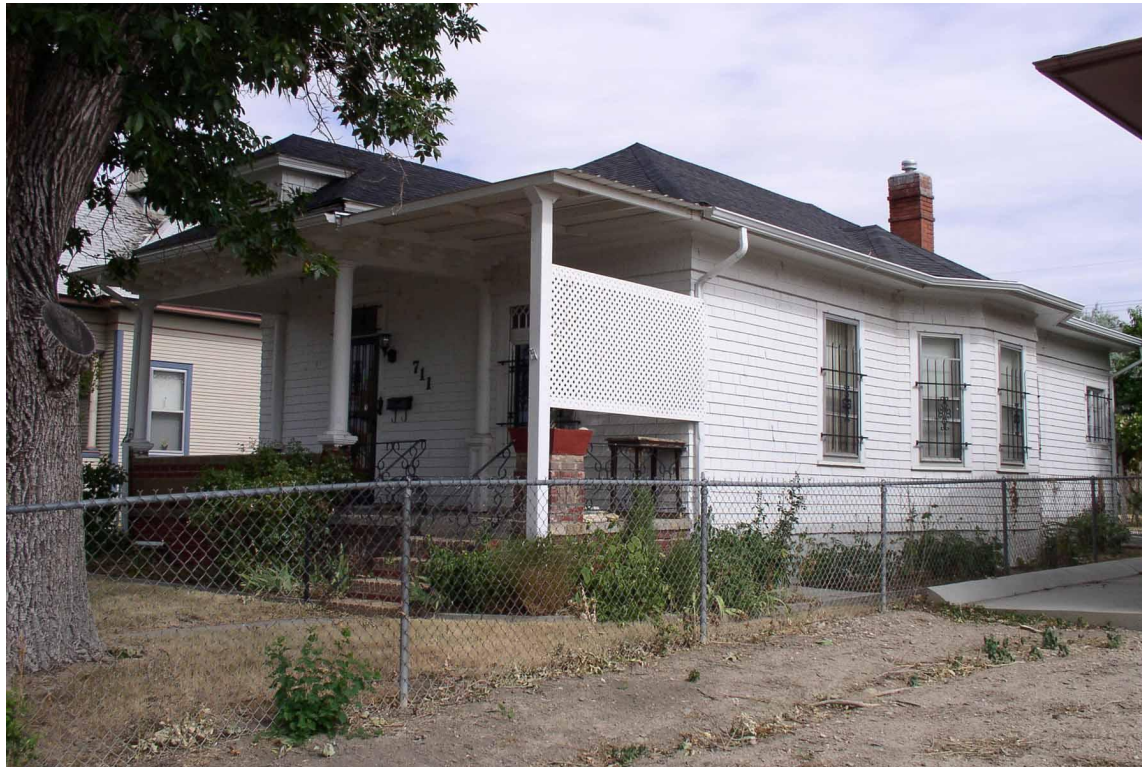
21. General architectural description:
Oriented to the south, this house rests on a concrete foundation. White-painted, square-cut wood shingles clad the exterior walls. Windows are generally 1-over-1-light, double-hung sash, with white-painted wood frames, aluminum-frame storm windows, and white-painted wood surrounds. Black, wrought-iron bars protect the windows. A 3-sided, canted bay protrudes from the center of the east elevation. Opening in the east end of the front (south) façade is a single-light, fixed-frame window, with a cottage-glazed transom. Hopper or awning windows open in the north and south ends of the west elevation. 6-light casement windows open in the north end of the side elevations and across a shed-roofed structure at the center of the rear elevation. A hipped-roof porch protrudes from the west half of the front façade. It has a concrete floor, red- and tan-brick kneewall and white-painted, wood, Doric columns. Closely spaced modillions appear beneath the porch eaves. Approaching the porch from the east is a large, covered stoop, which fills the rest of the elevation. It features a decorative, wrought-iron railing. Approaching the stoop on the east end of its west elevation are 4 brick steps. The principal doorway opens in the west end of the façade. It hosts a single-light, wood slab door, opening behind a black, security-type storm door. Above these doors is a single-light transom. A white-painted, wood slab door opens in the east elevation of the protruding, rear structure. A single

concrete step approaches the door. It provides access to an uncovered, concrete patio. Black asphalt shingles cover the cross-hipped roof, and white-painted wood soffit and fascia box the broadly overhanging, flared eaves. A hipped-roof dormer protrudes from the porch roof. It hosts a white, metal, louvered vent. A red-brick chimney protrudes from the north end of the roof's east-facing slope.

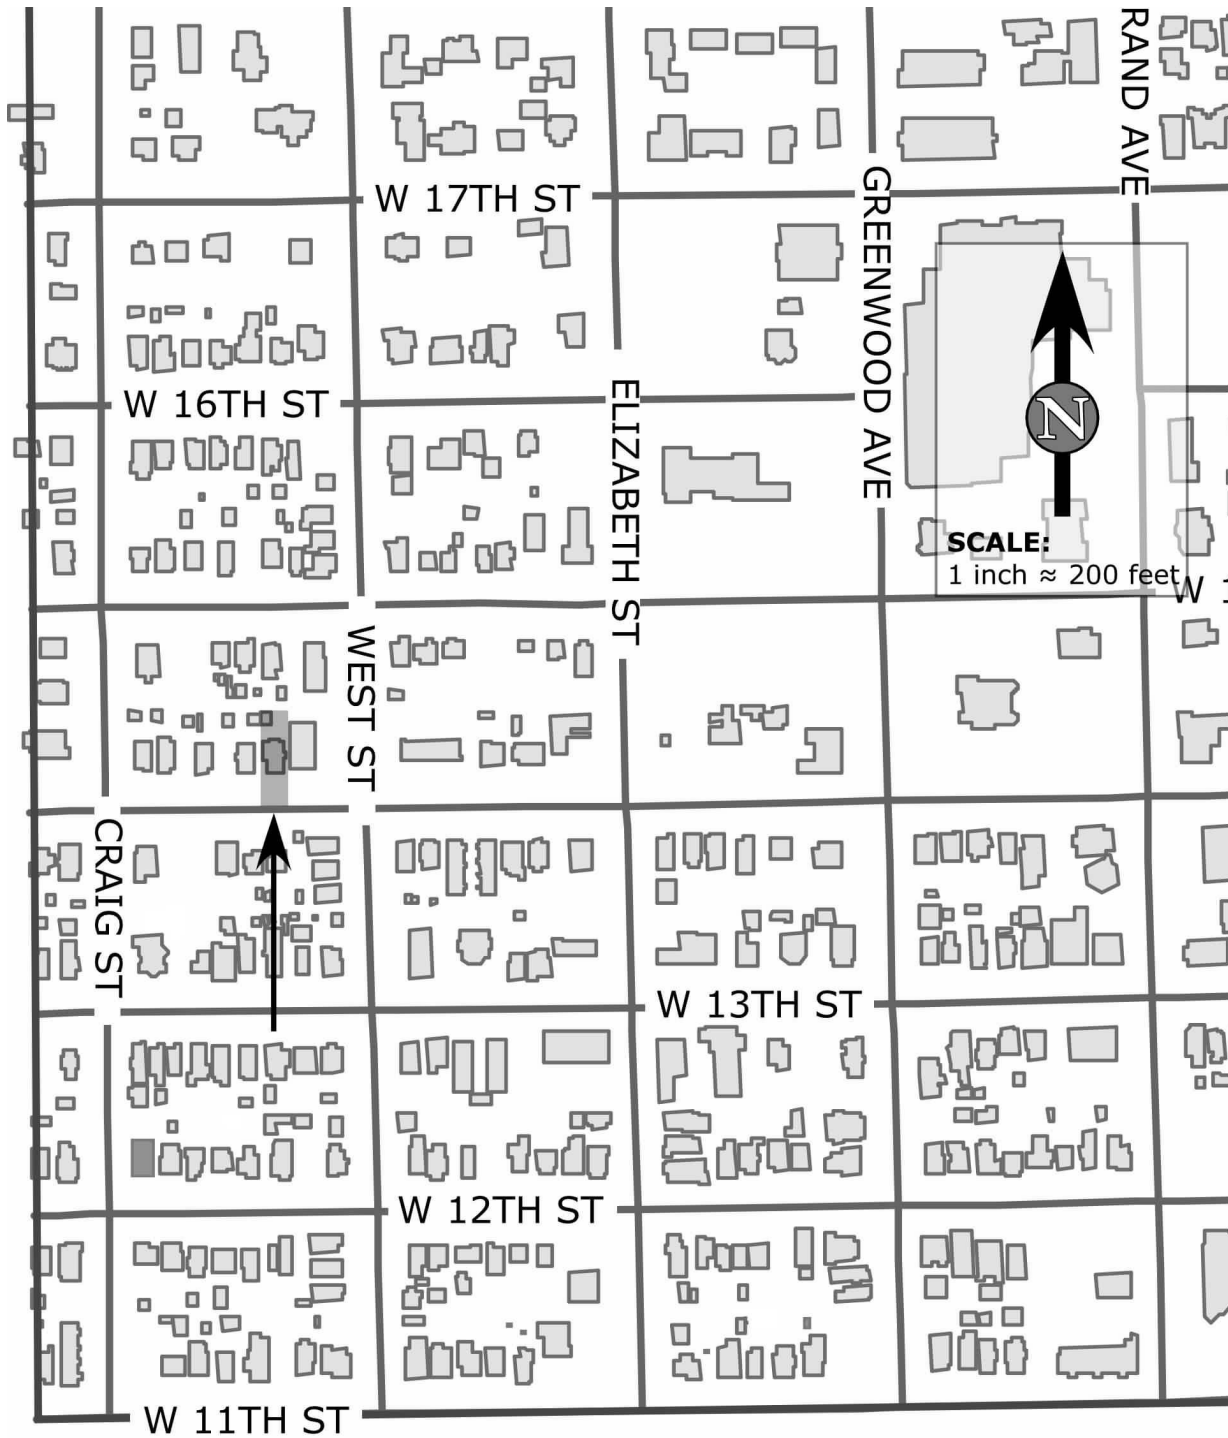
SITE SKETCH MAP

This property is located on terrain sloping downward from northwest to southeast, with an elevation of around 4,700 feet above mean sea level. The neighborhood features modest, one- and two-story houses. Setbacks from West 14th Street are generally the same on this block. This property is situated on the south side of West 14th Street, between 1325 West Street to the east and 712 West 14th Street to the west. Grass covers the strip separating the sidewalk from the street. A planted-grass yard, with mature landscaping, covers the property. Enclosing the back yard is a woven-wire fence.

Describe: **A 2-car garage is located on the northwest corner of the property. Oriented to the north, the building rests on a concrete slab. White-painted, vertical board-and-batten siding clads the exterior walls. Dominating the front (north) elevation is a wooden-composition, overhead-retractable garage door, painted tan. A 4-panel wood door opens in the north end of the east elevation. Protruding from the rear (south) elevation is a small, shed-roofed addition. Gray asphalt shingles cover the front-gabled roof. The rafter ends are exposed but capped by a fascia board, and knee brackets appear in the gables.**
