COLORADO CULTURAL RESOURCE SURVEY

Architectural Inventory Form

- 1. Resource number: **5PE.517.48**
- 2. Temporary resource number:
- 3. County: **Pueblo**
- 4. City: **Pueblo**
- 5. Historic building name: **Laben, Frank J., House**
- 6. Current building name: **Pumphrey, William R. House**
- 7. Building address: **715 W 14th Street**
- 8. Owner name: **William R. Pumphrey**
- Owner organization:
- Owner address: **425 W 3rd St**
Pueblo, CO 81003

47. Photograph numbers): **CD-ROM Photo Disc: North Side Photos**
File Name(s): 14thstw715
- Negatives filed at: **Special Collections**
Robert Hoag Rawlings Public Library
100 East Abriendo Avenue
Pueblo, CO 81004-4290
48. Report title: **Pueblo North Side Neighborhood Survey**
49. Date(s): **07/18/05**
50. Recorder(s): **Adam Thomas**
51. Organization: **Historitecture, L.L.C.**
52. Address: **PO Box 419**
Estes Park, CO 80517-0419
53. Phone number(s): **(970) 586-1165**

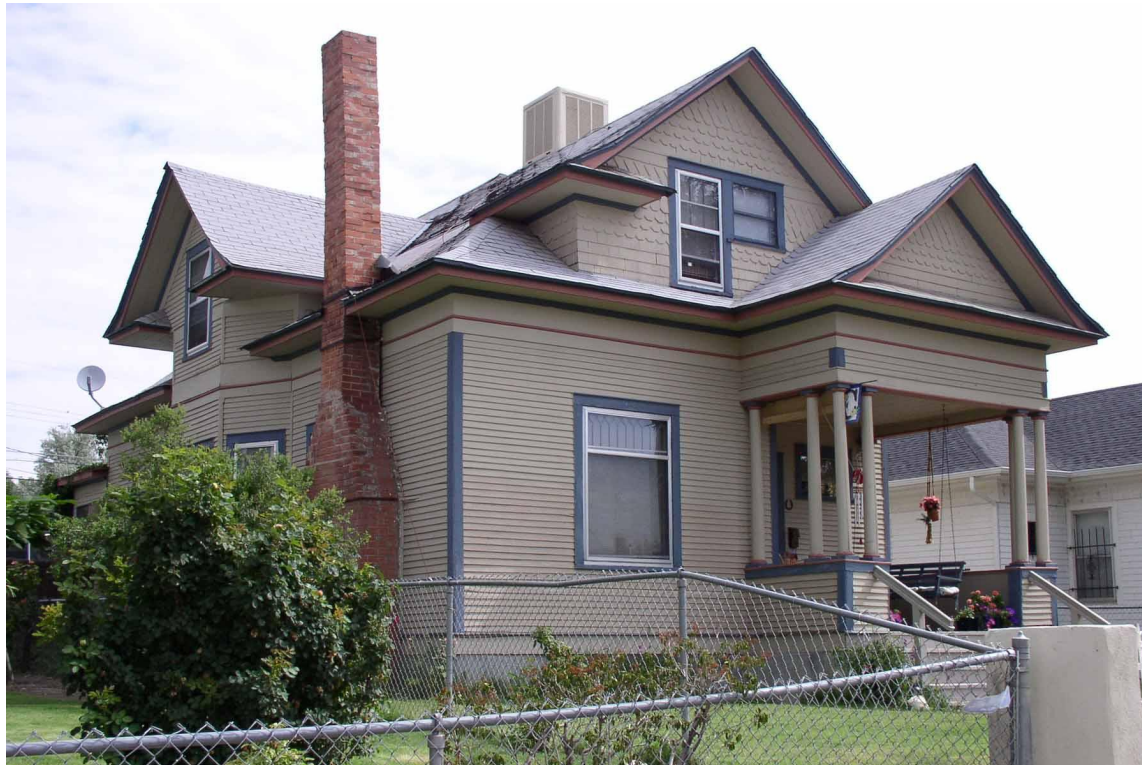
21. General architectural description:
Oriented to the south, this house appears to rest on a sandstone foundation, now concealed behind concrete stucco. Tan-painted, narrow wood siding, with blue-painted, 1-by-4-inch cornerboards, clads the exterior walls. Tan-painted, variegated wood shingles cover the gables. Windows are generally 1-over-1-light, double-hung sash, with blue-painted wood frames, aluminum-frame storm windows, and blue-painted wood surrounds. Dominating the west side of the front (south) facade is a 1-over-1-light window with a narrow upper sash. The sash has cottage-style glazing. Opening in the center of a 1-and-1/2-story, 3-sided, canted bay protruding from the center of the west elevation is a single-light hopper or awning window. A similar window opens in the east end of the front (south) facade. Opening in the south-facing, front-gabled dormer is a 6-over-1-light window. A 1-beside-1-light, fixed-frame window, with brown aluminum frames, pierces the east-facing, shed-roofed gable south of center. Fixed-frame windows open in the sides of this gable. A front-gabled porch protrudes from the east end of the facade. It has a wood floor, siding-clad kneewalls, and round supports, grouped in threes at the corner. Approaching the porch at its center are

4 wood steps. The principal doorway opens beneath the porch. It hosts an 11-panel, 1-light, glass-in-wood-frame door, with projecting top and locking rails. Another doorway opens in the west end of the rear (north) elevation. It hosts a white-painted, glass-in-wood frame door. Gray asphalt shingles cover the gable-on-hipped roof. Tan-painted beadboard soffit and pink-painted wood fascia box the broadly overhanging, flared eaves. An engaged, red-brick hearth and chimney protrudes from the south end of the west elevation. The gables have eave returns. The porch gable is pedimented.
