COLORADO CULTURAL RESOURCE SURVEY

Architectural Inventory Form

- 1. Resource number: **5PE.517.49** Parcel number(s):
- 2. Temporary resource number: **525301004**
- 3. County: **Pueblo**
- 4. City: **Pueblo**
- 5. Historic building name: **Allard, Joseph G., House**
- 6. Current building name: **McDaniel, Iva Nell, House**
- 7. Building address: **723 W 14th Street**
- 8. Owner name: **Iva Nell McDaniel**
- Owner organization:
- Owner address: **2415 N Elizabeth St**
Pueblo, CO 81003

47. Photograph numbers): **CD-ROM Photo Disc: North Side Photos**
File Name(s): 14thstw723
- Negatives filed at: **Special Collections**
Robert Hoag Rawlings Public Library
100 East Abriendo Avenue
Pueblo, CO 81004-4290
48. Report title: **Pueblo North Side Neighborhood Survey**
49. Date(s): **07/18/05**
50. Recorder(s): **Adam Thomas**
51. Organization: **Historitecture, L.L.C.**
52. Address: **PO Box 419**
Estes Park, CO 80517-0419
53. Phone number(s): **(970) 586-1165**

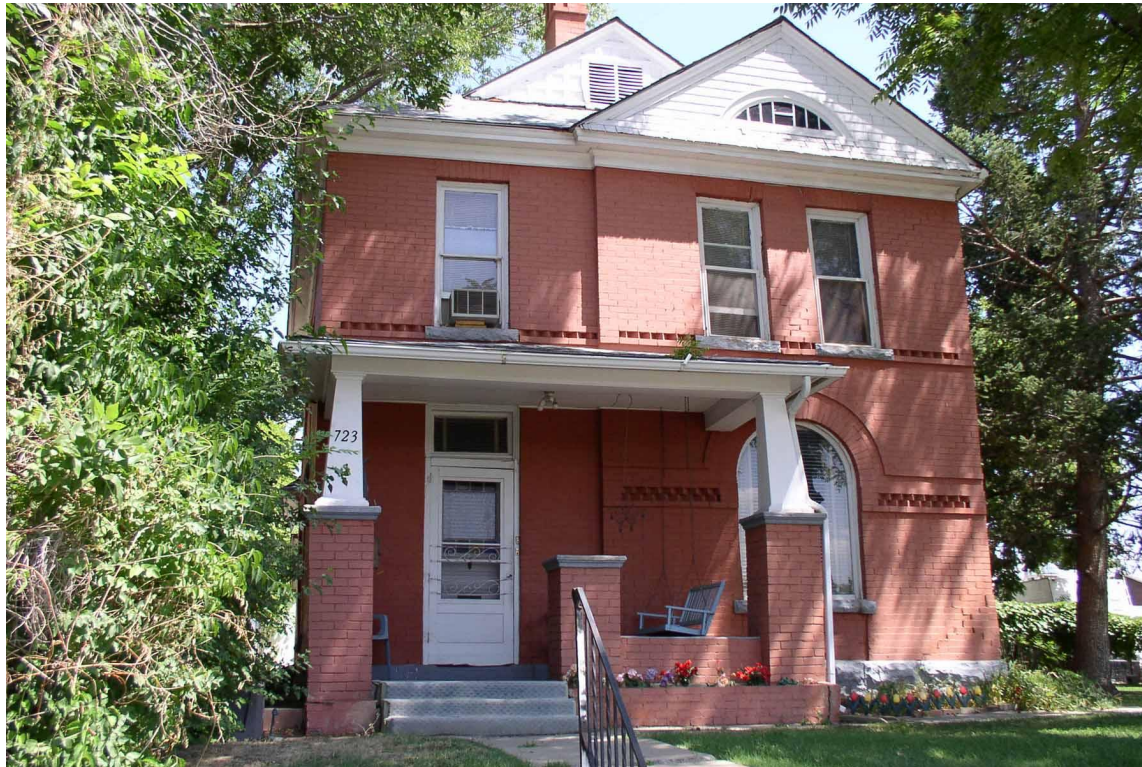
19. Primary external roof material: **Asphalt Roof/Composition Roof**
Other roof materials:
20. Special features: **Chimney**
Porch
Roof Treatment/Dormer
21. General architectural description:
Oriented to the south, this house rests on a gray-painted, rock-faced, random ashlar, sandstone foundation. A salmon-painted brick veneer clads the exterior walls. Square-cut, white-painted wood shingles cover the southernmost gable, while false half-timbering covers all other gables. Across the front (south) elevation are parallel bands of corbelled bricks, the lower corresponding to the door lintel and the upper corresponding to the second-story window sills. Windows are generally 1-over-1-light, double-hung sash, with white-painted wood frames. They open between gray-painted, rock-faced sandstone sills and flat arches. Dominating the east side of the front (south) façade is a single-light, fixed-frame, round-arch window. A brick archivolt traces the arch. A round-arch window pierces the southernmost gable. Single-light hopper or awning windows pierce a shed-roofed dormer protruding from a single-story, hipped-roof structure across the rear elevation. A hipped-roof porch protrudes from the west half of the façade. It has a concrete floor. The white-painted, battered piers rest on brick pedestals. Two concrete steps approach the porch on the west end of its south elevation. The principal doorway opens in the west side of the façade. It hosts a paneled, white-painted door, with a stained-glass light, opening behind a white-painted storm door. Above the doorway is a single-light transom. Another doorway opens in the east elevation of a shed-roofed enclosed porch protruding from the rear elevation. Gray, interlocking asphalt shingles cover the gable-on-hip main roof and all other roof surfaces. White-painted wood fascia, with protruding cornice, and soffit box the eaves. A red-brick chimney, with corbelled cap, protrudes from the south end of the roof's west slope. Another chimney emerges at the north edge of the roof's north slope.

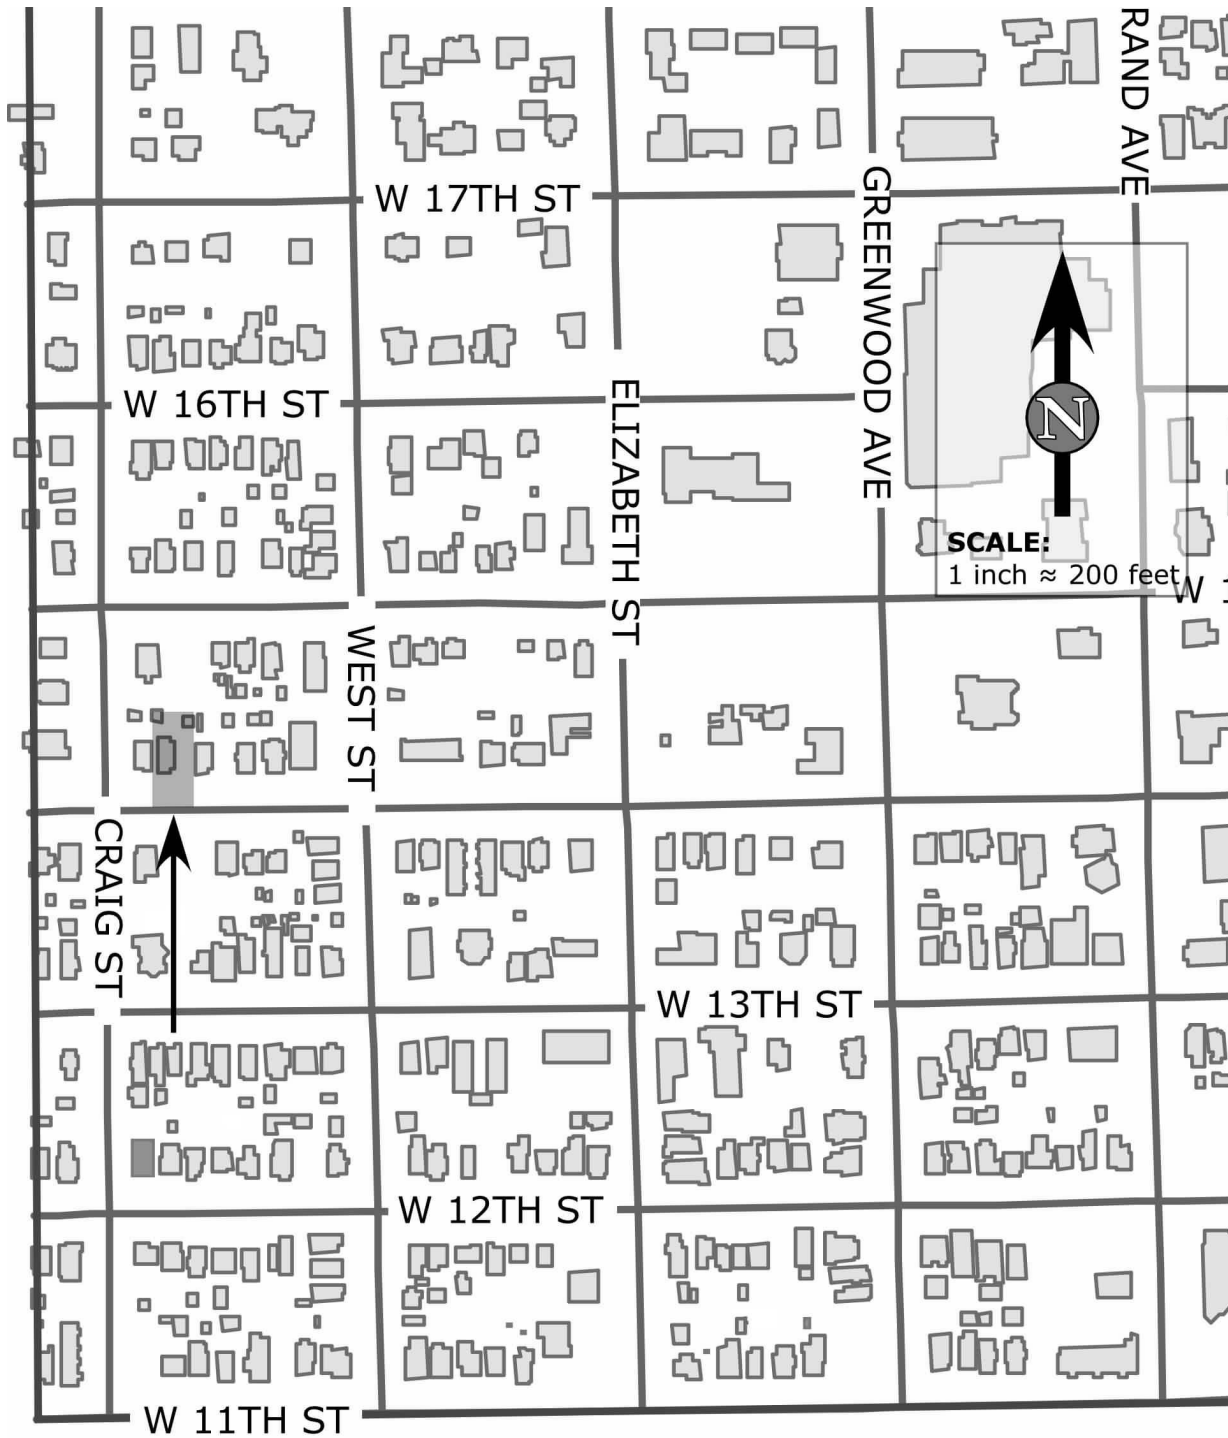
SITE SKETCH MAP

This property is located on terrain sloping downward from northwest to southeast, with an elevation of around 4,700 feet above mean sea level. The neighborhood features modest, one- and two-story houses. Setbacks from West 14th Street are generally the same on this block. This property is situated on the north side of West 14th Street, between 719 West 14th Street to the east and 725 West 14th Street to the west. Grass covers the strip separating the sidewalk from the street. A planted-grass yard, with mature landscaping, covers the rest of the property.

1: Type: **Cottage**

2: Type: **Chicken Coop**

3: Type: **Garage**
