COLORADO CULTURAL RESOURCE SURVEY

Architectural Inventory Form

- 1. Resource number: **5PE.5694**
- 2. Temporary resource number:
- 3. County: **Pueblo**
- 4. City: **Pueblo**
- 5. Historic building name: **Bauer, Minnie D., House**
- 6. Current building name: **724 West 14th Street**
- 7. Building address: **724 W 14th Street**
- 8. Owner name: **Gary N. and Leilani M. Adrian**
- Owner organization:
- Owner address: **727 W 13th St**
Pueblo, CO 81003

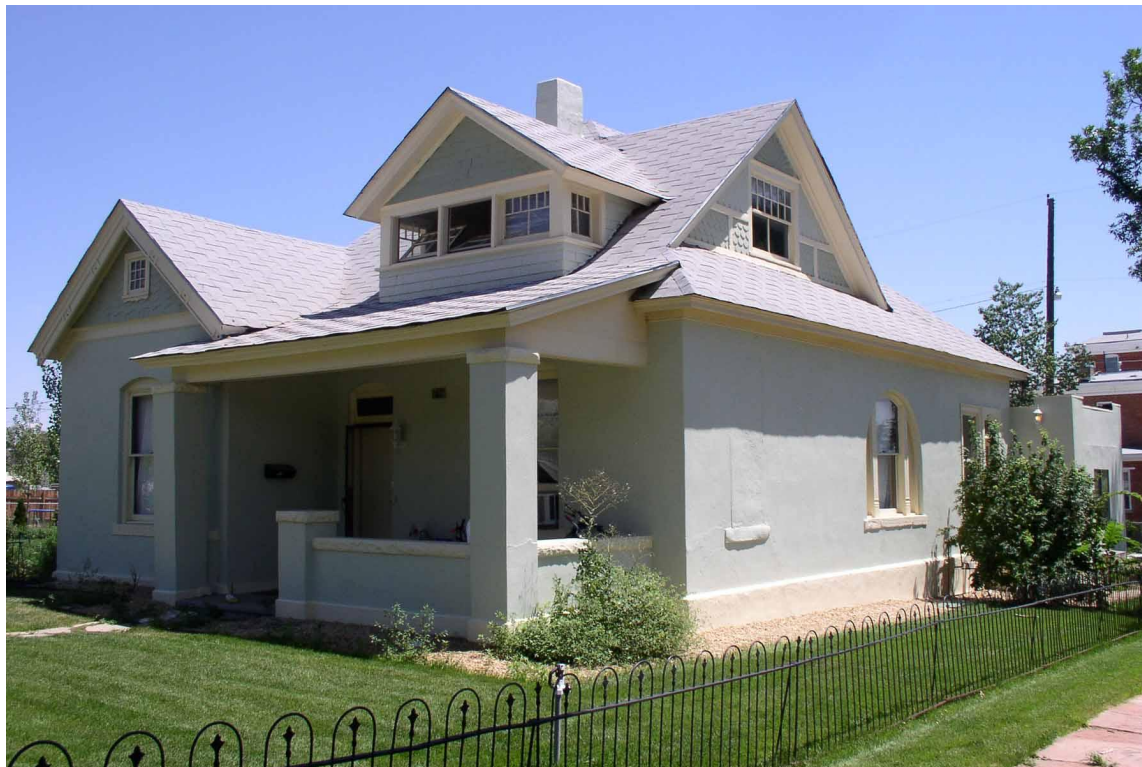
21. General architectural description:
This house is oriented to the north. Yellow-painted stucco entirely conceals the foundation. Sea-foam-green stucco clads the exterior walls. Variegated wood shingles cover the gables. Windows opening in the first floor are generally 1-over-1-light, double-hung sash, with yellow-painted wood frames. They open between yellow-painted, dressed sandstone sills and segmental arches. A window opening in the north end of the west elevation has been enclosed with stucco. A tripartite, round-arch window opens near the center of the west elevation. An enclosed garage, attached to the house's southwest corner, has 1-beside-1-light, sliding-sash windows, with aluminum frames and no surrounds. Piercing the center of the east- and west-facing gables are 12-over-2-light, double-hung sash windows, with yellow-painted wood frames and surrounds. The surrounds have

projecting cornices. A small, 9-light window pierces the north-facing gable. A front-gabled dormer above the front (north) porch appears to host a sleeping porch. Enclosing it is a band of 8-light hopper windows. A shed-roofed porch fills the inside (northwest-facing) corner of the porch. The porch has a low, concrete floor. The stucco-covered kneewall and supports have pink-painted, sandstone caps. The principal doorway opens in the north face of the corner, near the center of the asymmetrical façade. It hosts a yellow-painted, wood slab door, opening behind a black, security-type storm door. Above it is a single-light transom. Another doorway, addressed as 1320 Craig Street, opens in the south end of the west elevation. It hosts a 3-panel, 3-light (vertical) door, opening beneath a transom. Approaching it is a 3-step concrete stoop, with pipe railing. Gray, interlocking asphalt shingles cover the gable-on-hip main roof and all other roof surfaces. Yellow-painted wood soffit and fascia, with projecting cornice, box the eaves. A frieze is below the soffit. A decorative vergeboard traces the north-facing gable. A stucco-covered chimney protrudes from just south of the front-gabled dormer. Another protrudes from the south-facing slope. A parapet surrounds the attached garage's shed roof.

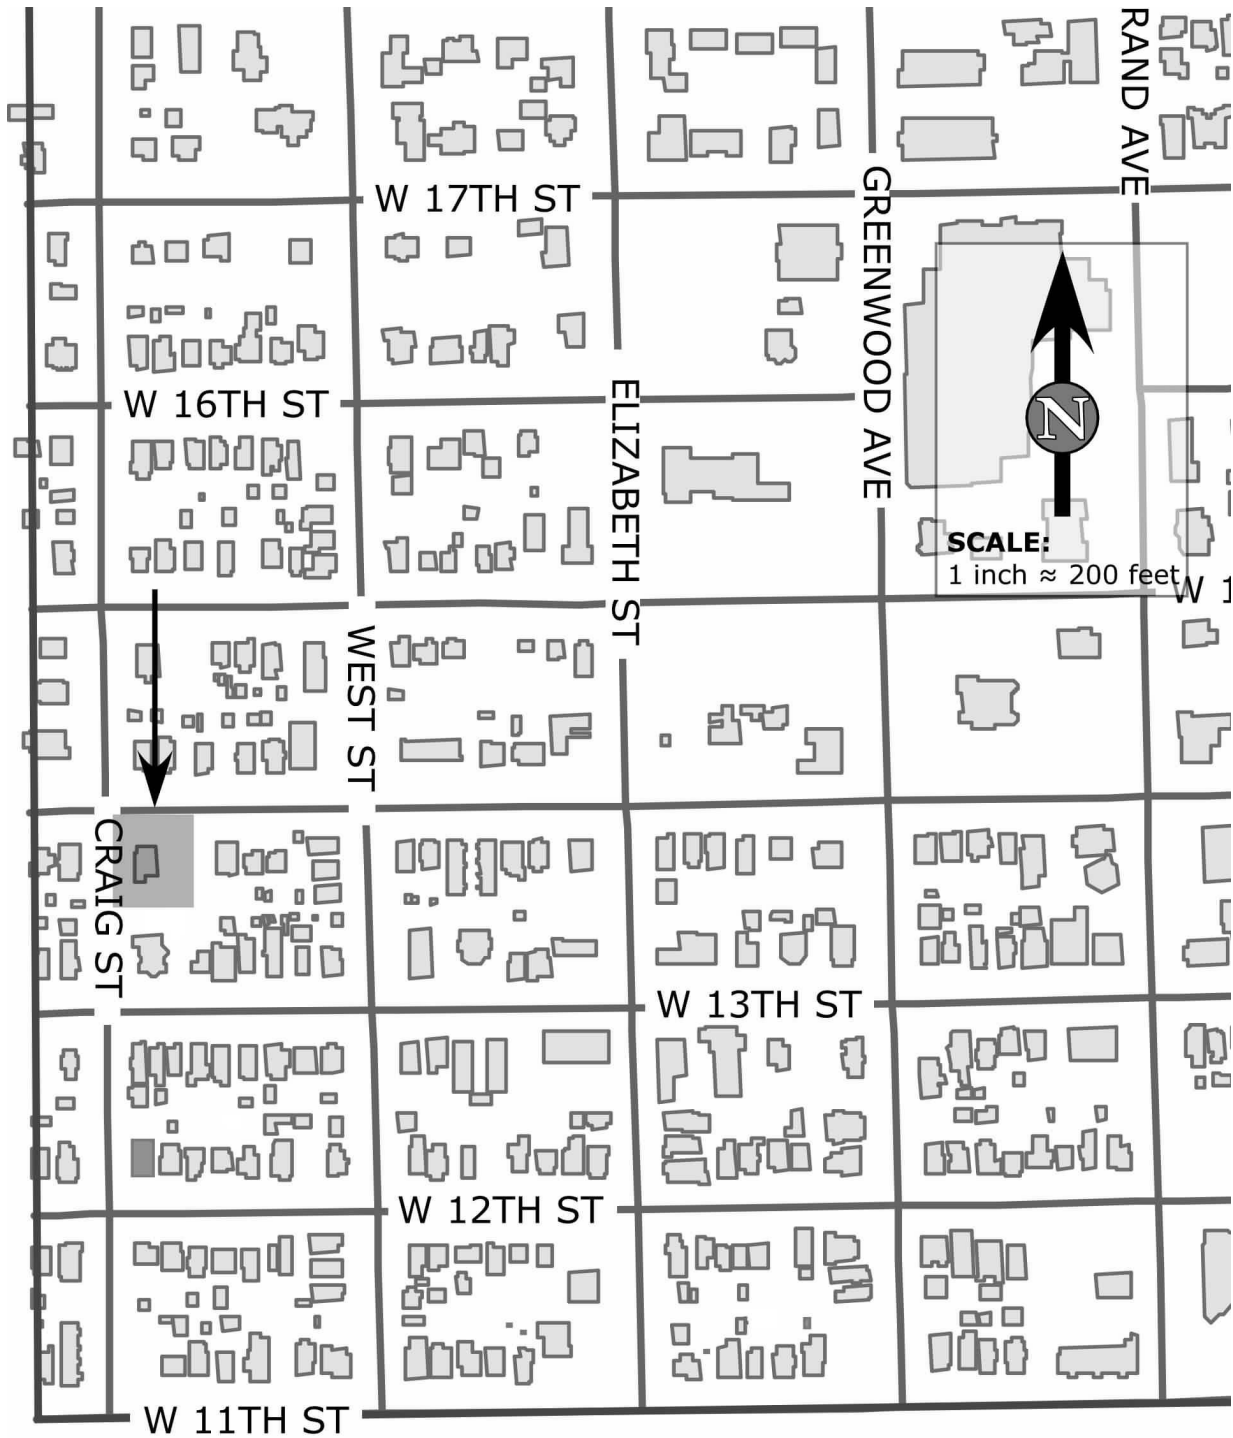
SITE SKETCH MAP

This property is located on terrain sloping downward from northwest to southeast, with an elevation of around 4,700 feet above mean sea level. The neighborhood features modest, one- and two-story houses. Setbacks from West 14th Street are generally the same on this block. This property is situated on the southeast corner of West 14th and Craig streets. Grass covers the strip separating the pink sandstone sidewalk from the streets. A planted-grass yard, with mature landscaping, covers the property. Encircling the house is a decorative, wrought-iron fence. The rest of the property has a combination of chain-link and white vinyl fences. Large, shady elm trees line Craig Street. A concrete driveway connects Craig Street to the former garage at the southwest corner of the house.

- 1: Type: **Shed**
 Describe: **A large kit-built shed is located on the southeast corner of the property. Oriented to the north, the structure lacks a formal foundation. The walls consist of green-painted sheet metal. The gables are painted yellow. A flakeboard door dominates the front (north) elevation. The front-gabled roof also consists of sheet metal.**
