COLORADO CULTURAL RESOURCE SURVEY

Architectural Inventory Form

- 1. Resource number: **5PE.517.50**
- 2. Temporary resource number:
- 3. County: **Pueblo**
- 4. City: **Pueblo**
- 5. Historic building name: **Reece, Charles W., House**
- 6. Current building name: **Lang, Betty, House**
- 7. Building address: **725 W 14th Street**
- 8. Owner name: **Betty Lang**
- Owner organization:
- Owner address: **2105 E 7th St**
Pueblo, CO 81001

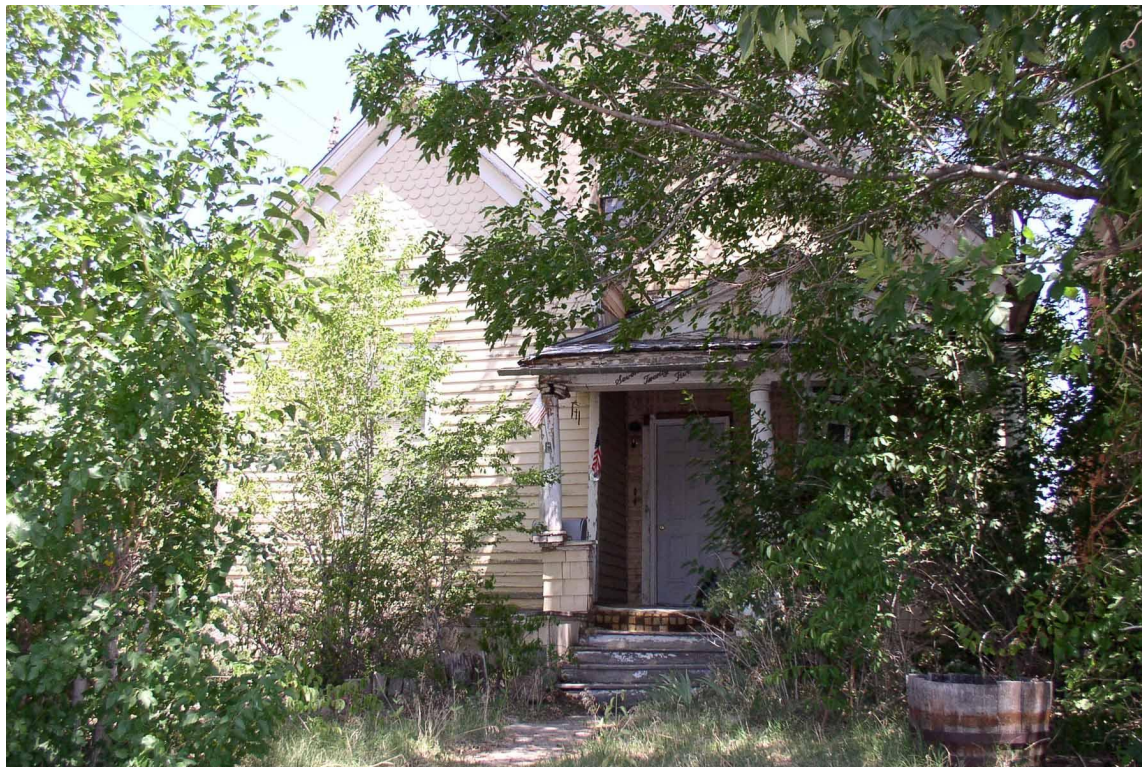
21. General architectural description:
Oriented to the south, this house rests on a concrete foundation. Yellow-painted, horizontal wood siding, with 1-by-4-inch cornerboards, clads the exterior walls. Variegated wood shingles cover the gables. Windows are generally 1-over-1-light, double-hung sash, with white-painted wood frames and aluminum-frame storm windows. The white-painted wood surrounds are pedimented. A 3-sided, canted bay protrudes from the south end of the west elevation. It has a steeply pitched roof with finial. A gable-on-hip-roof porch fills the inside (southeast-facing) corner. A single-light casement window opens in the west end of the rear (north) elevation. The porch features wood-shingle-clad kneewalls and white-painted, Doric columns. The porch's gable features white-painted, fan-shaped decorative elements at the apex and corners. A set of 4 wood steps approaches the porch on the west end of its south elevation. The principal doorway corresponds to these steps. It hosts a 6-panel, gray, metal door. A small, shed-roofed porch protrudes from the house's northeast corner. White-painted sheets of plywood enclose the porch. The north elevation of this porch hosts a wood slab door, opening beneath a single-light transom. Gray, interlocking asphalt shingles cover the cross-gabled main roof and all other roof surfaces. White-painted wood soffit and fascia box the shallowly overhanging eaves. Front-gabled dormers protrude from the west- and north-facing roof slopes. Red-brick chimneys emerge north and south of center on the north-south-oriented roof ridge.
