COLORADO CULTURAL RESOURCE SURVEY

Architectural Inventory Form

- 1. Resource number: **5PE.5695**
- 2. Temporary resource number:
- 3. County: **Pueblo**
- 4. City: **Pueblo**
- 5. Historic building name: **Kohn, Max, House**
- 6. Current building name: **Cummins, Sharon June and Gary Lynn, House**
- 7. Building address: **802 W 14th Street**
- 8. Owner name: **Sharon June Cummins**
- Owner organization:
- Owner address: **802 W 14th St**
Pueblo, CO 81003

48. Report title: Pueblo North Side Neighborhood Survey

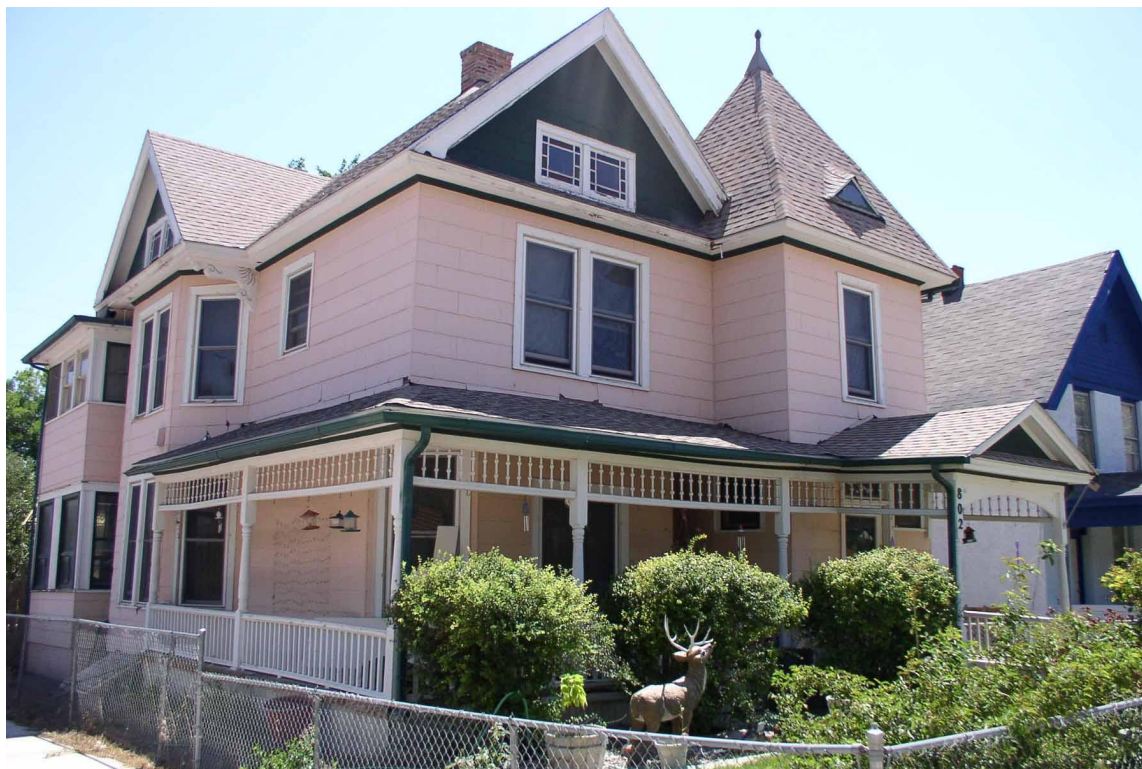
21. General architectural description:
Oriented to the north, this house rests on a sandstone foundation, nearly obscured behind a pink-painted, concrete stucco. Pink-painted, asbestos shingle siding clads the exterior walls. It is painted green in the gables. Windows are generally 1-over-1-light, double-hung sash, with white vinyl frames, and white-painted wood surrounds. These windows open in a 2-story, 3-sided, canted bay protruding from the center of the west elevation. This bay has its own, steeply pitched, octagonal roof, crowned by a metal finial. Another canted bay protrudes from the east elevation. It sits beneath its own, pedimented gabled. Single-light hopper or awning windows appear on either side of the principal doorway. A 1-beside-1-light, sliding-sash window, with an aluminum frame, opens in the center of a single-story canted bay, protruding from the east side of the front (north) façade. Opening in the first story of a two-story porch, protruding from the southeast corner, are windows consisting of a 1-beside-1-light, sliding-sash window beneath a single, fixed frame. The gables host paired hopper or awning windows, with stained glass. A small, half-circular window opens beneath a small roof projecting from a steeply pitched, pyramidal roof capping the

northwest corner of the house. This roof also has a finial. A porch spans the entire facade and wraps around the northeast corner. It has a simple, white-painted wood balustrade. The supports are turned. Between them is a spindlework frieze. Approaching the porch on the west end of its north elevation is a single wood step. Above the step is a pediment. This portion of the porch provides access to the principal doorway, which hosts a two-panel, 1-light, glass-in-wood-frame door, painted white. The door's light and transom host stained glass depicting a bull elk in a mountain setting, with a bald eagle soaring overhead. Another doorway opens in the east face of the inside (southeast-facing) corner. It hosts a 6-panel, white-painted door, opening behind a white, aluminum-frame storm door. The door provides access to a concrete porch, sheltered beneath a shed roof of corrugated, translucent fiberglass, on wrought-iron supports. Another doorway opens in the east elevation of a front-gabled structure protruding from the west end of the rear (south) elevation. It hosts a 5-panel, white-painted wood door. A 4-step concrete stoop, with wrought-iron railing, approaches the door from the south. Brown asphalt shingles cover the cross-gabled main roof and all other roof surfaces. White-painted wood fascia, with projecting cornice, and soffit box the eaves. Red-brick chimneys protrude from the roof's apex and from the south-facing slope.

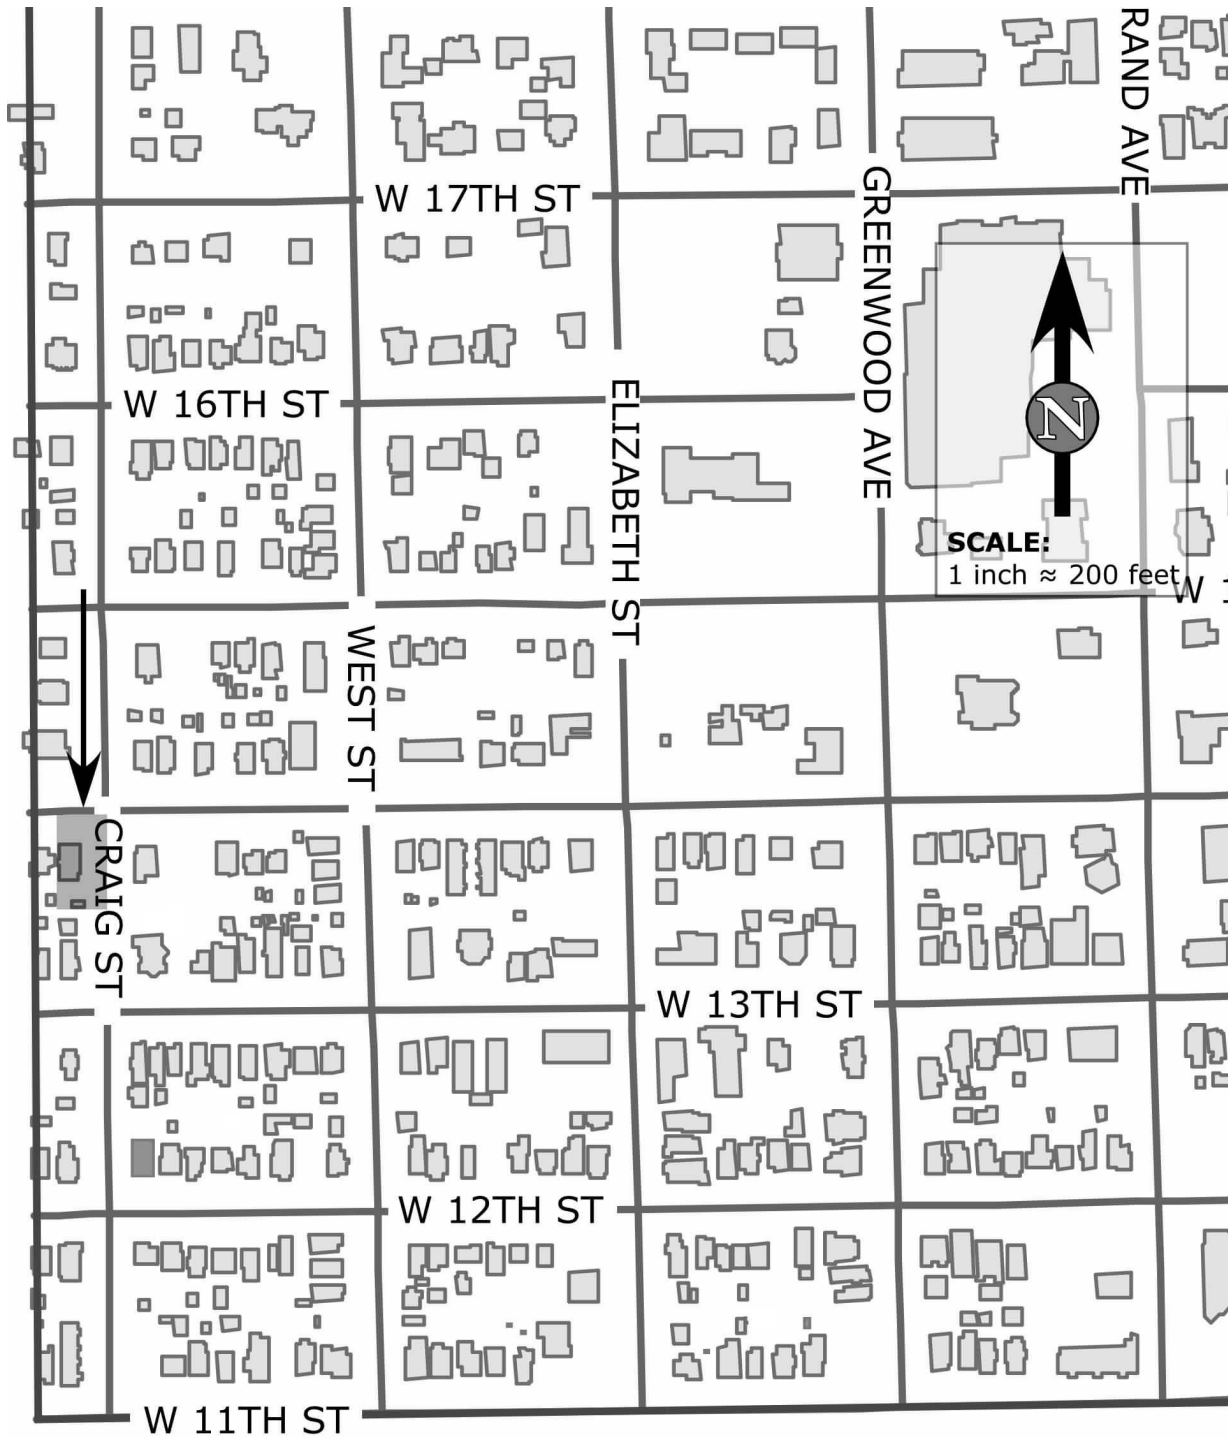
SITE SKETCH MAP

This property is located on terrain sloping downward from northwest to southeast, with an elevation of around 4,700 feet above mean sea level. The neighborhood features modest, one- and two-story houses. Setbacks from West 14th Street are generally the same on this block. This property is situated on the southwest corner of West 14th and Craig streets. Gravel covers the strip separating the sidewalk from the streets. A planted-grass yard, with mature landscaping, covers the property. Encircling the front yard is a chain-link fence; a wood privacy fence encloses the backyard.

Describe: **A prefabricated shed, constructed by the Morgan Company, is located on the southeast corner of the lot. Oriented to the north, it rests on a loosely laid, red brick foundation. Walls of pale-yellow-painted sheet metal clad the exterior walls. A sheet-metal-covered door opens in the center of the front (north) elevation. Flanking the doorway are 1-beside-1-light, sliding sash windows, with brown aluminum frames. On either side of the windows are white, board-and-batten shutters. White sheet metal covers the front-gabled roof.**

Describe: **A shed is located on the southwest corner of the lot. Oriented to the east, the building lacks a formal foundation. Pink-painted asbestos siding clads the exterior walls. Opening in the center of the front (east) elevation is a green-painted wood slab door. A window opening in the south elevation has been boarded shut. Brown sheets of asphalt cover the side-gabled roof, and a fascia board caps the otherwise exposed rafter ends.**
