COLORADO CULTURAL RESOURCE SURVEY

Architectural Inventory Form

- 1. Resource number: **5PE.5710** Parcel number(s):
- 2. Temporary resource number: **525147004**
- 3. County: **Pueblo**
- 4. City: **Pueblo**
- 5. Historic building name: **Pace, Leonard A., Sr., and Mabel, House**
- 6. Current building name: **Bell, James K., Jr., House**
- 7. Building address: **624 W 15th Street**
- 8. Owner name: **James K. Bell, Jr.**
- Owner organization:
- Owner address: **624 W 15th St**
Pueblo, CO 81003

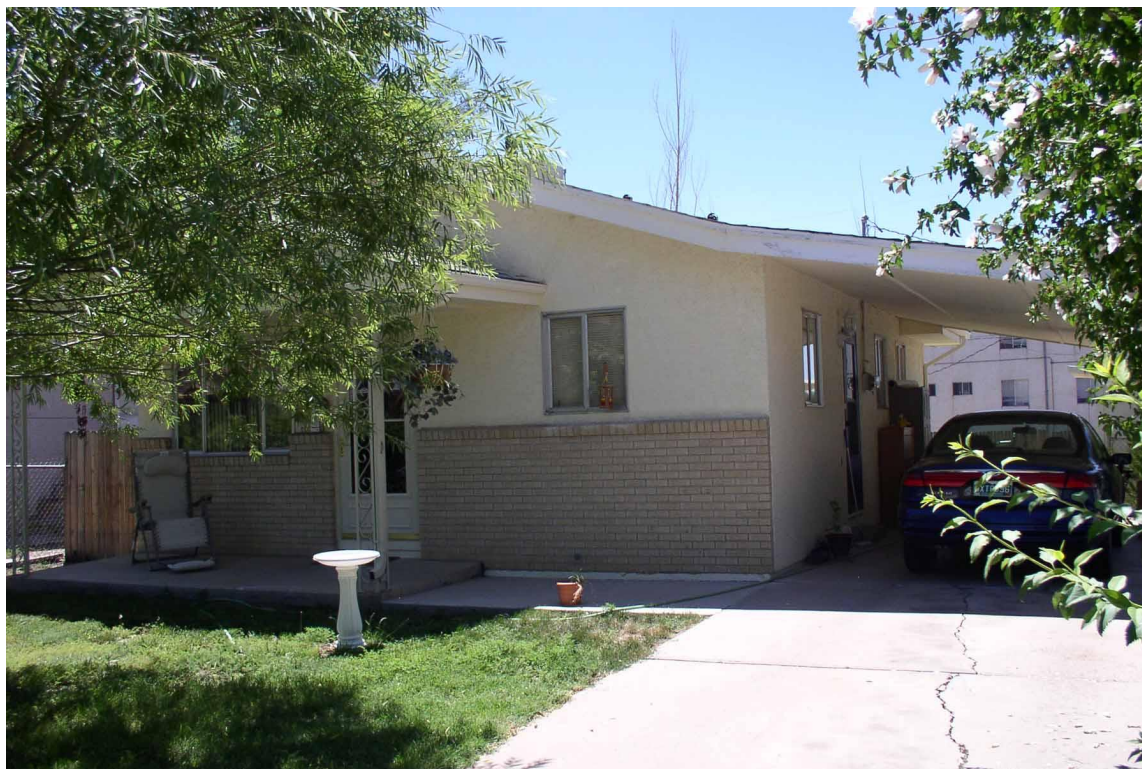
19. Primary external roof material: **Asphalt Roof/Composition Roof**
Other roof materials:
20. Special features: **Fence**
Car Port
Porch
21. General architectural description:
Oriented to the north, this house rests on a concrete foundation. White stucco clads the exterior walls. A tan-colored brick veneer extends up approximately 4 feet from the foundation across the front (north) façade only. Windows generally consist of a single-light casement beside a single-light fixed-frame. Dominating the east side of the façade is a tripartite picture window; it consists of single-light casements flanking a single-light, fixed-frame window. All windows have aluminum frames. A front-gabled porch protrudes from the eastern two-thirds of the asymmetrical façade. It has a low, concrete floor, and white-painted, wrought-iron supports. The principal doorway opens near the center of the facade. It hosts a white, 2-panel, 9-light steel door, opening behind a white, aluminum-frame storm door. Another doorway opens near the center of the west elevation. It provides access to a shed-roofed carport, which rests on white-painted, wrought-iron supports. Gray, asphalt shingles cover the front-gabled roof. White-painted wood fascia and soffit box the eaves.
