COLORADO CULTURAL RESOURCE SURVEY

Architectural Inventory Form

- 1. Resource number: **5PE.516.22** Parcel number(s):
- 2. Temporary resource number: **525150009**
- 3. County: **Pueblo**
- 4. City: **Pueblo**
- 5. Historic building name: **Booth, Albert S., House**
- 6. Current building name: **Pelto, Susan May and Charles B., House**
- 7. Building address: **425 W 18th Street**
- 8. Owner name: **Susan May and Charles B. Pelto**
- Owner organization:
- Owner address: **425 W 18th St**
Pueblo, CO 81003

47. Photograph numbers): **CD-ROM Photo Disc: North Side Photos**
File Name(s): 18thstw425
- Negatives filed at: **Special Collections**
Robert Hoag Rawlings Public Library
100 East Abriendo Avenue
Pueblo, CO 81004-4290
48. Report title: **Pueblo North Side Neighborhood Survey**
49. Date(s): **08/01/05**
50. Recorder(s): **Adam Thomas**
51. Organization: **Historitecture, L.L.C.**

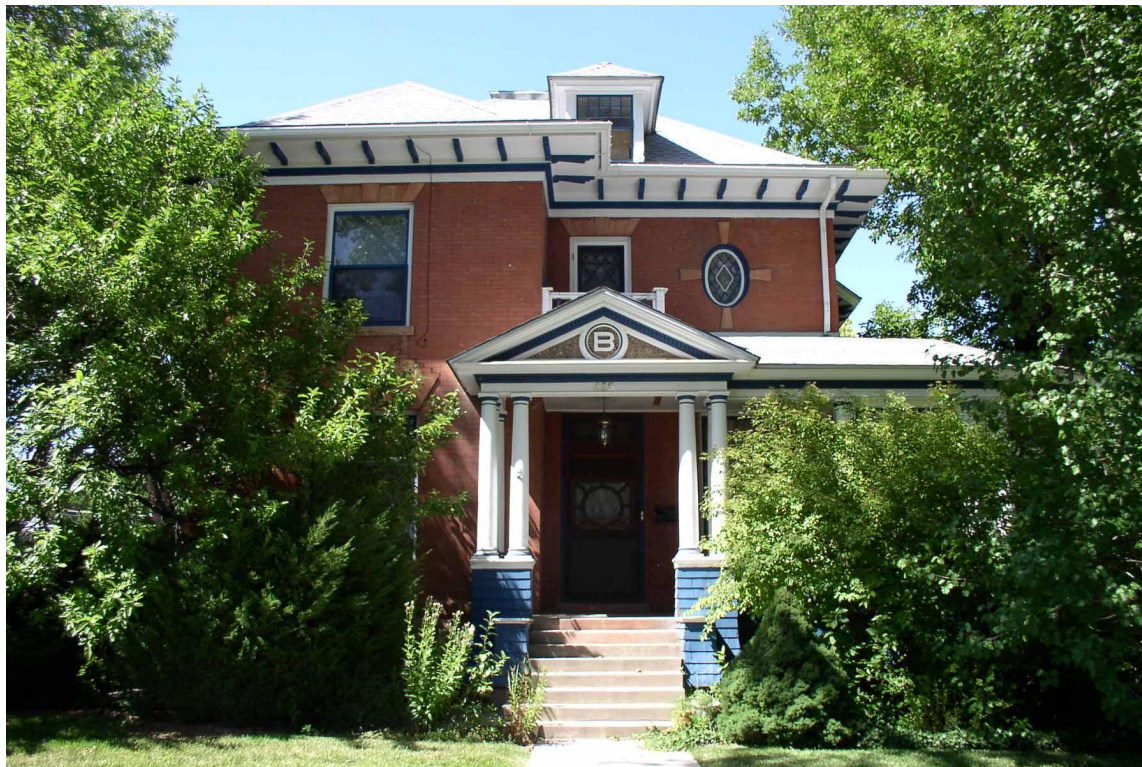
21. General architectural description:
Oriented to the south, this house rests on a pink-colored, rock-faced, regular-coursed, sandstone and rhyolite ashlar foundation, with raised and beaded mortar. The basement windows are 2-light hopper. The garage attached to the northwest corner of the house and the 2-story addition to the northeast corner of the house both have concrete foundations. A garage door pierces the north elevation of this addition and the east elevation hosts a 9-beside-9-light, sliding sash window. The walls of the house consist of a red pressed brick, with thin, pink-tinted mortar. The north elevation of the attached garage features unusual brickwork, depicting a key-like pattern beneath a series of cross-shaped voids. Blue-painted, square-cut wood shingles cover a front-gabled addition to the second story of the rear (north) elevation. (This addition rests partially on the east-facing slope of the attached garage's roof and on its own supports.) Windows are generally 1-over-1-light, double-hung sash, with blue-painted wood frames. They open between rock-faced sandstone sills and flat arches. Those arches above windows in the front (south) façade consist of sawn sandstone, while those in secondary elevations are brick, with sawn sandstone

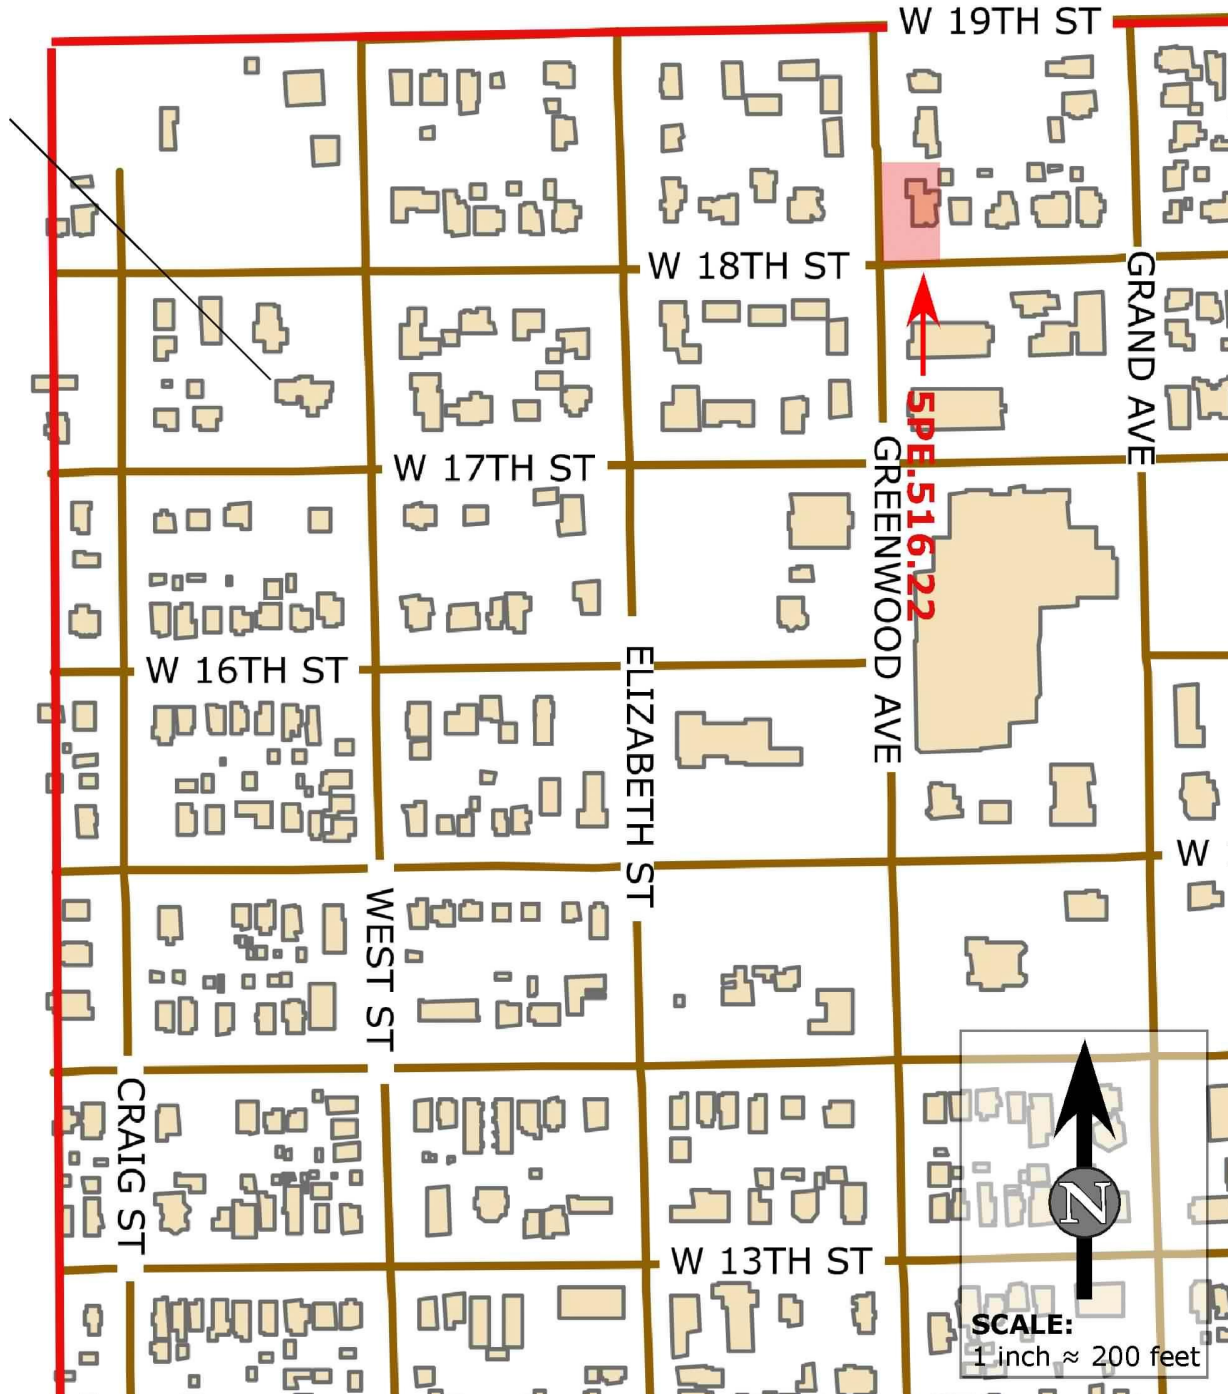
SITE SKETCH MAP

This property is located on terrain sloping downward from west to east, with an elevation of around 4,700 feet above mean sea level. The neighborhood features modest and large, one- and two-story houses. Setbacks from West 18th Street are generally the same on this block. This property is situated on the northeast corner of West 18th Street and North Greenwood Street. Separating the streets from the sidewalks is a grass strip. A planted-grass yard, with mature landscaping, covers the lot. Surrounding the back yard is a brick wall, and a sandstone retaining wall delimits the eastern edge of the property. A concrete driveway connects the attached garage to North Greenwood Street.
