COLORADO CULTURAL RESOURCE SURVEY

Architectural Inventory Form

- 1. Resource number: **5PE.6622** Parcel number: **525124003**
- 2. Temporary resource number:
- 3. County: **Pueblo**
- 4. City: **Pueblo**
- 5. Historic building name: **John L. Smith House**
- 6. Current building name: **Priscilla G. and Marvin Peterson House**
- 7. Building address: **620 West 20th Street**
- 8. Owner name: **Priscilla G. and Marvin Peterson**
- Owner organization:
- Owner address: **3001 Cheyenne Ave
Pueblo, CO 81008**

48. Report title: **Pueblo North Side Neighborhood Survey, Phase 2**

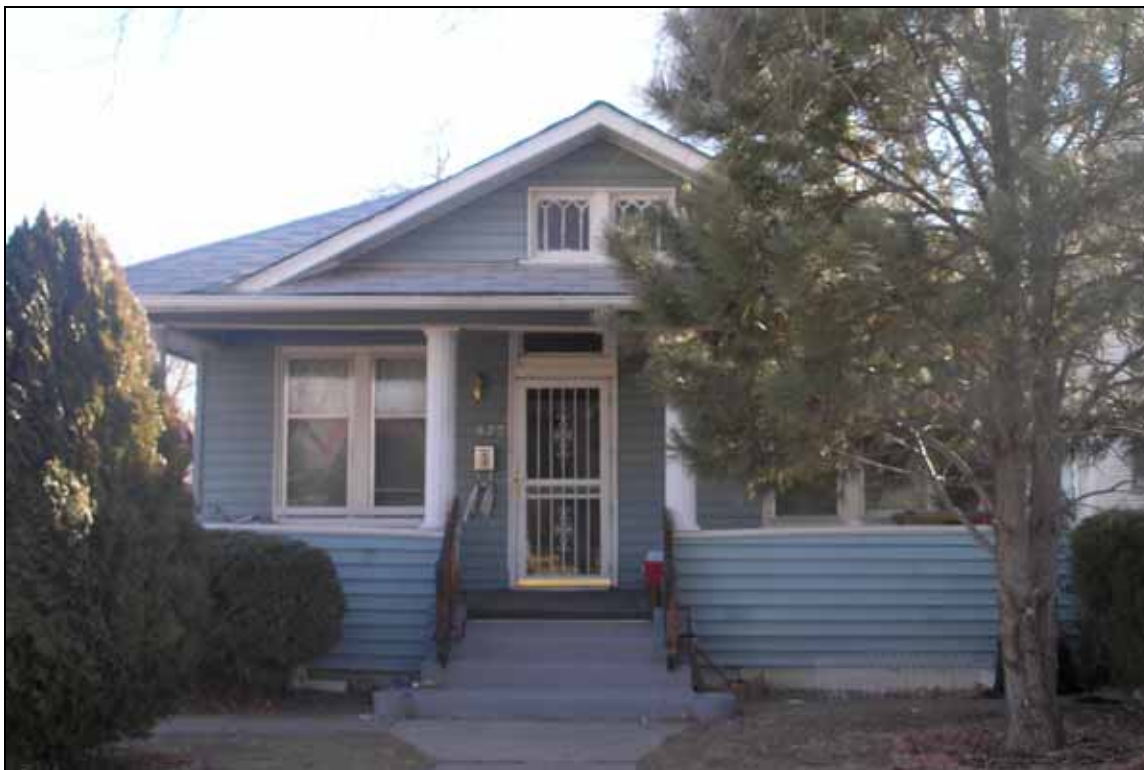
20. Special features: **Chimney
Fence
Porch**
21. General architectural description:
This house is oriented to the north. The foundation is entirely concealed behind stucco. Blue aluminum siding clads the exterior walls. Windows are generally 1-over-1-light, double-hung sash, with white-painted wood frames and surrounds, and aluminum-frame storm windows. A rectangular bay protrudes shallowly from near the center of the east elevation. It hosts a trio of windows with cottage-style glazing in their upper sashes. Pairs of these windows open in either end of the nearly symmetrical front (north) facade. A pair of hopper, awning, or sash windows, with cottage-style glazing, pierce the front (north-facing) gable or pediment. An integral porch spans the facade. It has a wood floor, aluminum-siding-clad kneewalls, and aluminum, fluted columns. Approaching the porch east of center are concrete steps, flanked by wrought-iron railings. The steps align to the principal doorway, which also hosts a transom. A secondary doorway opens in the south elevation of a shed-roofed rear addition. Gray, interlocking asphalt shingles cover centrally hipped main roof, and the rafter ends are exposed. Aluminum fascia and soffit box the eaves. A tan-brick chimney, with elaborately corbelled cap, protrudes from the roof's south-facing slope, near its apex.
