COLORADO CULTURAL RESOURCE SURVEY

Architectural Inventory Form

- 1. Resource number: **5WL.5600** Parcel number: **080721202005**
- 2. Temporary resource number: **Not Applicable**
- 3. County: **Weld**
- 4. City: **Windsor**
- 5. Historic building name: **Wilson Chevrolet, Inc.; Foster Chevrolet Company; Kennedy Chevrolet Company; Starck Blacksmith Shop**
- 6. Current building name: **Ross Building**
- 7. Building address: **213-215 4th Street**
- 8. Owner name: **Robert E. and Cheryl A. Ross Trust**
- Owner organization:
- Owner address: **8220 Golden Eagle Dr
Fort Collins, CO 80525**

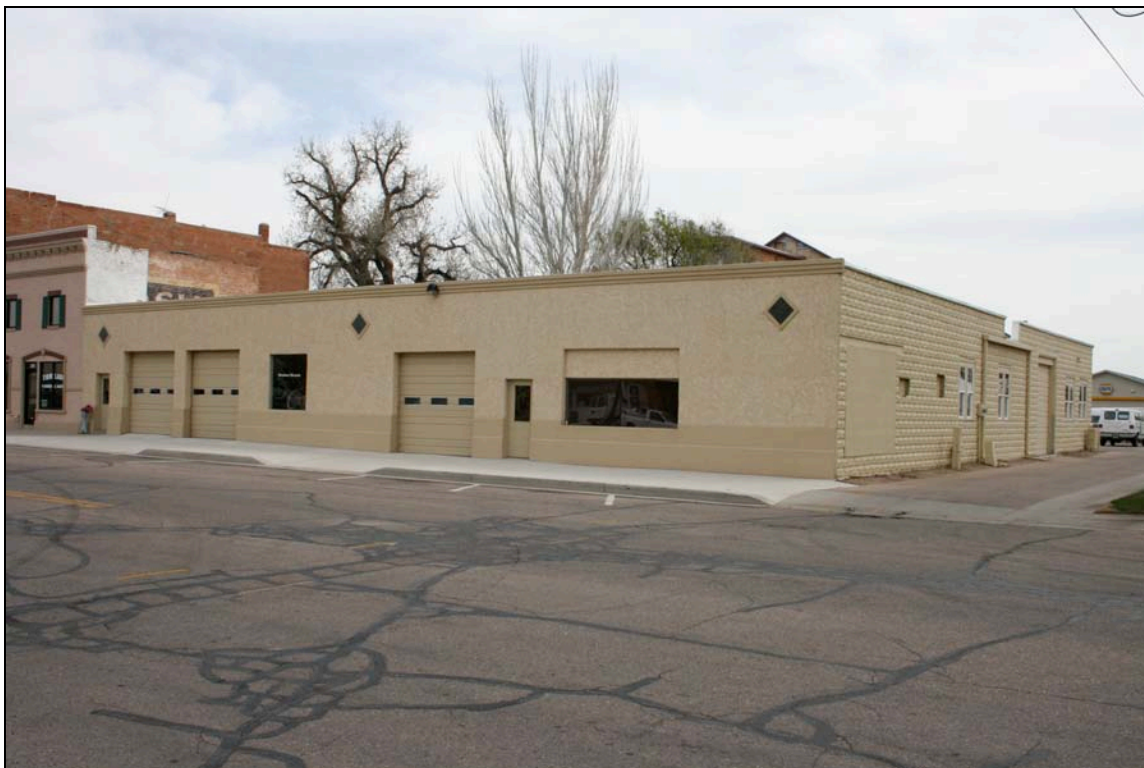
19. Primary external roof material: **Synthetic Roof/Rubber Roof**
Other roof materials:
20. Special features: **Ornamentation/Decorative Terra Cotta**
21. General architectural description:
Oriented to the west, this building rests on a concrete foundation. The walls consist of concrete blocks, which are rock-faced on the south elevation. All of the blocks are painted tan, except for the north elevation, where they are unpainted. Two textures of stucco cover the front (west) façade, with the smoother stucco a deeper shade of tan than the rougher stucco. The smoother stucco covers the façade from the foundation up four feet as well as the slightly protruding cornice. Framed in the smoother stucco are three, diamond-shaped, terra cotta tiles evenly spaced beneath the cornice. Openings in the façade are as follows (from north to south): a standard doorway, two garage doorways, a window, a garage doorway, a standard doorway, and another window opening. The two standard doorways host tan-painted steel doors, with two panels each and single lights. Occupying the garage doorways are tan-painted, steel, overhead-retractable doors, with three lights each. Both window openings have tinted, plate glass. Tan stucco partially encloses the southern window opening. A large window opening at the west end of the south elevation and two adjacent but much smaller openings have been boarded shut with tan-painted plywood. All other window openings in this elevation host paired, 1-over-1-light, double-hung sash windows, with white vinyl frames. Opening east of center in the south elevation is a tan-painted, steel, overhead-retractable garage door. The rear elevation consists of distinctive halves, with the northern half recessed relative to the southern half. A pair of openings, each hosting paired, 1-over-1-light, double-hung sash windows, are concentrated to the southern end of the south half of the rear elevation. The northern end of this half has smaller, paired, 3-light casement windows, with tan-painted steel frames. Two sets of paired, single-light casement windows, spanned by a single transom, open in the southern end of the northern half of the rear elevation. They have tan-painted steel frames. North of these windows is a doorway hosting a tan-painted, steel slab door. Dominating the remainder of the elevation are two garage doorways, each with a tan-painted, steel, overhead-retractable garage door. A white rubber membrane covers the nearly flat roof surfaces. The rafter ends are exposed beneath the roof above the northern half of the rear elevation.

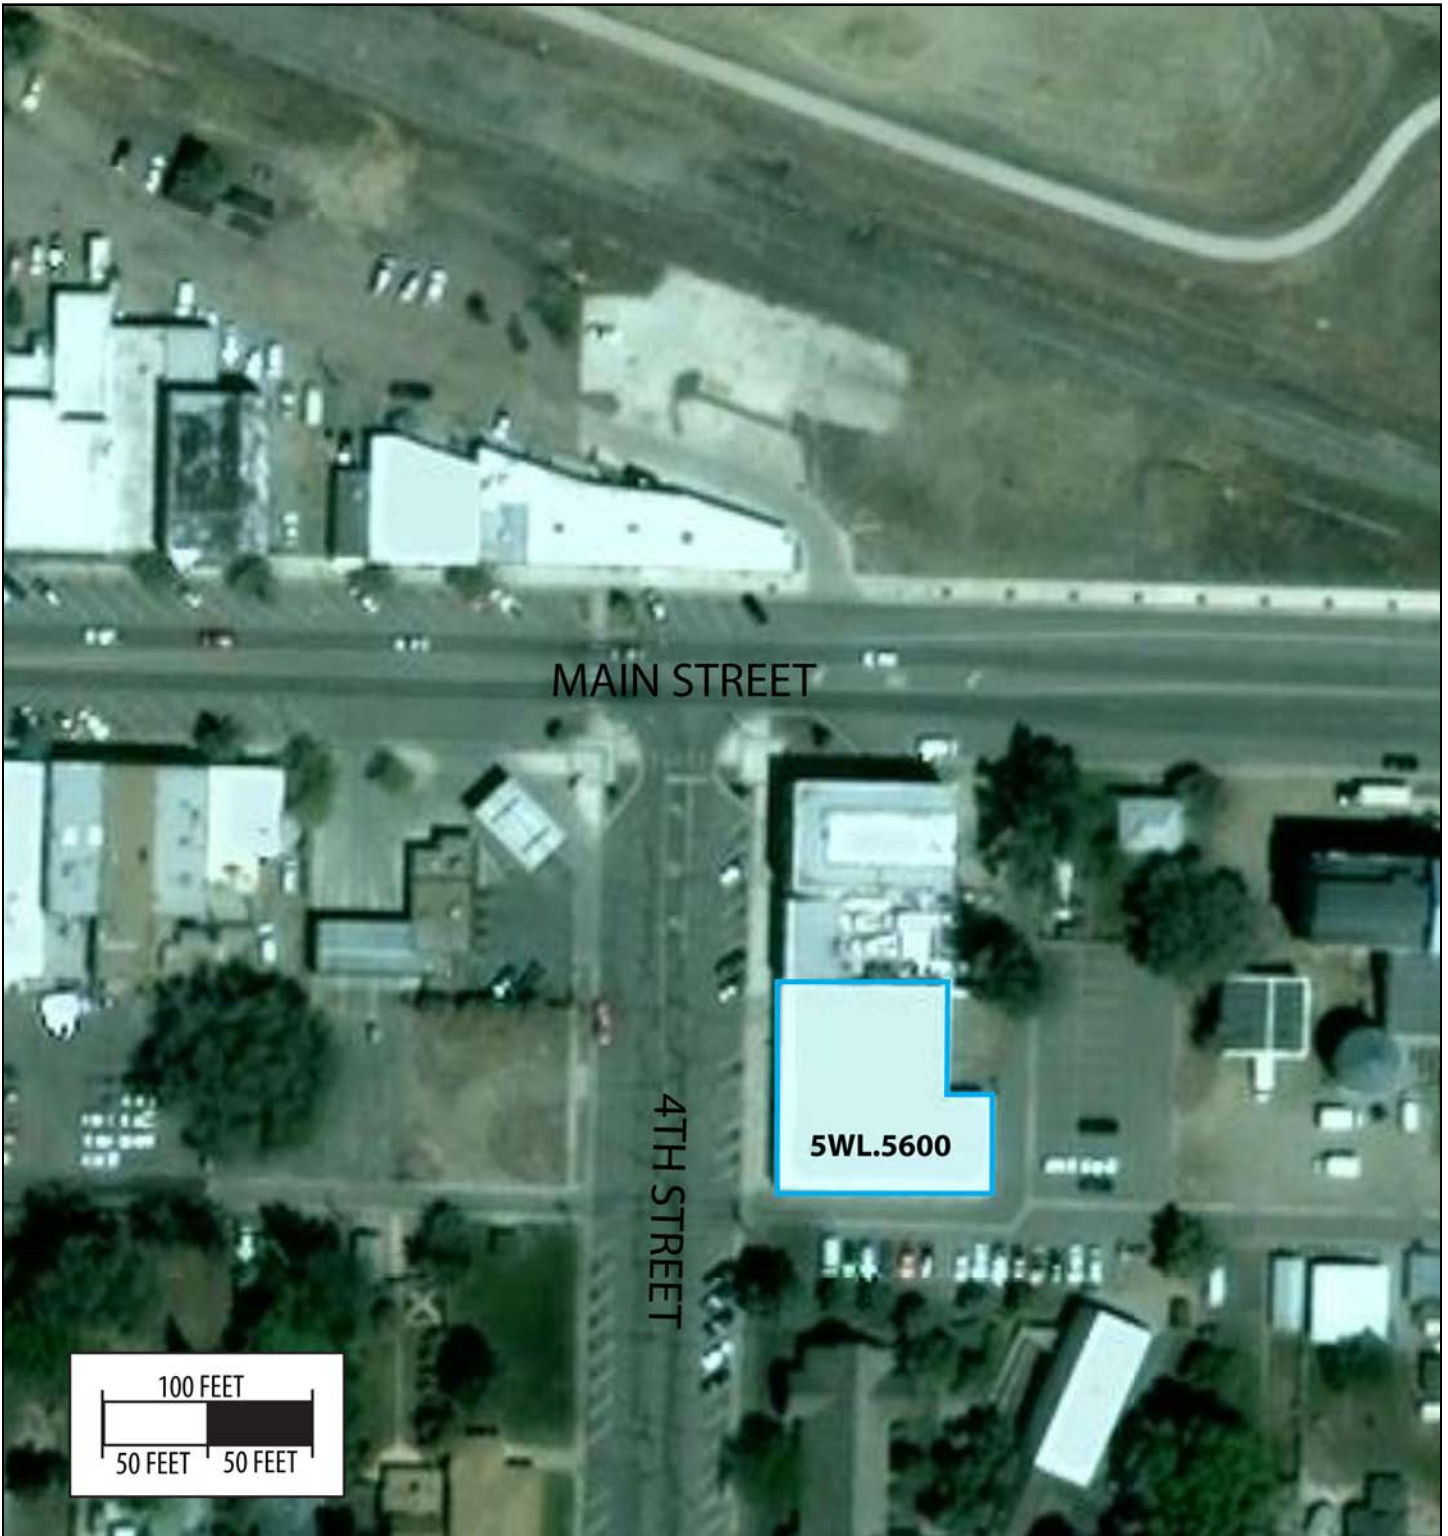
SKETCH MAP

22. Architectural style: **No Style**
Other architectural style:
Building type:
23. Landscape or special setting features:
This building is located in Windsor's commercial district, between 207 4th Street to the north and an east-west-oriented alley to the south. Separating the building's front (west) facade from the street is a concrete sidewalk.

Concrete covers the small parking area and garage approach on the northeast corner of the property.
