COLORADO CULTURAL RESOURCE SURVEY

Architectural Inventory Form

- 1. Resource number: **5WL.5601** Parcel number: **080716308001**
- 2. Temporary resource number: **Not Applicable**
- 3. County: **Weld**
- 4. City: **Windsor**
- 5. Historic building name: **113-115 5th Street**
- 6. Current building name: **Kunz Building**
- 7. Building address: **113-115 5th Street**
- 8. Owner name: **Karen M. Kunz**
- Owner organization:
- Owner address: **30991 Weld County Rd 17
Windsor, CO 80550**

distinction.

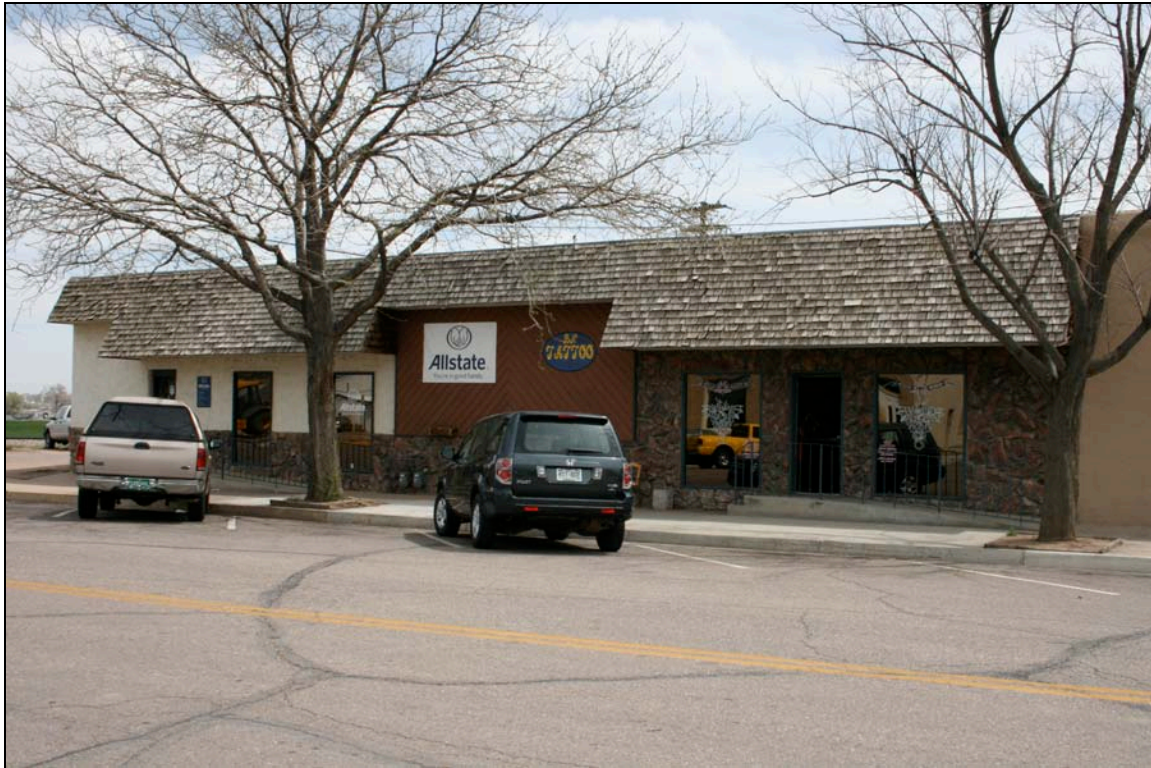
20. Special features: **None Applicable**
21. General architectural description:
Oriented to the west, this building rests on a concrete foundation. White stucco clads the exterior walls, which appear to consist of masonry, either bricks or concrete blocks. A random-coursed sandstone veneer covers all of the southern third of the façade and extends in a four-foot band across the rest of the façade elevation the foundation. Brown, wood siding, set in an angled pattern, covers the middle of the façade. Storefronts punctuate the northern and southern thirds of the nearly symmetrical façade. The northern storefront features a doorway to the north and two windows to the south. The doorway hosts a 12-light door with faux, x-shaped bracing, painted gray. Approaching the doorway from the south is a concrete ramp and from the north are concrete steps, flanked by a steel railings. Both of the windows are single-light, plate-glass, with tinted glazing and gray-painted frames. The doorway opens between the windows in the southern storefront. It hosts a door similar to one opening in the northern storefront. Approaching it are steps and a ramp similar to the northern storefront. Both of the windows are single-light, plate glass, with reflective glazing. Spanning both storefronts are extensions of the pent roof extending from the parapet. Covering the pent roof are square-cut wood shingles. Dominating the north elevation is a garage door opening, largely enclosed with red-brown, horizontal wood siding. However, the western edge of the opening hosts a wide, unpainted, wood slab door. A rubber membrane covers the nearly flat main roof.
