COLORADO CULTURAL RESOURCE SURVEY

**Architectural Inventory Form**

- 1. Resource number: **5WL.2525** Parcel number: **080721204010**
- 2. Temporary resource number: **Not Applicable**
- 3. County: **Weld**
- 4. City: **Windsor**
- 5. Historic building name: **Windsor Hospital; Vaughn Apartments**
- 6. Current building name: **Riverbend Apartments**
- 7. Building address: **216 5th Street**
- 8. Owner name: **Value Added Partners, LLC**
- Owner organization:
- Owner address: **1220 S College Ave  
Fort Collins, CO 80524**

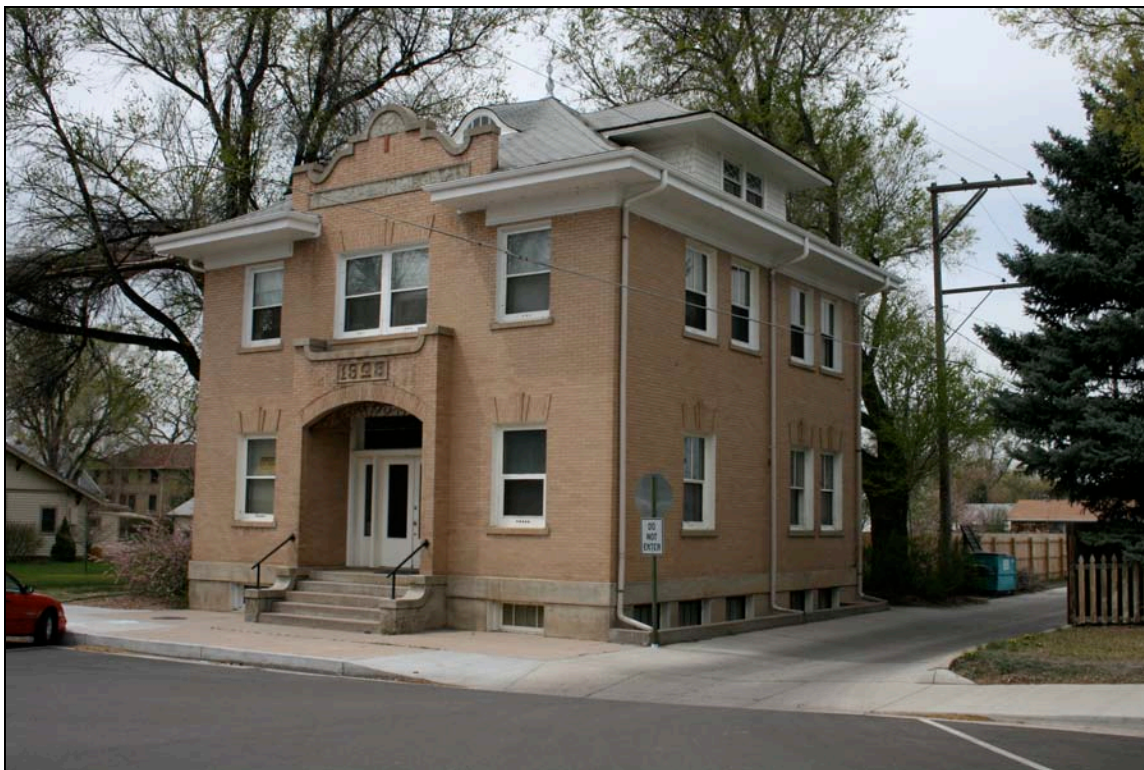
**Window/Stained Glass**  
**Roof Treatment/Finial**
21. General architectural description:  
**Oriented to the east, this building rests on a concrete foundation, with generally 3-light hopper basement windows. The rear elevation hosts 4-over-4-(vertical)-light, double-hung sash windows, with brown-painted wood frames. Basement windows open into deep, concrete-lined wells along the north and south elevations. Descending from north to south along the rear (west) elevation is a concrete stairwell providing access to the basement. A dressed sandstone watertable separates the foundation from the exterior walls. A veneer of tan, pressed brick, with thin, pink mortar, clads the exterior walls. Windows are 1-over-1-light, with white-painted wood frames. Most windows have 1-over-1-light or 2-over-1-light storm windows, with white-painted wood frames. The windows have dressed sandstone sills. Those windows opening in the first story and at the center of the front (east) façade's second story, have flat arches, with raised keystones and springers. The principal doorway opens beneath a small porch protruding slightly from the center of the symmetrical façade. Approaching it are concrete or sandstone steps, flanked by black-painted pipe railings. Spanning the segmental archway of the porch is a decorative, wrought-iron spandrel. An engraved sandstone signband above the archway reads, "1908." The doorway hosts paired, single-light doors, with beveled glass and white-painted wood frames. Flanking the doors are single-light sidelights. A leaded, stained-glass transom spans the doors and sidelights. Secondary doorways open in either end of the rear (west) elevation. Approaching them are unsheltered concrete stoops. The doorways host white-painted, two-panel, single-light wood doors. The southern doorway hosts a storm door, with a white-painted wood frame. The central third of the façade extends through the eaves and culminates in a curvilinear-shaped parapet, with sandstone caps. The parapet hosts a signband with the faint outline of the words "WINDSOR HOSPITAL." Crowning the building is a centrally hipped roof. White-painted wood fascia and beadboard soffit box the broadly overhanging, flared eaves. Eyebrow dormers, each hosting 5-light windows, protrude from the roof's east- and west-facing slopes. The north- and south-facing slopes host hipped-roof dormers, each with a pair of double-hung sash windows. The upper lights of these windows have diamond-shaped glazing. White-painted, square-cut wood shingles cover the sides of the dormers, which also have flared eaves. Gray asphalt shingles cover the main hipped roof and all other roof surfaces. Crowning the apex of the roof is a wrought-iron finial. A tan-brick chimney is engaged to the south elevation, east of center.**
