COLORADO CULTURAL RESOURCE SURVEY

Architectural Inventory Form

- 1. Resource number: **5WL.834** Parcel number: **080721203002**
- 2. Temporary resource number: **Not Applicable**
- 3. County: **Weld**
- 4. City: **Windsor**
- 5. Historic building name: **Mountain States Telephone & Telegraph Company Windsor Telephone Exchange Building**
- 6. Current building name: **Velasquez Building; Natural Therapy's**
- 7. Building address: **217 5th Street**
- 8. Owner name: **Michael E. and Geraldine M. Velasquez**
- Owner organization:
- Owner address: **834 Locust St
Windsor, CO 80550**

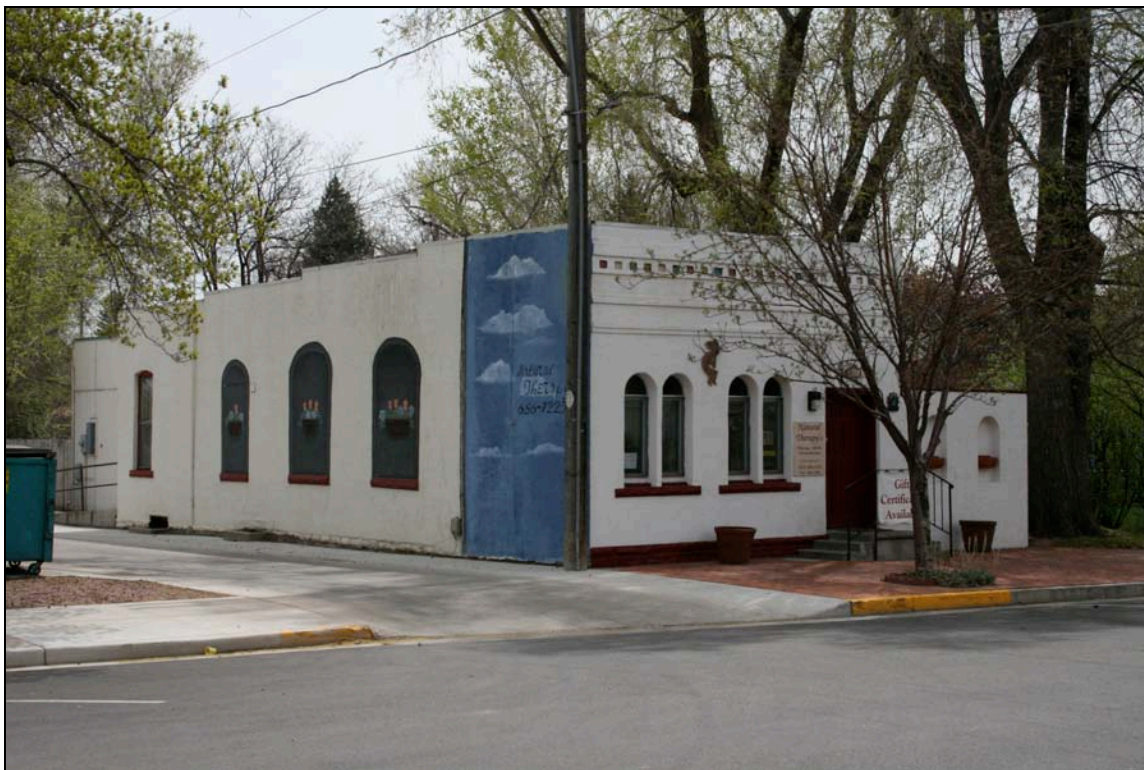
20. Special features: **Window/Segmental Arch**
21. General architectural description:
Oriented to the west, this building rests on a rock-faced, sandstone foundation. It is painted red across the front elevation and white on all other elevations. White-painted stucco clads the exterior walls of most of the building. However, white-painted sheets of plywood cover the north and south elevations of an addition to the rear (east) elevation. White vinyl siding covers the rear elevation. A mural painted on the west end of the north elevation depicts white clouds in a blue sky. The façade features three parallel, corbelled belt courses between the tops of the windows and the parapet cap. The topmost band hosts a row of square recesses, painted in alternating colors of dark red, tan, and blue. Opening in two pairs in the façade are single-light casement windows, with red-painted wood frames, opening behind storm windows. Each window has a round-arch transom, but the pairs share a common, red-painted, rock-faced sandstone sill. Mimicking the front windows, round-arch alcoves punctuate a wing wall extending southward from the southwest corner. Three, round-arch window openings in the north elevation of the original portion of the building have been boarded shut and now host paintings of flowers. A third window opening, at the east end of the same elevation of the original building, has a 1-over-1-light, double-hung sash window, with brown-painted wood frames. It opens between a red-painted, rock-faced sandstone sill and a segmental arch. The north elevation of the rear addition hosts a 1-beside-1-light, sliding sash window, with an aluminum frame and a white-painted wood surround. A similar window opens near the center of the rear elevation and in the west elevation of the addition. The principal doorway opens in the south end of the asymmetrical façade. It hosts a wide, red-painted, 9-panel wood door, with a decoratively carved center panel. A small, concrete stoop, with a wrought-iron railing, approaches the doorway from the north and the south. A narrow, secondary doorway opens in the extreme north end of the original building's rear elevation, beneath a segmental arch. Approaching this doorway from the east is a concrete ramp, with a black-painted pipe railing. Opening east of center in the south elevation are three sets of sliding, plate-glass doors, with red-painted wood frames. White-painted sheets of asphalt cover the nearly flat roof.

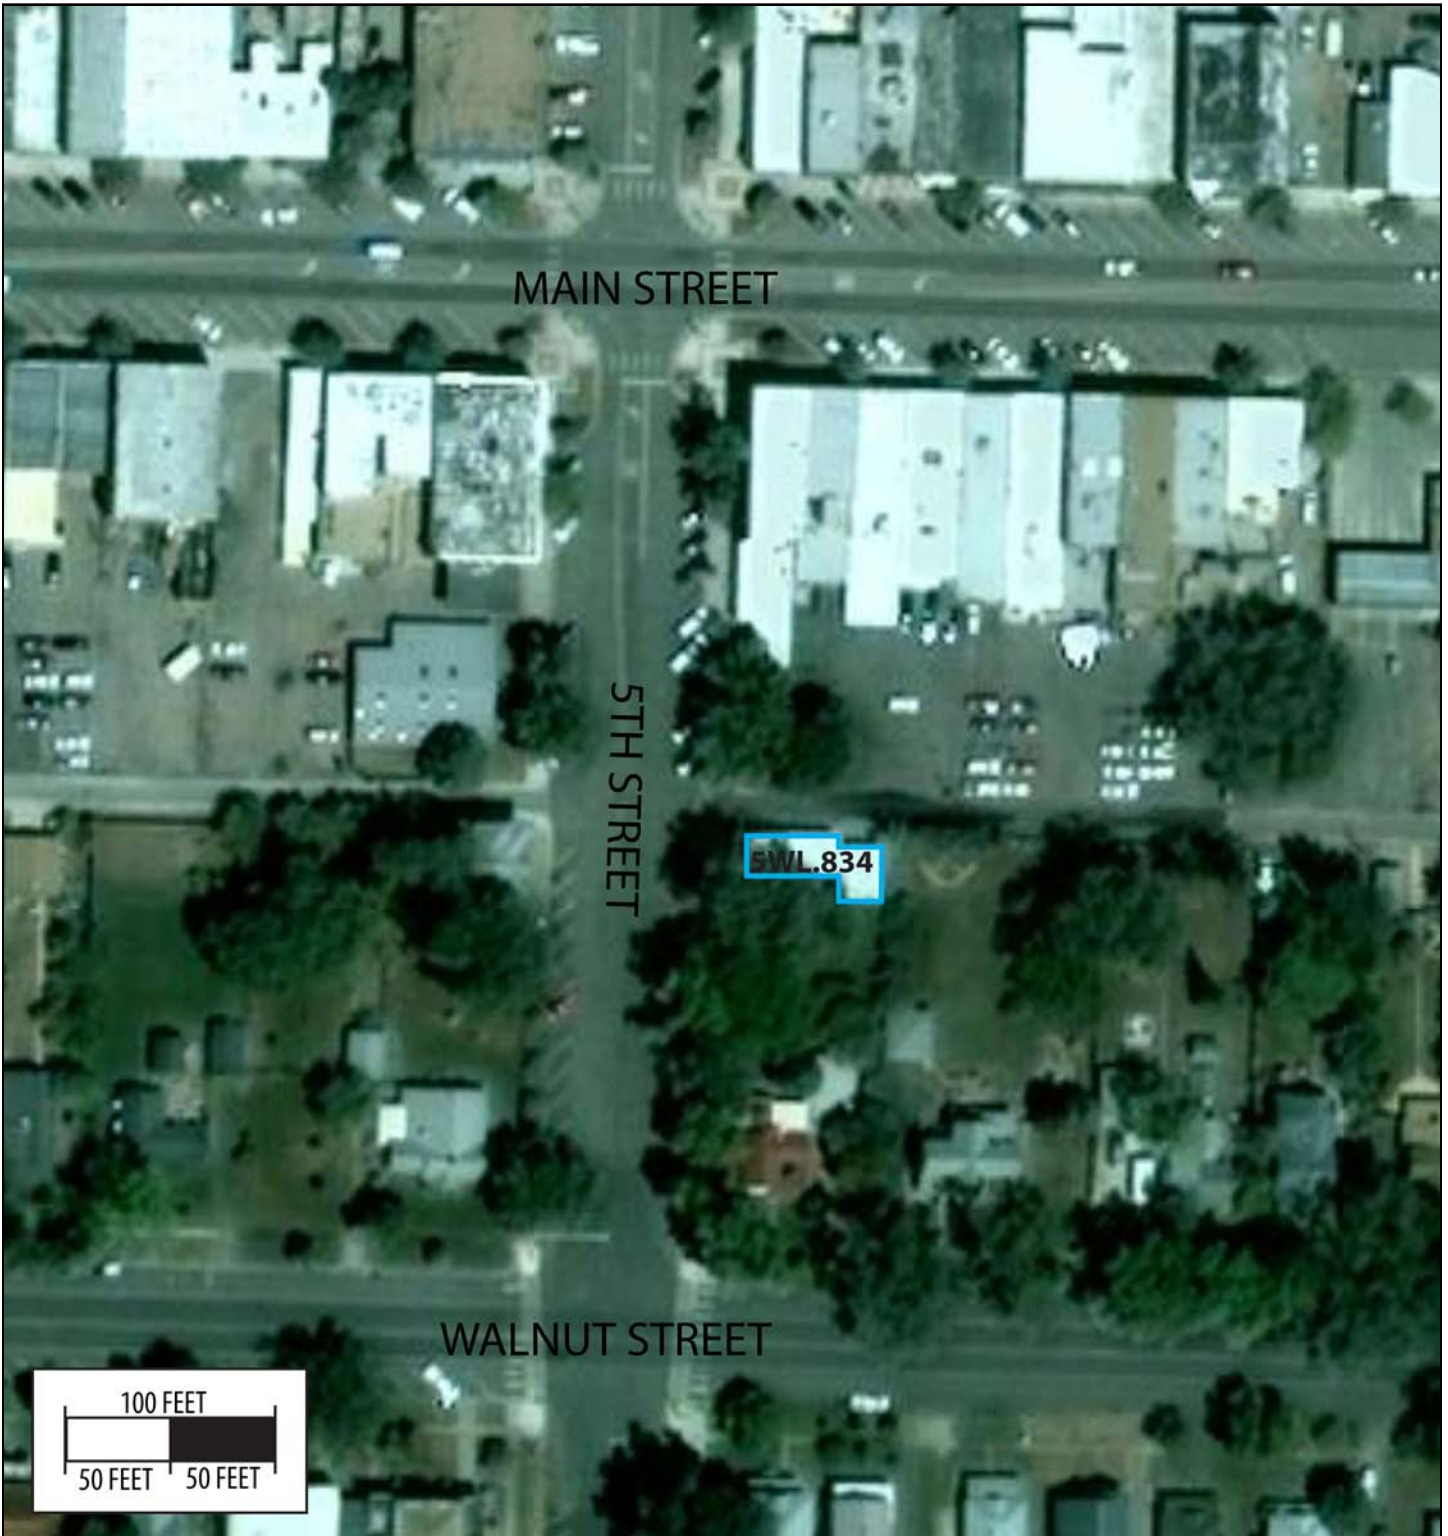
SKETCH MAP

22. Architectural style: **Late 19th And Early 20th Century American Movements/Commercial Style**
Other architectural style:
Building type:
23. Landscape or special setting features:
This commercial building is located on 5th Street, a north-south thoroughfare through downtown Windsor. It is situated on the east side of the street, between an east-west-oriented alley to the north and 430 Walnut Street to the

south. Separating the building's front (west) facade from the street is red-brick sidewalk. A pair of planters integrated into the sidewalk host mature trees. A large cottonwood is located off the southwest corner of the building. A hedge spans from the cottonwood eastward to the southeast corner of the building.
