COLORADO CULTURAL RESOURCE SURVEY

Architectural Inventory Form

- 1. Resource number: **5PE.5802** Parcel number(s):
- 2. Temporary resource number: **525141017**
- 3. County: **Pueblo**
- 4. City: **Pueblo**
- 5. Historic building name: **Center for Eye Care and Surgery**
- 6. Current building name: **Center for Eye Care and Surgery**
- 7. Building address: **1501 Court Street**
- 8. Owner name: **James B. and Sharon K. Fowler**
- Owner organization:
- Owner address: **1903 Bonforte Blvd**
Pueblo, CO 81001

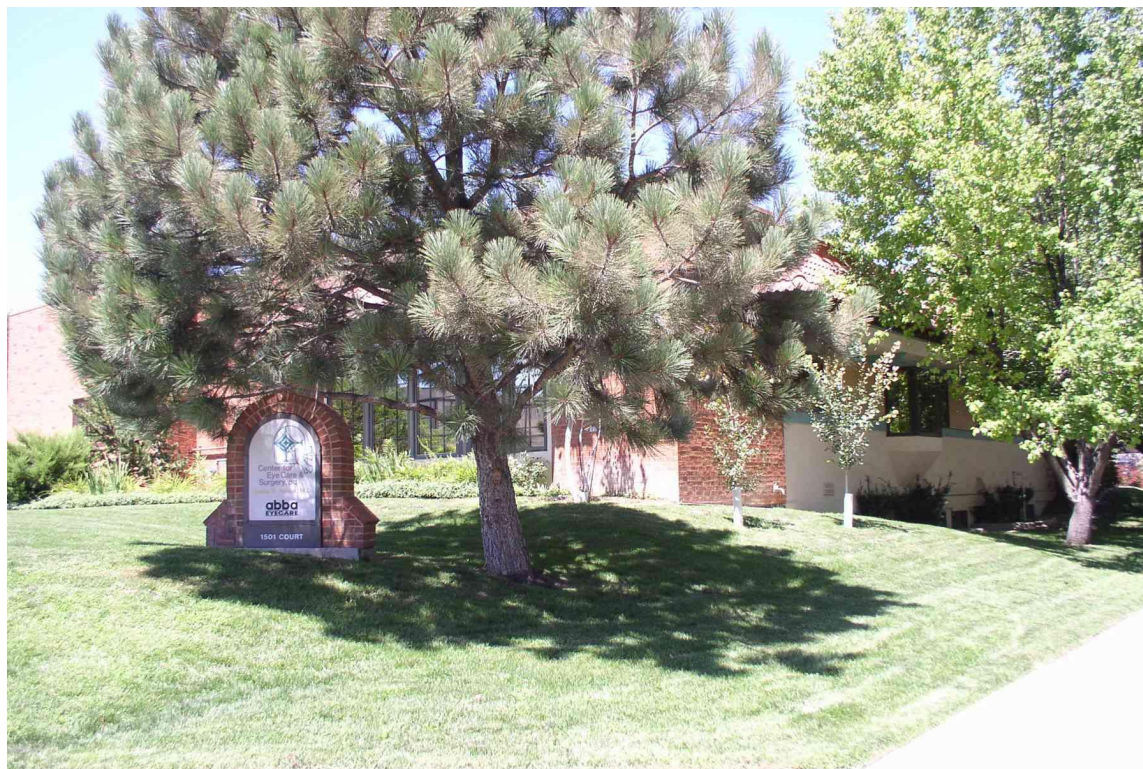
19. Primary external roof material: **Synthetic Roof/Rubber Roof**
Other roof materials:
20. Special features: **Porch**
21. General architectural description:
Oriented to the west, this medical office building rests on a concrete foundation. A red-brown brick veneer clads the exterior walls, except for portions of the east and west elevations, which have bands of white-, blue-, and tan-tinted stucco. Windows are divided-light fixed frame, with brown-tinted glazing and brown, aluminum frames. The principal doorway opens beneath a hipped roof porch at the south end of the east elevation. It hosts a brown-tinted, plate-glass door. Opening in the east end of the north elevation is a brown-painted metal slab door, with a single light. Spanning the stuccoed portions of the building are pent roofs, covered in red, terra-cotta tiles. The rest of the building has a flat roof, covered with a rubber membrane.
