COLORADO CULTURAL RESOURCE SURVEY

Architectural Inventory Form

- 1. Resource number: **5PE.5804** Parcel number(s):
- 2. Temporary resource number: **525151013**
- 3. County: **Pueblo**
- 4. City: **Pueblo**
- 5. Historic building name: **Matheney, W. Howard, House**
- 6. Current building name: **Haney, Dagmar A., House**
- 7. Building address: **1805 Court Street**
- 8. Owner name: **Dagmar A. Haney**
- Owner organization:
- Owner address: **1805 Court St**
- Pueblo, Colorado 81003**

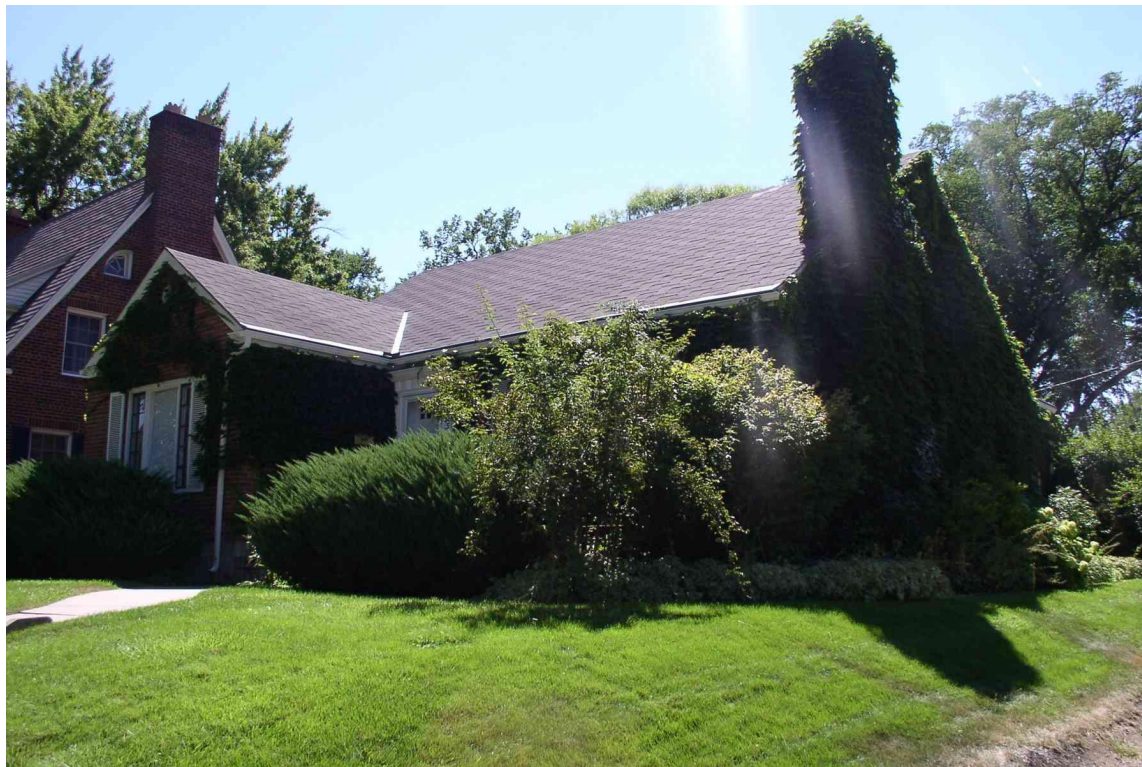
19. Primary external roof material: **Asphalt Roof/Composition Roof**
Other roof materials:
20. Special features: **Fence**
Chimney
21. General architectural description:
Oriented to the east, this house rests on a concrete foundation. The walls consist of red brick. Windows are generally 6-over-6-light, double-hung sash, with white-painted wood frames, black-painted, wood-frame screens, and brick sills. Opening on either end of the asymmetrical front (east) façade are tripartite picture windows. They consist of 10-light casements flanking a central, single-light fixed frame. Flanking these windows are white, louvered shutters. An unsheltered porch fills the inside (northeast-facing) corner of the house. It has a concrete floor and wrought-iron railing. Three brick steps approach the porch on the south end of its east elevation, corresponding to the principal doorway. This doorway hosts a white-painted, 4-panel, 8-light wood door, opening behind an aluminum-frame storm door. It features a Doric surround of fluted pilasters supporting an entablature of evenly spaced triglyphs. Another doorway opens in the south face of the inside (southwest-facing) corner. It provides access to a concrete stoop. Gray, interlocking asphalt shingles cover the cross-gabled roof. The house lacks overhanging eaves, and the gable host eave returns. A red-brick hearth and chimney protrudes from the east end of the north elevation.

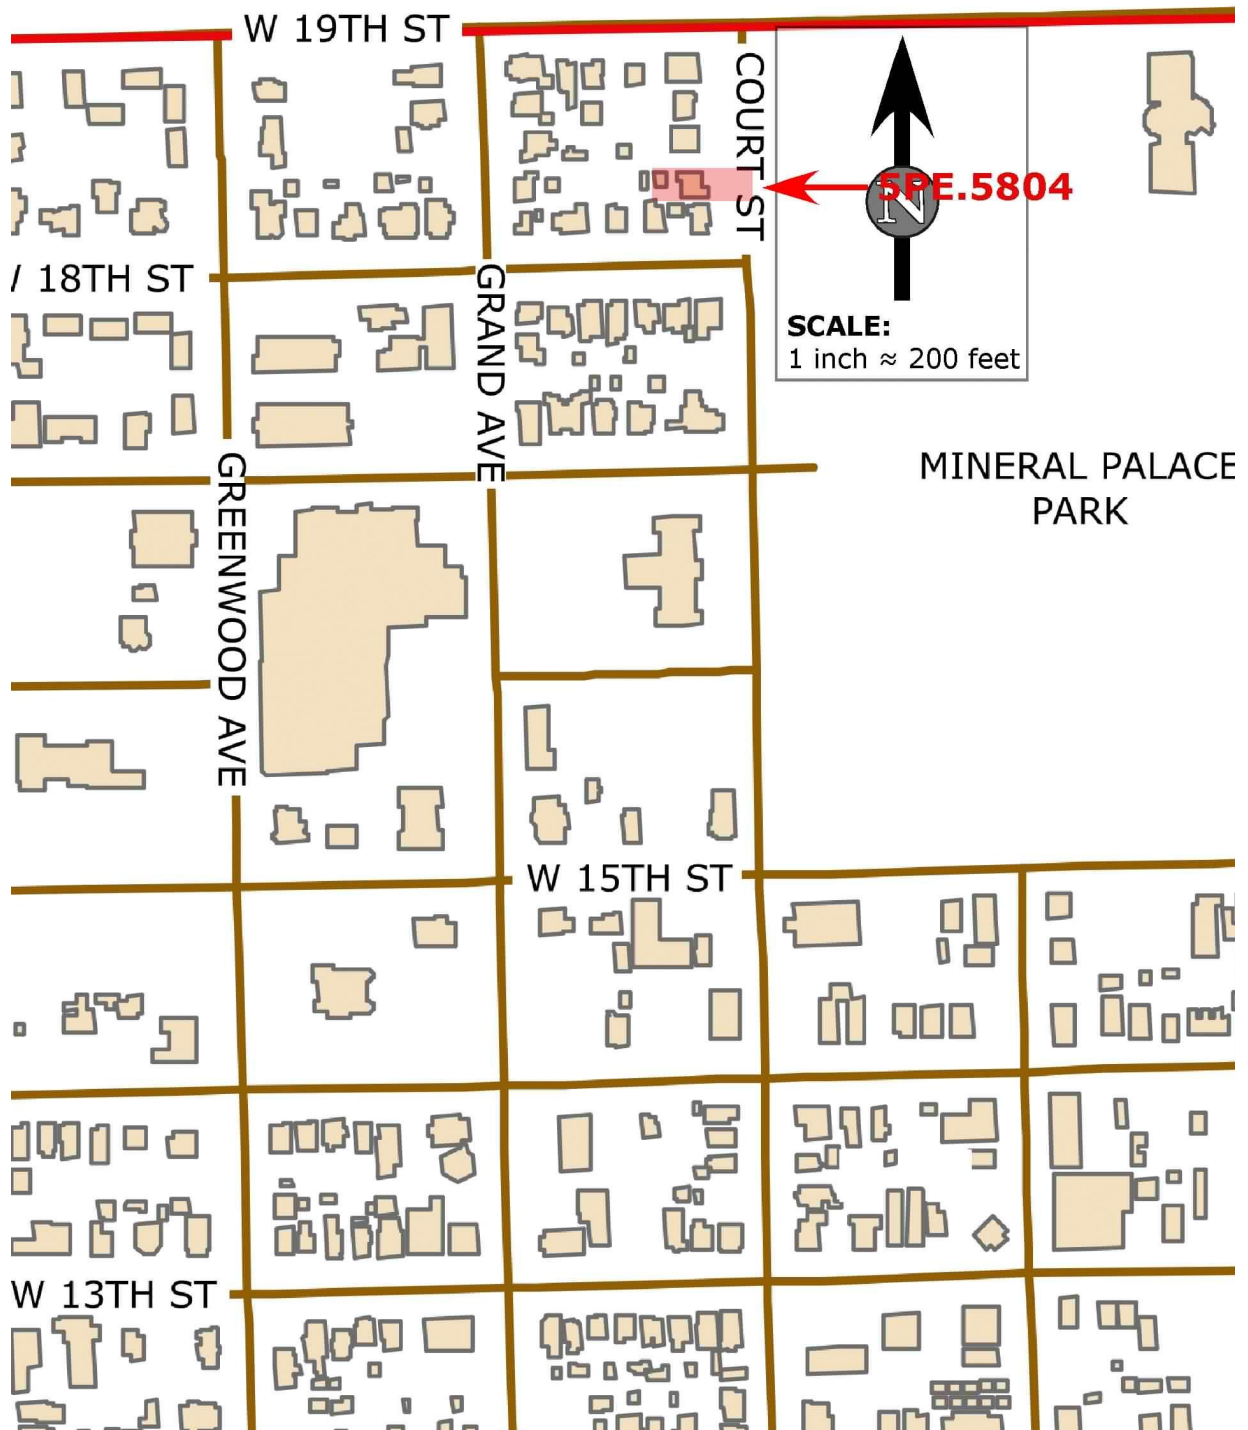
SITE SKETCH MAP

This property is located on terrain sloping downward from west to east, with an elevation of around 4,700 feet above mean sea level. The neighborhood features modest and large 1- and 2-story houses. Setbacks from Court Street are generally the same on this block; Mineral Palace Park is located directly across Court Street. This property is situated on the west side of Court Street, between 1801 Court Street to the south and an east-west-oriented alley to the north. Separating the street from the pink sandstone sidewalk is a grass-covered strip. A planted-grass yard, with mature landscaping, covers the lot. Nearly obscuring the front façade and north elevation is a grapevine. Encircling the small back yard is a wood privacy fence. A macadam parking area is located northwest of the house.
