COLORADO CULTURAL RESOURCE SURVEY

Architectural Inventory Form

- 1. Resource number: **5PE.5952**
- 2. Temporary resource number:
- 3. County: **Pueblo**
- 4. City: **Pueblo**
- 5. Historic building name: **Maese, Eugene L., House**
- 6. Current building name: **Maese, Eugene L., House**
- 7. Building address: **1303 Craig Street**
- 8. Owner name: **Eugene L. Maese**
- Owner organization:
- Owner address: **1303 Craig St**  
**Pueblo, CO 81003**

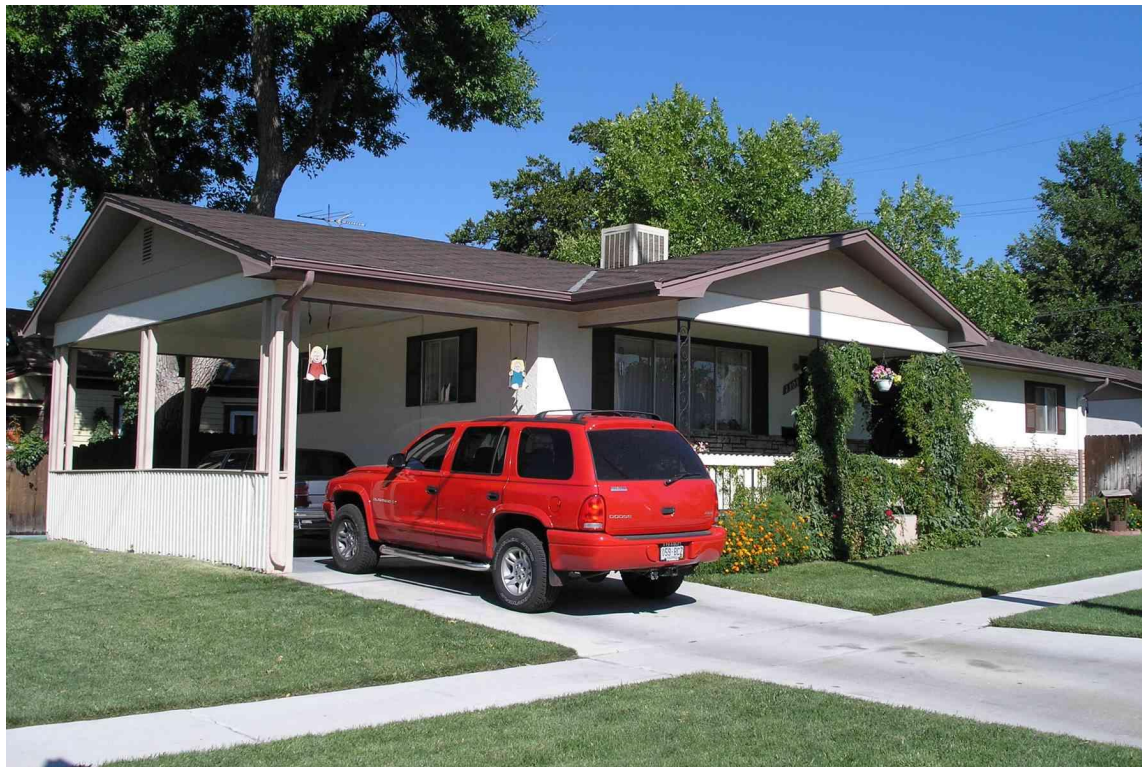
**Oriented to the east, this house rests on a concrete foundation. Cream-colored stucco clads the exterior walls, and tan-painted, horizontal wooden composition siding covers the gables. Across the lower 3 feet of the façade is a sandstone veneer. Windows are generally 1-beside-1-light, sliding sash, with aluminum frames. They have brown-painted wood surrounds and louvered shutters. Opening in the south end of the asymmetrical front (east) elevation is a tripartite window with sliding side sashes and a fixed middle sash. A front-gabled porch protrudes from the south end of the façade. It has a concrete floor and decorative wrought-iron supports and railings. Steps approach the porch from the north. The principal doorway opens onto the porch and hosts a 3-light, wood slab door. Another doorway opens in the south end of the rear (west) elevation. Spanning the south elevation is a shed-roof carport. Brown, interlocking asphalt shingles cover the side-gabled roof, and the eaves are boxed.**

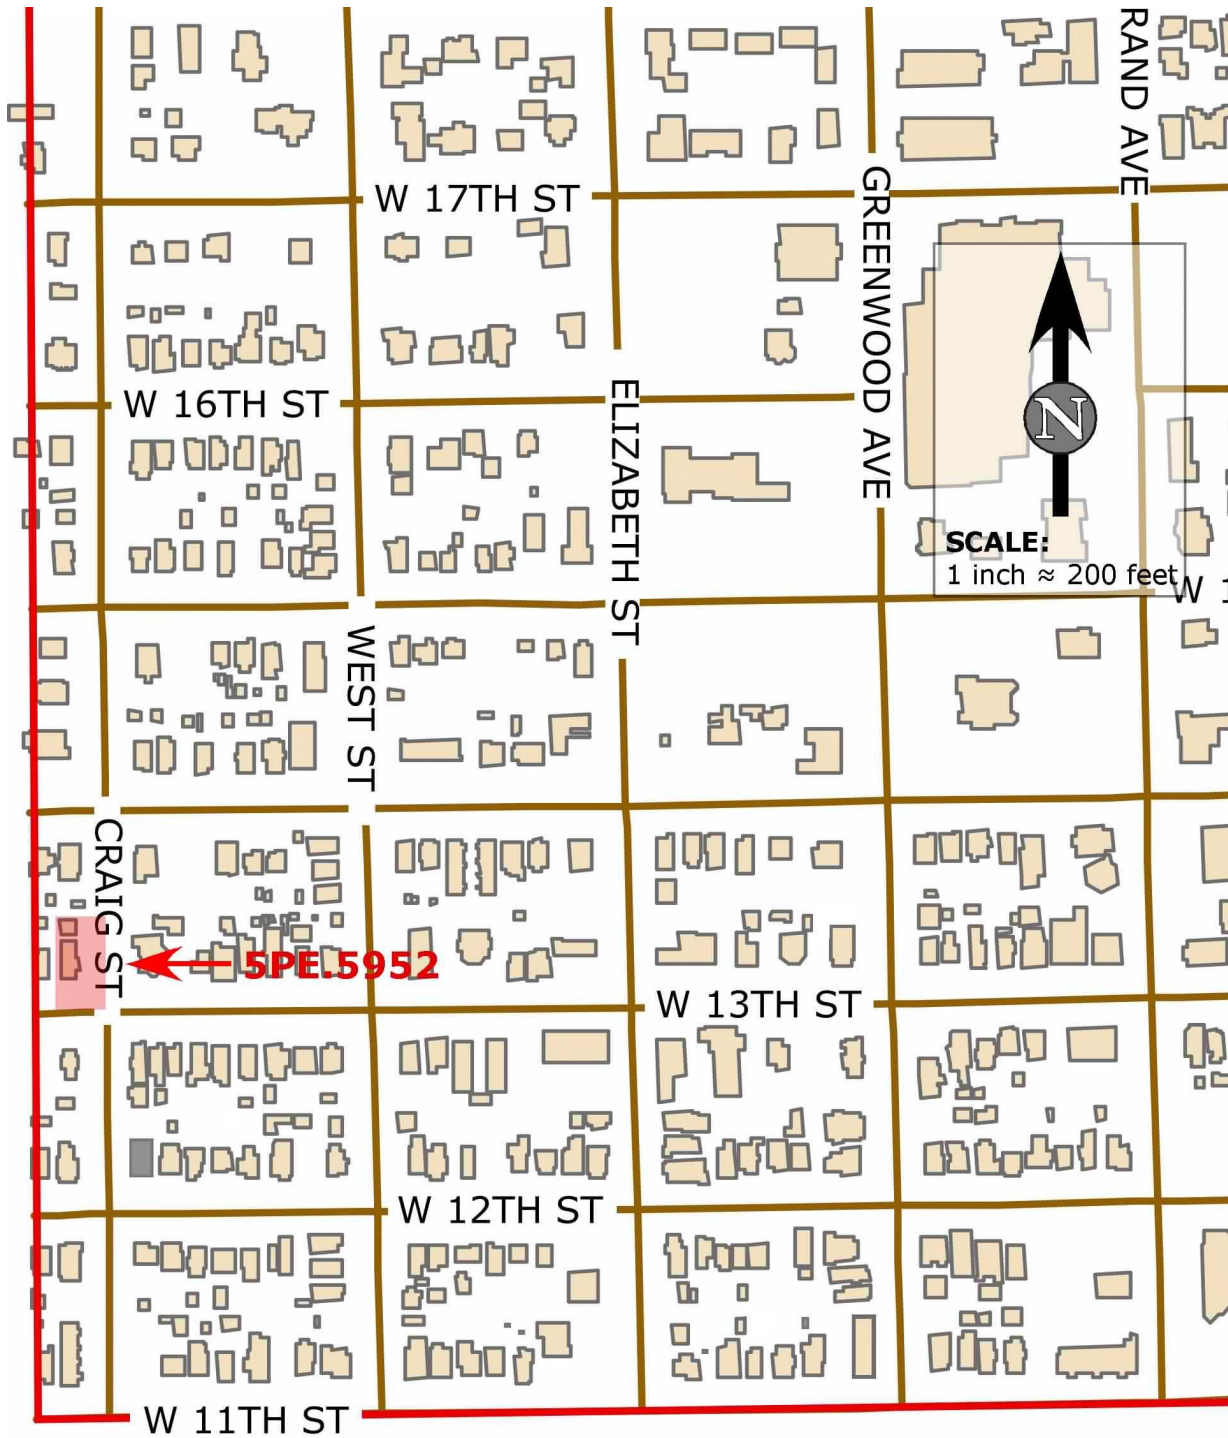
SITE SKETCH MAP

This property is located on terrain sloping downward from northeast to southwest, with an elevation of around 4,700 feet above mean sea level. The neighborhood features modest 1- and 2-story houses and apartment buildings. Setbacks from Craig Street are generally the same on this block. This property is situated on the northwest corner of Craig and West 13th streets. Separating the street from the sidewalk is a grass strip. A planted-grass yard, with mature landscaping, covers the lot. Connecting the carport to Craig Street is a concrete driveway.
