COLORADO CULTURAL RESOURCE SURVEY

Architectural Inventory Form

- 1. Resource number: **5PE.5954**
- 2. Temporary resource number:
- 3. County: **Pueblo**
- 4. City: **Pueblo**
- 5. Historic building name: **Tienda, Manuel, House**
- 6. Current building name: **Tienda, Thomas and Ronnie, House**
- 7. Building address: **1419 Craig Street**
- 8. Owner name: **Thomas and Ronnie Tienda**
- Owner organization:
- Owner address: **172 Kingsley Ave**
Pueblo, CO 81005

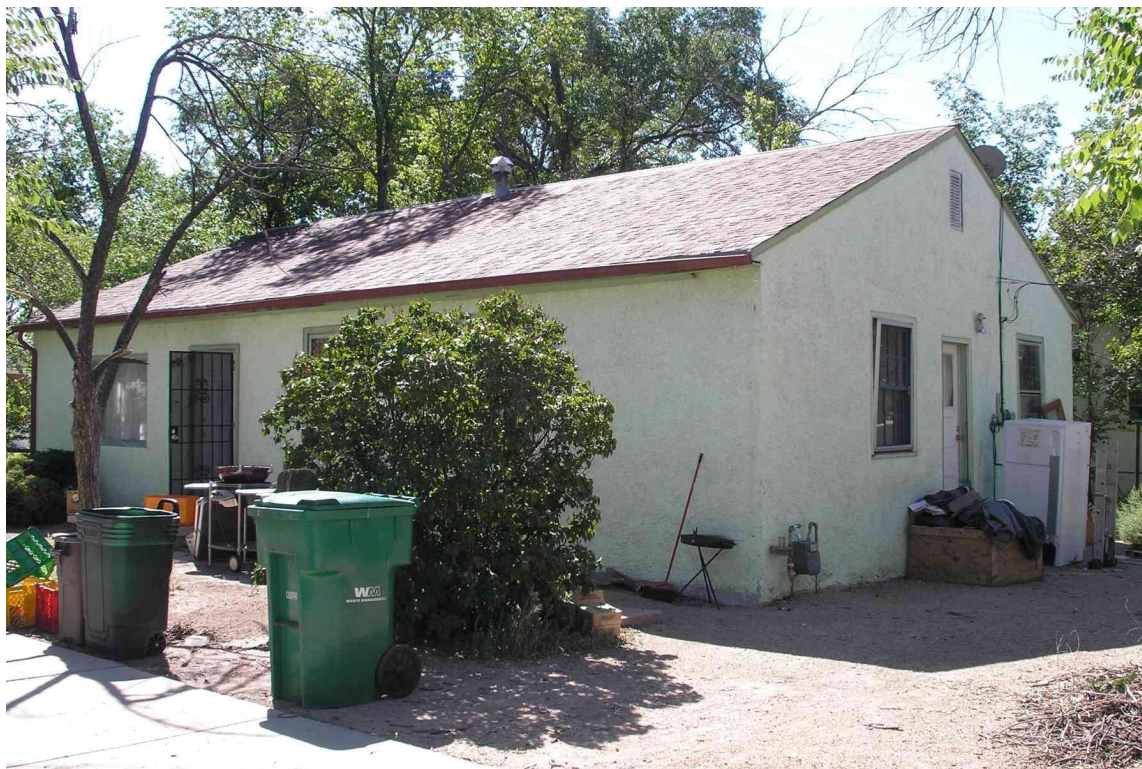
19. Primary external roof material: **Asphalt Roof/Composition Roof**
Other roof materials:
20. Special features: **Fence**
21. General architectural description:
Oriented to the north (toward West 15th Street), this house rests on a concrete foundation. Green-painted stucco clads the exterior walls. Most windows are 8-over-8-light, double-hung sash, with blue-painted wood frames, aluminum-frame storm windows, and green-painted wood surrounds. Single-light picture windows pierce both faces of the northeast corner. The principal doorway opens east of center in the front (north) façade. It hosts a white-painted wood door, with a bas-relief lion in its center panel. Another doorway opens in the center of the west elevation. Red asphalt shingles cover the side-gabled roof, and green-painted wood fascia and soffit box the shallowly overhanging eaves.
