COLORADO CULTURAL RESOURCE SURVEY

Architectural Inventory Form

- 1. Resource number: **5PE.5955** Parcel number(s):
- 2. Temporary resource number: **525229005**
- 3. County: **Pueblo**
- 4. City: **Pueblo**
- 5. Historic building name: **Karr, George W., House**
- 6. Current building name: **Pendarvis, Isaac M. and Barbara M., House**
- 7. Building address: **1520 Craig Street**
- 8. Owner name: **Isaac M. and Barbara M. Pendarvis**
- Owner organization:
- Owner address: **1520 Craig St**  
**Pueblo, CO 81003**

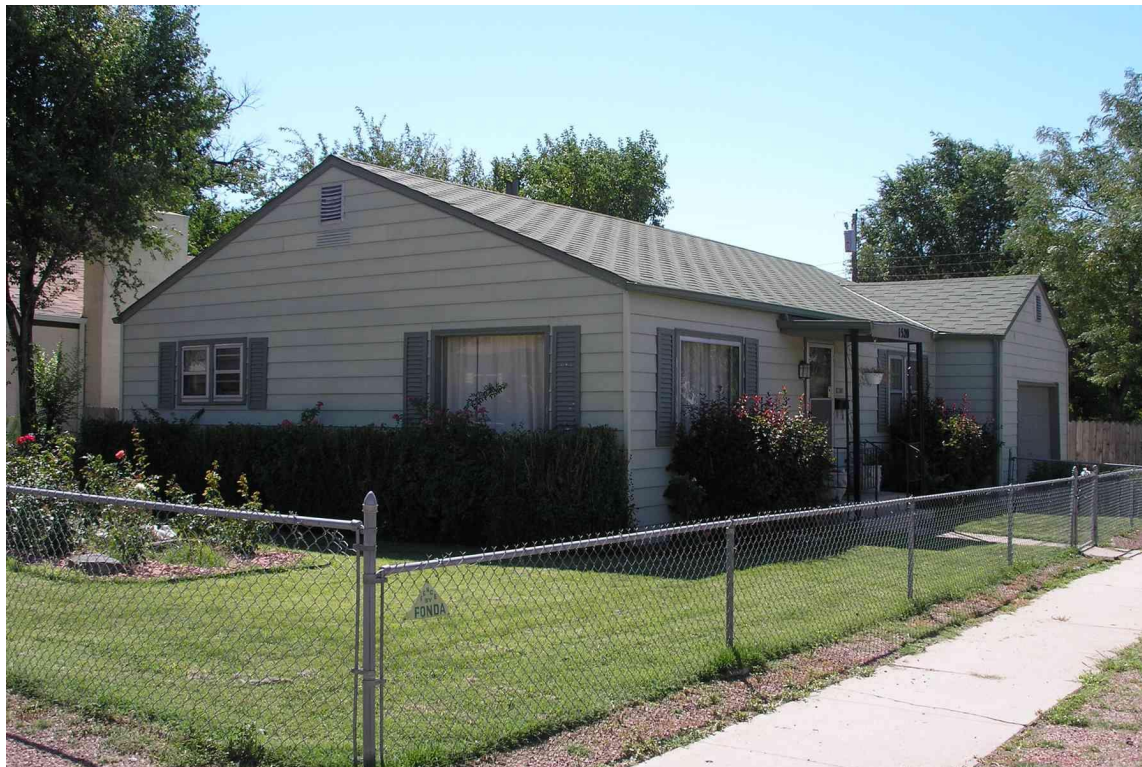
**Porch**
21. General architectural description:  
**Oriented to the west, this house rests on a concrete foundation. Light-green-painted aluminum siding clads the exterior walls. Windows are generally 1-over-1-light, double-hung sash, with green-painted wood frames and aluminum-frame storm windows. Green, louvered shutters flank those windows opening in the front (west) façade and the north elevation. Picture windows pierce either face of the northwest corner. A small porch protrudes near the center of the asymmetrical façade. It has wrought iron railings and supports, and a shallowly pitched aluminum roof. It shelters the principal doorway, which hosts a 4-panel, green-painted wood door, with a fanlight. The door is protected behind an aluminum-frame storm window. Another doorway opens north of center in the rear (east) elevation, sheltered beneath a fiberglass awning. A single-car garage is attached to the south elevation, protruding outward from the rest of the façade. Its west elevation hosts a green-painted, 16-panel, overhead-retractable garage door. Green, interlocking asphalt shingles cover the side-gabled roof, and the building lacks overhanging eaves.**

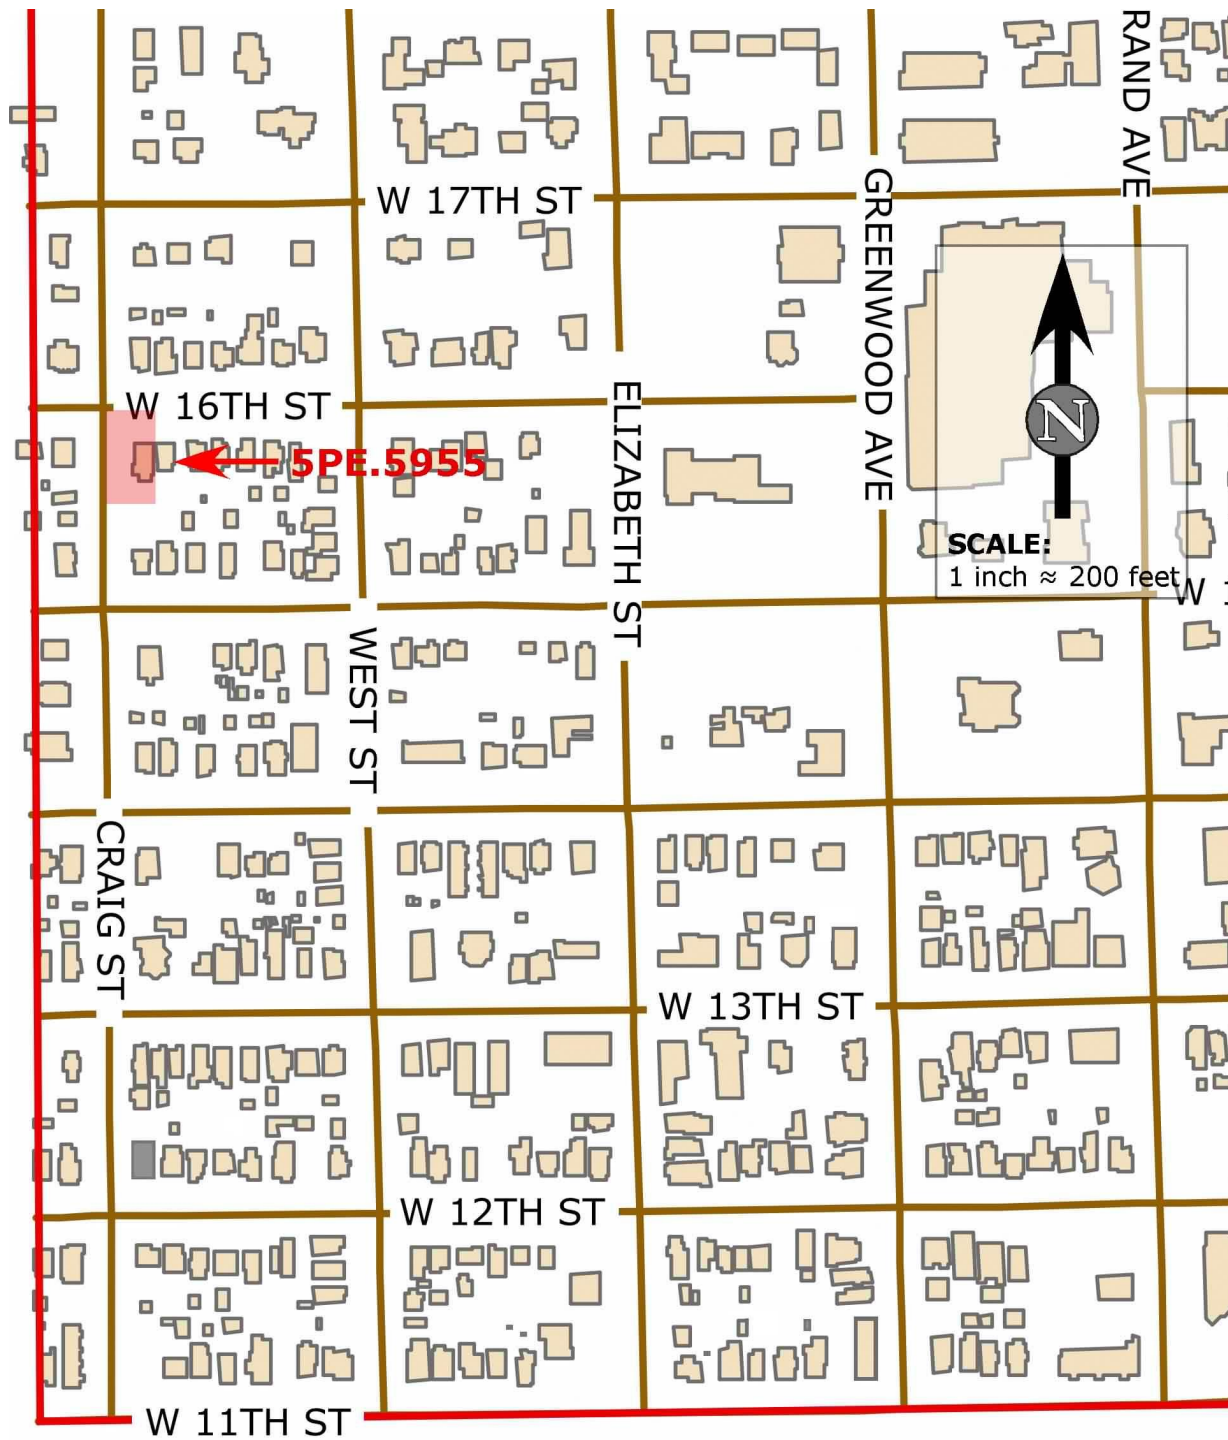
#### SITE SKETCH MAP

This property is located on terrain sloping downward from northeast to southwest, with an elevation of around 4,700 feet above mean sea level. The neighborhood features modest and large, 1- and 2-story houses and apartment buildings. Setbacks from Craig Street are generally the same on this block. This property is situated on the southwest corner of Craig and West 15th streets. Separating the street from the sidewalk is a lava-rock-covered strip. A planted-grass yard, with mature landscaping, covers the lot. Delimiting the eastern and northern portions of the yard is a split-rail fence; enclosing the rest of the property is a chain-link fence.
