COLORADO CULTURAL RESOURCE SURVEY

Architectural Inventory Form

- 1. Resource number: **5BL.10447** Parcel number: **158321002007**
- 2. Temporary resource number:
- 3. County: **Boulder**
- 4. City: **Eldora**
- 5. Historic building name: **Henry Jonasson Cabin**
- 6. Current building name: **Bryce-Commons Cabin**
- 7. Building address: **185 Eldorado Avenue**
- 8. Owner name: **Daniel P. Bryce and Colleen K. Commons**
- Owner organization:
- Owner address: **2704 W 134th Cr
Broomfield, CO 80020**

48. Report title: **Eldora Historical and Architectural Survey, 2007-08**

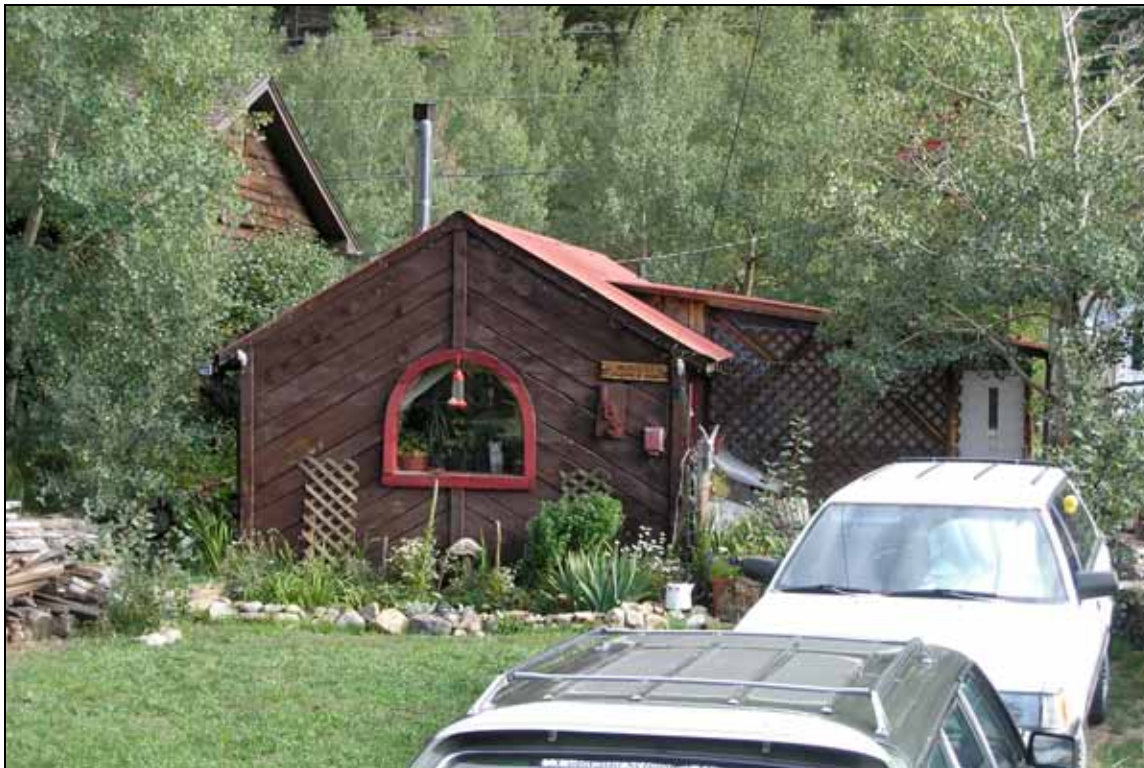
19. Primary external roof material: **Metal Roof/Tin Roof**
Other roof materials:
20. Special features: **Porch**
21. General architectural description:
Oriented to the south, this cabin appears to lack a formal foundation. The building consists of a front-gabled core, with a shed-roofed addition to the northern half of the east elevation. Extending the south elevation of this addition is a shed-roofed porch, enclosed with a combination of wood latticework and sheets of translucent plastic. Unpainted, vertical wood planks clad the exterior walls, except for the front (south) façade, which has boards set at 45-degree angles. Windows are generally 4-light hopper, awning, or casement. They have red-painted wood frames and surrounds. Dominating the front (south) elevation is a single-light, fixed-frame, round-arch window. The east elevation hosts a 1-beside-1-light, sliding-sash window, with an aluminum frame. The principal doorway opens in the east end of the south elevation of the enclosed porch. The doorway hosts a white vinyl, single-light slab door. Another doorway opens in the east elevation of a shed-roofed addition to the north elevation. It is a wood plank door. Red sheets of corrugated metal cover the front-gabled roof. The rafter ends are exposed but capped by a fascia board. A metal chimney protrudes from the roof's west-facing slope.
