COLORADO CULTURAL RESOURCE SURVEY

Architectural Inventory Form

- 1. Resource number: **5BL.10469** Parcel number: **158321002005**
- 2. Temporary resource number:
- 3. County: **Boulder**
- 4. City: **Eldora**
- 5. Historic building name: **August Barkeen Cabin**
- 6. Current building name: **"Golden-West" Cabin; Kready-Maxwell Cabin**
- 7. Building address: **199 Eldorado Avenue**
- 8. Owner name: **John L. Kready and Jo Ann Maxwell**
- Owner organization:
- Owner address: **1447 Lawrence Ave
Lawrence, KS 66049**

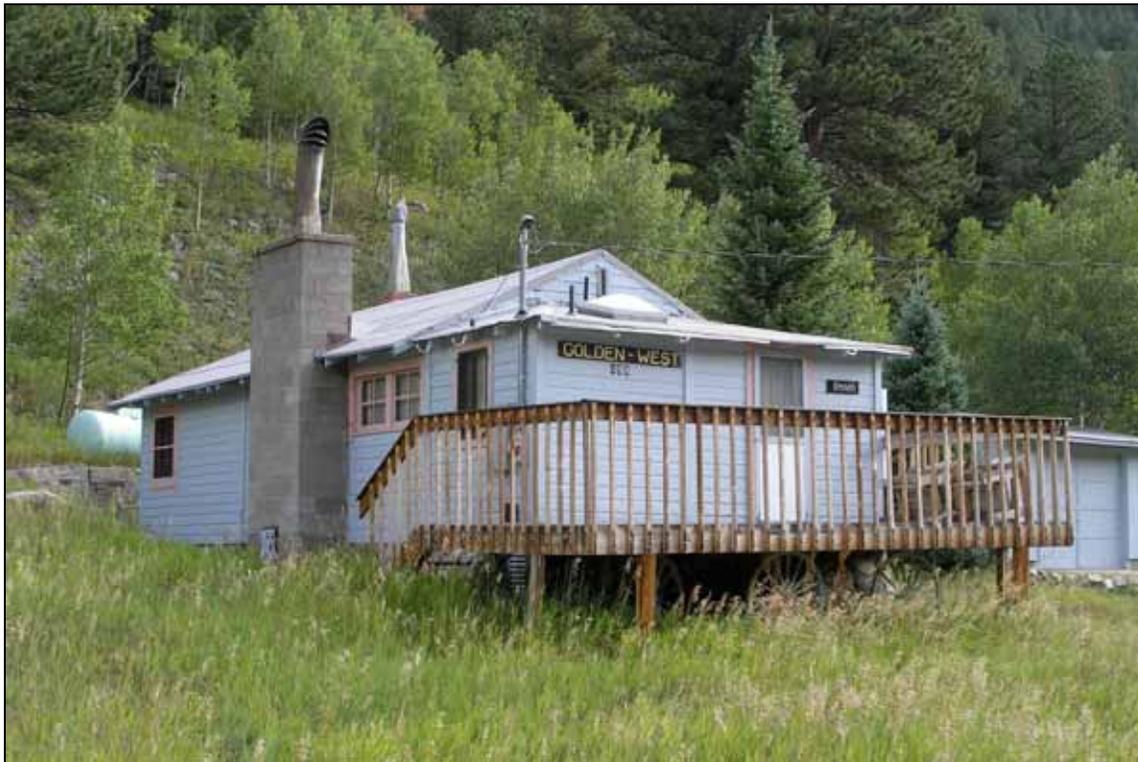
20. Special features: **Porch**
Chimney
21. General architectural description:
Oriented to the south, this house rests on an uncoursed rubble stone foundation. A vertical-plank door provides access to the crawlspace at the southern end of the east elevation. Blue-painted horizontal wood weatherboard, with 1-by-4-inch cornerboards, clads the exterior walls. Windows are generally 4-, 6-, and 9-light hopper, awning or casement windows, with unpainted or pink-painted wood frames and surrounds. The south end of the west elevation hosts a 1-beside-1-light, sliding sash window, with an aluminum frame. A doorway opens east of center in the south facing gable end. It hosts a single-light wood door, opening behind a wood-frame storm door. The doorway provides access to an unsheltered wood deck, with steps descending to the north. Another doorway opens in the south elevation of a small, side-gabled wing attached to the north end of the east elevation. It hosts a blue-painted, 4-panel, 1-light wood door, opening behind a wood-frame storm door. The doorway provides access to an unsheltered concrete porch, with a pipe railing. Above the doorway is a small gable or pediment. Gray sheets of asphalt cover the cross-gabled roof, and the rafter ends are exposed. A concrete block is engaged to the middle of the west elevation. A red-brick chimney protrudes from the west end of the east-west roof ridge.
