COLORADO CULTURAL RESOURCE SURVEY

Architectural Inventory Form

- 1. Resource number: **5BL.10472** Parcel number: **158321004001**
- 2. Temporary resource number:
- 3. County: **Boulder**
- 4. City: **Eldora**
- 5. Historic building name: **Hornback Cabin**
- 6. Current building name: **Hornback Cabin**
- 7. Building address: **315 Eldorado Avenue**
- 8. Owner name: **Arne Hedegarrd Exemption Trust (half) and Charles E. Hornback (half)**
- Owner organization:
- Owner address: **836 E 17th Ave #2D
Denver, CO 80218**

48. Report title: **Eldora Historical and Architectural Survey, 2007-08**

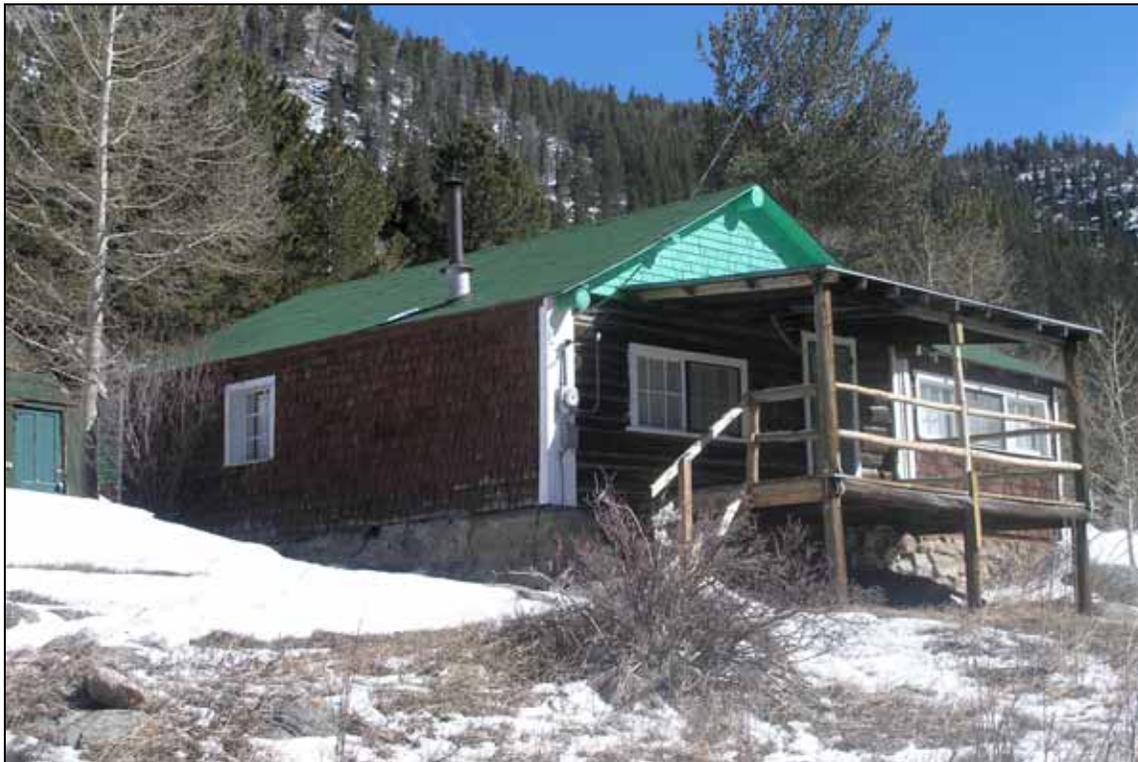
19. Primary external roof material: **Asphalt Roof/Composition Roof**
Other roof materials:
20. Special features: **Porch**
21. General architectural description:
Oriented to the south, this cabin rests on a random-coursed granite foundation, partially encased in concrete. The walls of the original, front-gabled cabin consist of peeled logs, with hog-through corners. Square-cut wood shingles cover the west and north elevations of the original cabin, as well as side-gabled and shed-roofed additions to the east. The wood shingles covering the south-facing gable have been painted green. Windows are generally 6-beside-6-light sliding sash, with white-painted wood frames and surrounds. The building also hosts 6-light casement windows of the same construction as the sliding sash windows. The principal doorway opens in the east end of the front-gable portion of the asymmetrical front (south) facade. It appears to host a vertical plank door, opening behind a wood-frame screen door. The doorway provides access to a shed-roofed porch spanning the gabled portion of the facade. It consists of stickwork supports and railings, and a corrugated metal roof. Wood steps approach the porch from the west. Another doorway opens in the north-facing gable end. Green asphalt shingles cover the front-gabled main roof and all other roof surfaces, except the porch. The cabin lacks overhanging eaves, and the long perlin ends are exposed.

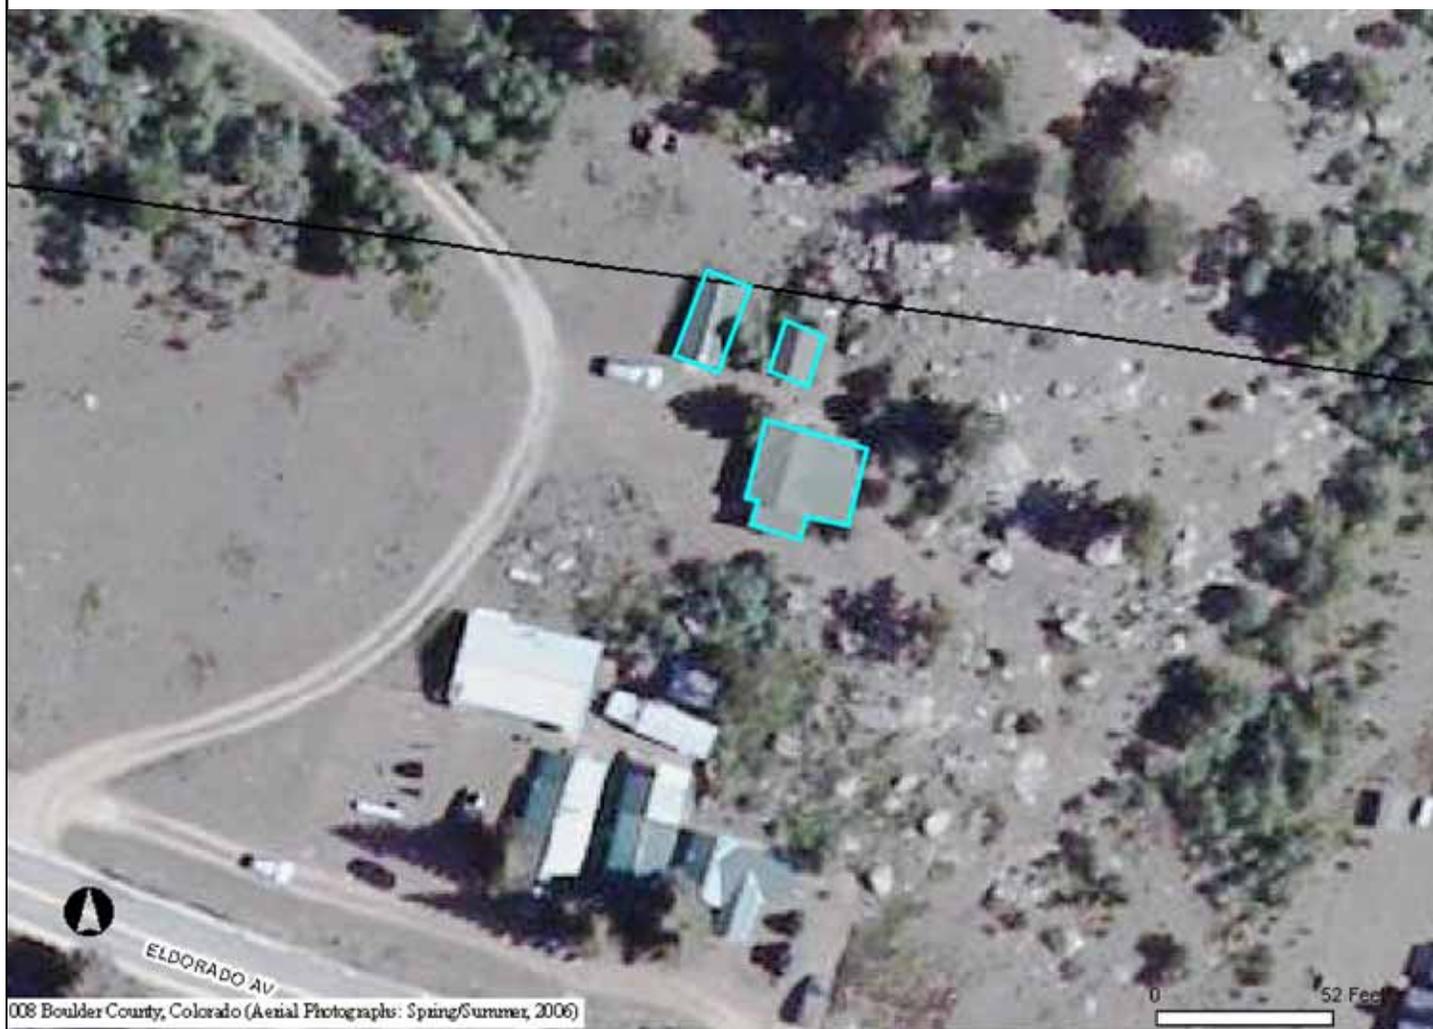
SKETCH MAP

008 Boulder County, Colorado (Aerial Photographs: Spring/Summer, 2006)
