COLORADO CULTURAL RESOURCE SURVEY

Architectural Inventory Form

- 1. Resource number: **5BL.10476** Parcel number: **158321212002**
- 2. Temporary resource number:
- 3. County: **Boulder**
- 4. City: **Eldora**
- 5. Historic building name: **Lilly Cabin**
- 6. Current building name: **Michael J. and Patricia Anne Audet Cabin**
- 7. Building address: **475 Eldorado Avenue**
- 8. Owner name: **Michael J. and Patricia Anne Audet**
- Owner organization:
- Owner address: **334 Sugarloaf Mountain Rd
Boulder, CO 80302**

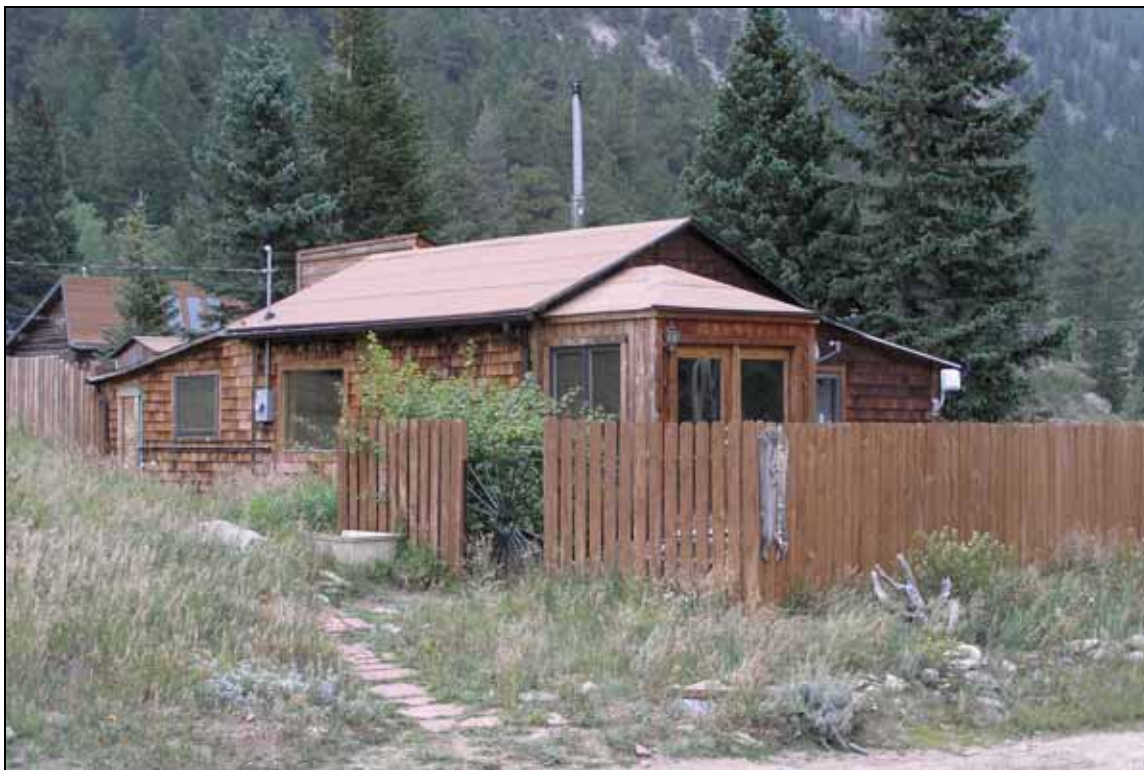
19. Primary external roof material: **Asphalt Roof/Composition Roof**
Other roof materials:
20. Special features: **Fence**
21. General architectural description:
Oriented to the south, this cabin rests on a stone foundation. Stained wood shingles clad the exterior walls. Unpainted, wood weatherboard covers a shed-roofed, story-and-a-half addition to the northeast corner of the cabin. Windows are generally single-light casement, with brown aluminum frames. The principal doorway opens in the south elevation of a hipped roof foyer protruding from the west end of the south elevation. It hosts paired, single-light wood doors. Another doorway opens in the north end of the east elevation. Brown sheets of asphalt cover the front-gabled main roof and other roof surfaces. The shed roof of the northeast addition has brown, interlocking asphalt shingles.
