COLORADO CULTURAL RESOURCE SURVEY

Architectural Inventory Form

- 1. Resource number: **5BL.10491** Parcel number: **158320006001**
- 2. Temporary resource number:
- 3. County: **Boulder**
- 4. City: **Eldora**
- 5. Historic building name: **James J. and Margaret M. Yeager Cabin**
- 6. Current building name: **John B. and Wilma Brocklehurst Cabin**
- 7. Building address: **1120 Eldorado Avenue**
- 8. Owner name: **John B. and Wilma Brocklehurst**
- Owner organization:
- Owner address: **PO Box 253
Nederland, CO 80466**

48. Report title: **Eldora Historical and Architectural Survey, 2007-08**

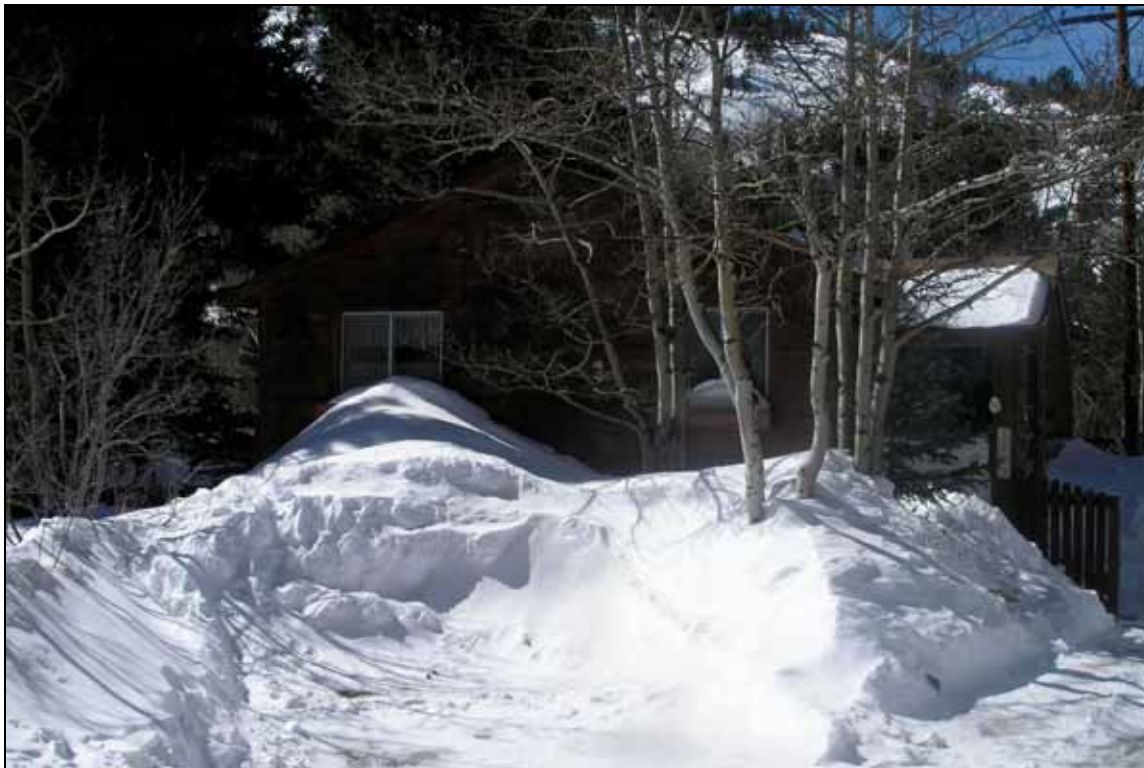
20. Special features: **Chimney
Fence**
21. General architectural description:
This cabin is oriented to the north. Because of snow cover, the nature of foundation could not be determined. Horizontal, unpainted wood siding, with an unfinished bottom edge, clads the exterior walls. Windows are generally 1-beside-1-light, sliding-sash, with aluminum frames. Larger window openings host single-light, fixed-frame windows. Protruding from the east end of the rear (south) elevation is a small, canted bay window. The principal doorway opens within a front-gabled foyer protruding from the south end of the asymmetrical front (north) facade. A secondary doorway opens in the east elevation of a shed-roofed wing protruding from the rear elevation. Approaching it are wood steps. Brown asphalt shingles cover the side-gabled main roof and all other roof surfaces. Wood fascia and soffit box the overhanging eaves. A random-coursed cobblestone hearth and chimney are engaged to the north elevation, near its center.
