COLORADO CULTURAL RESOURCE SURVEY

Architectural Inventory Form

- 1. Resource number: **5PE.5822**
- 2. Temporary resource number:
- 3. County: **Pueblo**
- 4. City: **Pueblo**
- 5. Historic building name: **Russell, Raymond H., House**
- 6. Current building name: **Russell, Theodore R., House**
- 7. Building address: **1106 N Elizabeth Street**
- 8. Owner name: **Theodore R. Russell**
- Owner organization:
- Owner address: **1106 N Elizabeth St**  
**Pueblo, CO 81003**

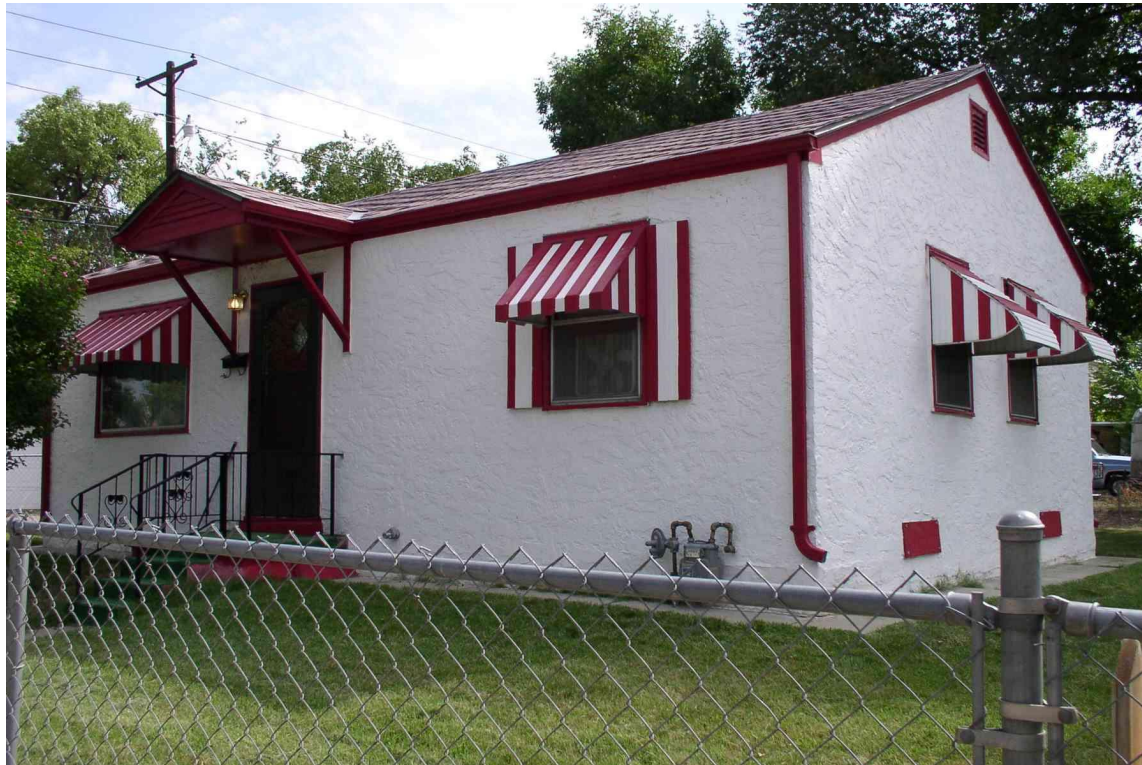
**Oriented to the west, this house rests on a concrete foundation. White-painted stucco clads the exterior walls. Windows are generally 1-over-1-light, double-hung sash, with red-painted wood frames, aluminum-frame storm windows, and thin, red-painted wood surrounds. Red-and-white-striped, beadboard shutters flank the window opening in the south end of the front (west) façade. A single-light picture window dominates the opposite end of the façade. Red-and-white-striped, metal awnings shade the windows in the façade and south elevation. The principal doorway opens in the center of the façade. It hosts a red-painted wood slab door, with diamond-shaped glazing, opening behind a brown, aluminum-frame storm door. Approaching the doorway is a small, concrete stoop, with wrought-iron railings. Sheltering it is a front-gabled hood on knee brackets. Another doorway opens in the north end of the rear (east) elevation. It hosts a 4-panel, 1-light wood door, painted white, opening behind an aluminum-frame storm door. A low, concrete stoop approaches the doorway. An aluminum awning shelters the stoop and the northern portion of the rear elevation. Interlocking, gray-red asphalt shingles cover the side-gabled roof, and house lacks overhanging eaves.**

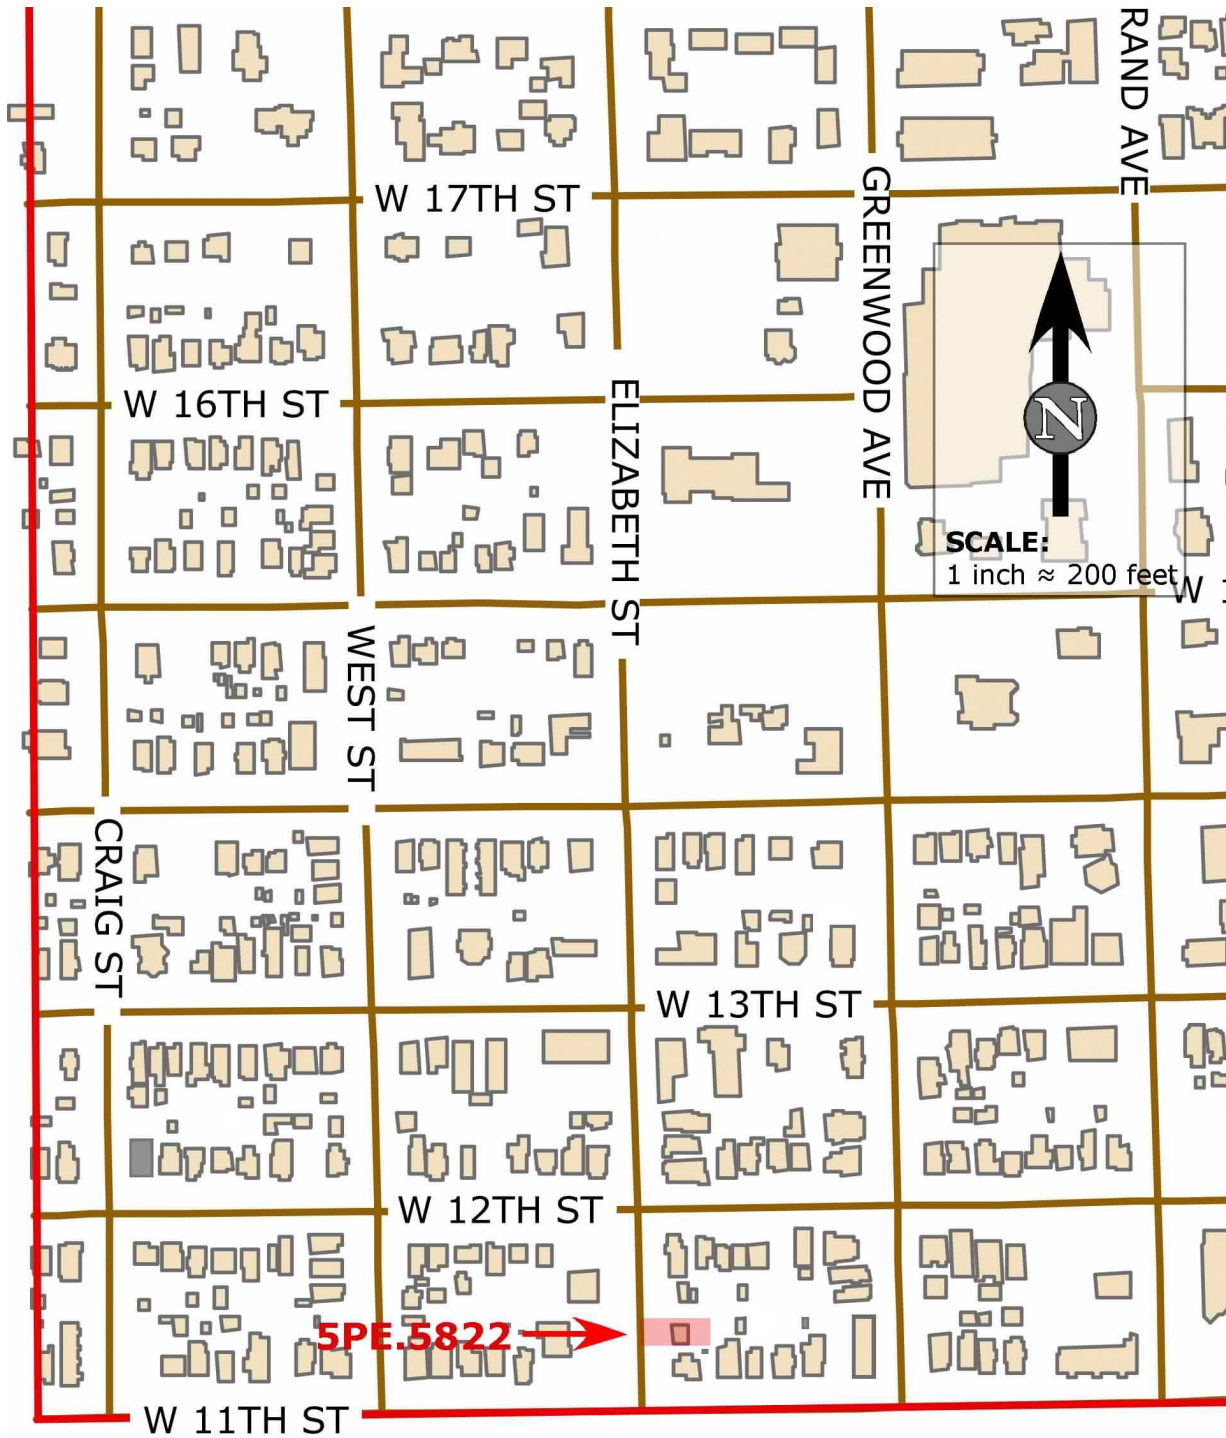
SITE SKETCH MAP

- 1: Type: **Shed (East of House)**  
Describe: **A standard, modular type shed is located directly behind (east) of the house. Oriented to the west, the building lacks a formal foundation. White-painted particleboard sheets, with thin red cornerboards, clad the exterior walls. A particleboard door, with X-shaped bracing, opens in the center of the front (west) façade. Gray, interlocking asphalt shingles cover the front-gabled roof.**

- 2: Type: **Shed (Northeast of House)**  
Describe: **A small shed is located on the northeast corner of the property. Oriented to the west, the building lacks a formal foundation. Sheets of white-painted particleboard, pressed into a faux stucco pattern, clad the exterior walls. Red-painted, 1-by-4-inch cornerboards, mark the corners of the building. Asphalt shingles, as painted red, cover the gables. Opening at the center of the front (west) elevation is a red-painted, vertical plank door, on metal strap hinges. Gray, interlocking asphalt shingles cover the front-gabled roof, and the rafter ends are exposed.**
