COLORADO CULTURAL RESOURCE SURVEY

Architectural Inventory Form

- 1. Resource number: **5PE.5824** Parcel number(s):
- 2. Temporary resource number: **525424016**
- 3. County: **Pueblo**
- 4. City: **Pueblo**
- 5. Historic building name: **1126 North Elizabeth Street**
- 6. Current building name: **Martinez-Guerrero House**
- 7. Building address: **1126 N Elizabeth Street**
- 8. Owner name: **Irene C. and Ronnie Martinez; Thelma Guerrero; and Hubert Martinez, Jr.**
- Owner organization:
- Owner address: **1126 N Elizabeth St**
Pueblo, CO 81003

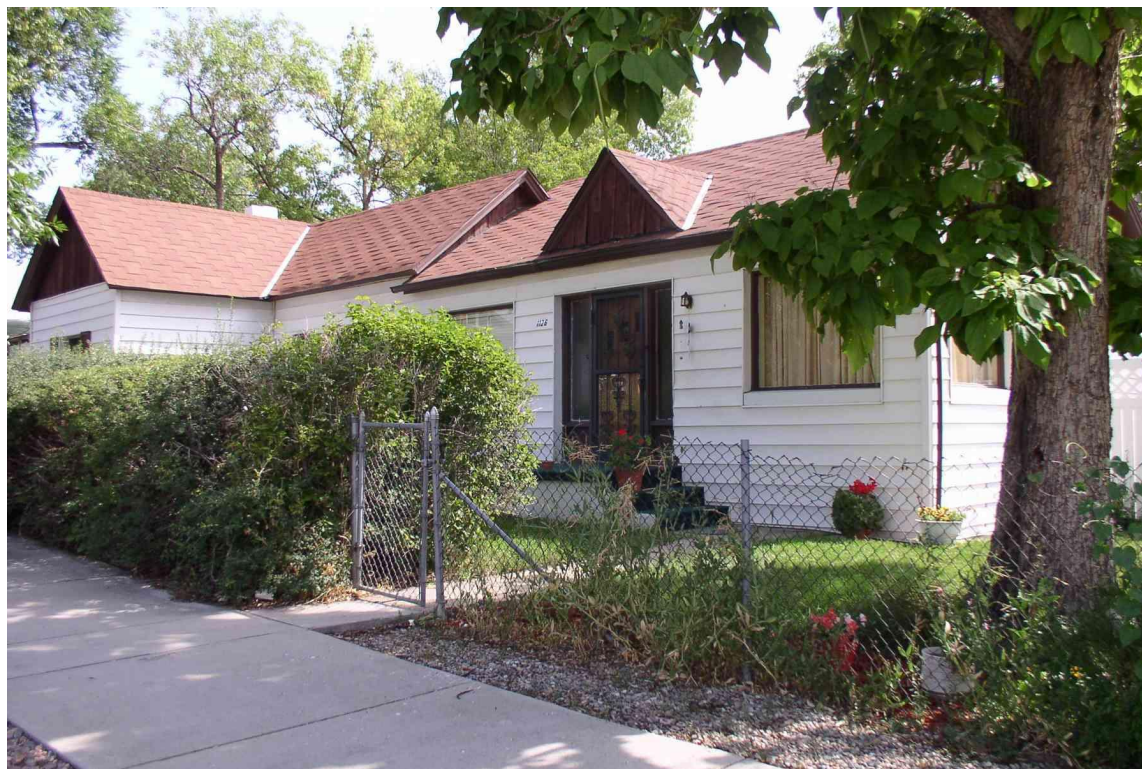
19. Primary external roof material: **Asphalt Roof/Composition Roof**
Other roof materials:
20. Special features: **Fence**
Chimney
21. General architectural description:
Oriented to the west, this house appears to rest on a concrete foundation. Broad, white vinyl siding clads the exterior walls. Brown, vertical wood siding covers the gables. Windows are generally 1-beside-1-light sliding sash, with aluminum frames. Most have flanking, brown, louvered shutters. Wood-frame, single-light picture windows pierce the asymmetrical front (west) façade on either side of the principal doorway. The same type of window pierces the west end of the south elevation. The principal doorway opens in the south side of the façade. It hosts a 3-light wood slab door, opening behind a security-type storm door. Flanking the doorway on either side are sidelights with frosted glazing. A 3-step concrete stoop approaches the doorway from the south. Above the doorway is a simple pediment. Another doorway opens near the center of the rear (east) elevation, in what appears to have been an enclosed, integral porch. Brown, interlocking asphalt shingles cover the cross-gabled roof and brown-painted wood fascia and soffit box the shallowly overhanging eaves. Concrete-encased chimneys emerge near the northern and northeastern portions of the roof.

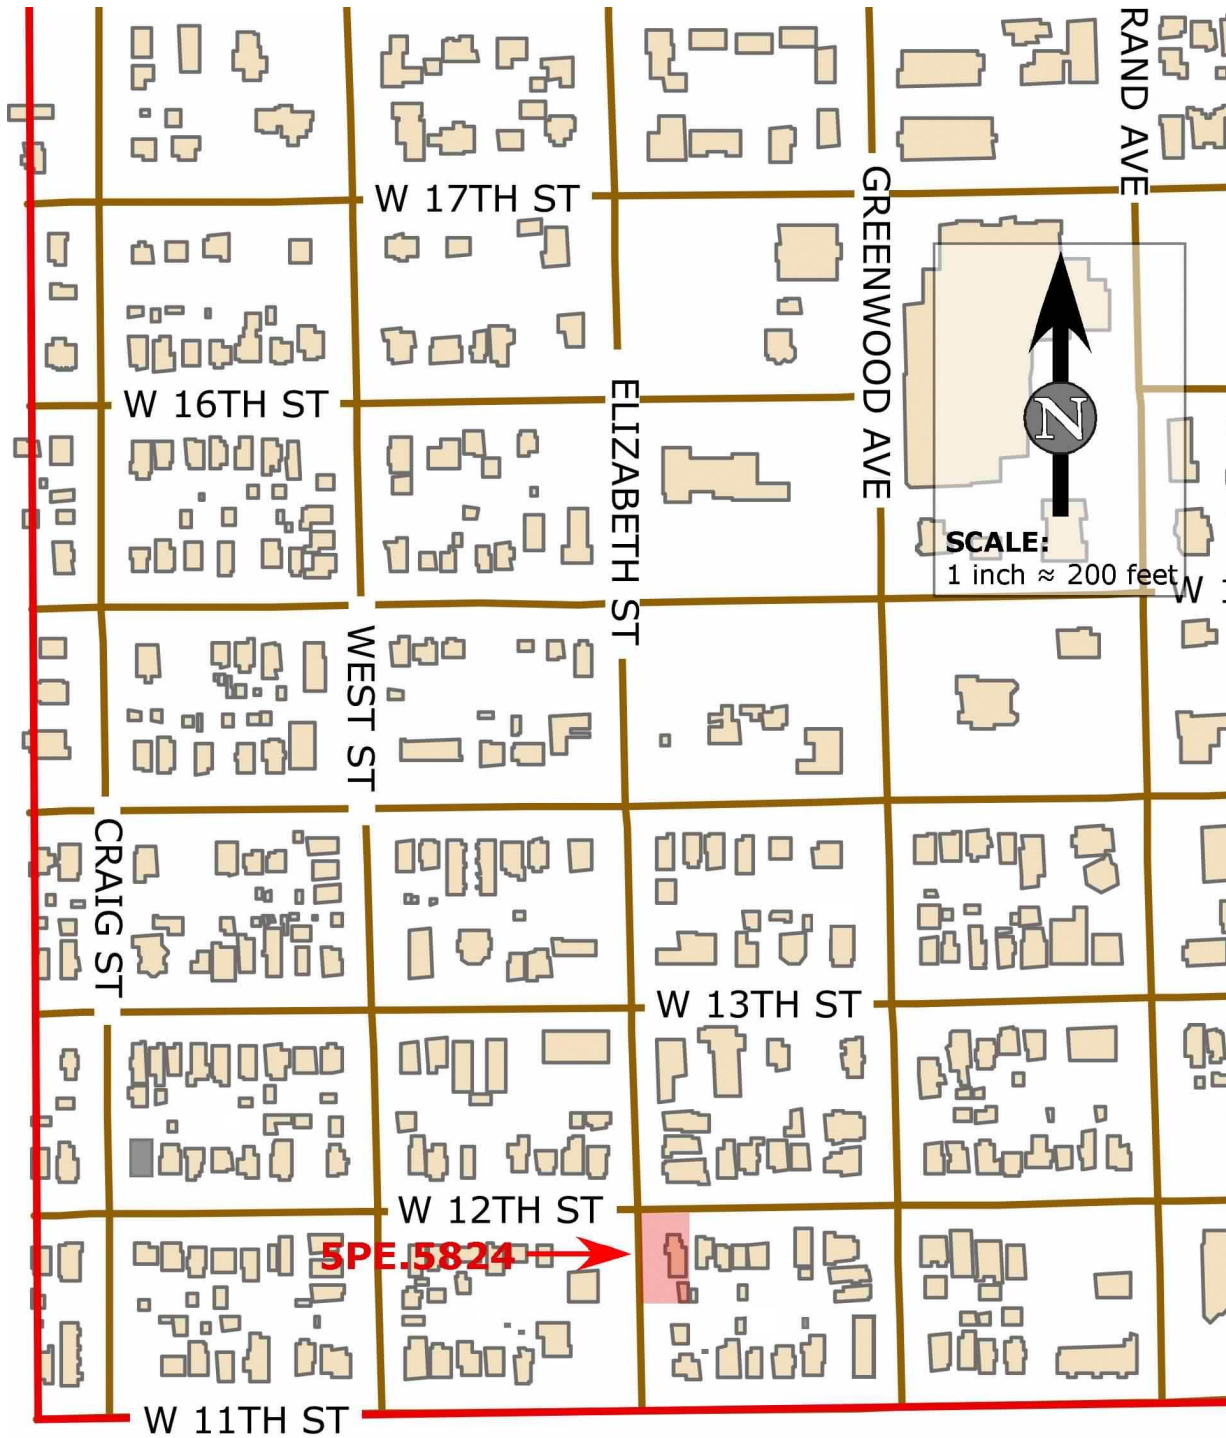
SITE SKETCH MAP

This property is located on terrain sloping downward from northeast to southwest, with an elevation of around 4,700 feet above mean sea level. The neighborhood features modest one- and two-story houses. Setbacks from North Elizabeth Street are generally the same on this block. This property is situated on the southeast corner of North Elizabeth and West 12th streets. Separating the streets from the sidewalks is a gravel-covered strip. A planted-grass yard, mature landscaping, covers the property. Surrounding the back yard is a chain-link fence.

Describe: **A single-car garage is located on the southeast corner of the lot. Oriented to the south, the building rests on a concrete foundation. White stucco clads the exterior walls. Brown-painted, horizontal wood siding covers the gables. Dominating the front (south) elevation is a 16-panel, wood, overhead-retractable garage door, painted white. A brown-painted, 4-panel wood door opens in the south end of the west elevation. In the center of the same elevation is a pair of single-light awning, hopper, or casement windows. Brown, interlocking asphalt shingles cover the front-gabled roof. A brown-painted wood fascia board caps the exposed rafter ends.**
