COLORADO CULTURAL RESOURCE SURVEY

Architectural Inventory Form

- 1. Resource number: **5PE.517.60** Parcel number(s):
- 2. Temporary resource number: **525420012**
- 3. County: **Pueblo**
- 4. City: **Pueblo**
- 5. Historic building name: **Mennitt, Theodore J., House**
- 6. Current building name: **15th Street Barber Shop**
- 7. Building address: **1205 N Elizabeth Street**
- 8. Owner name: **Melissa Joy and John Emilio Martinez**
- Owner organization:
- Owner address: **1415 Craig St**  
**Pueblo, CO 81003**

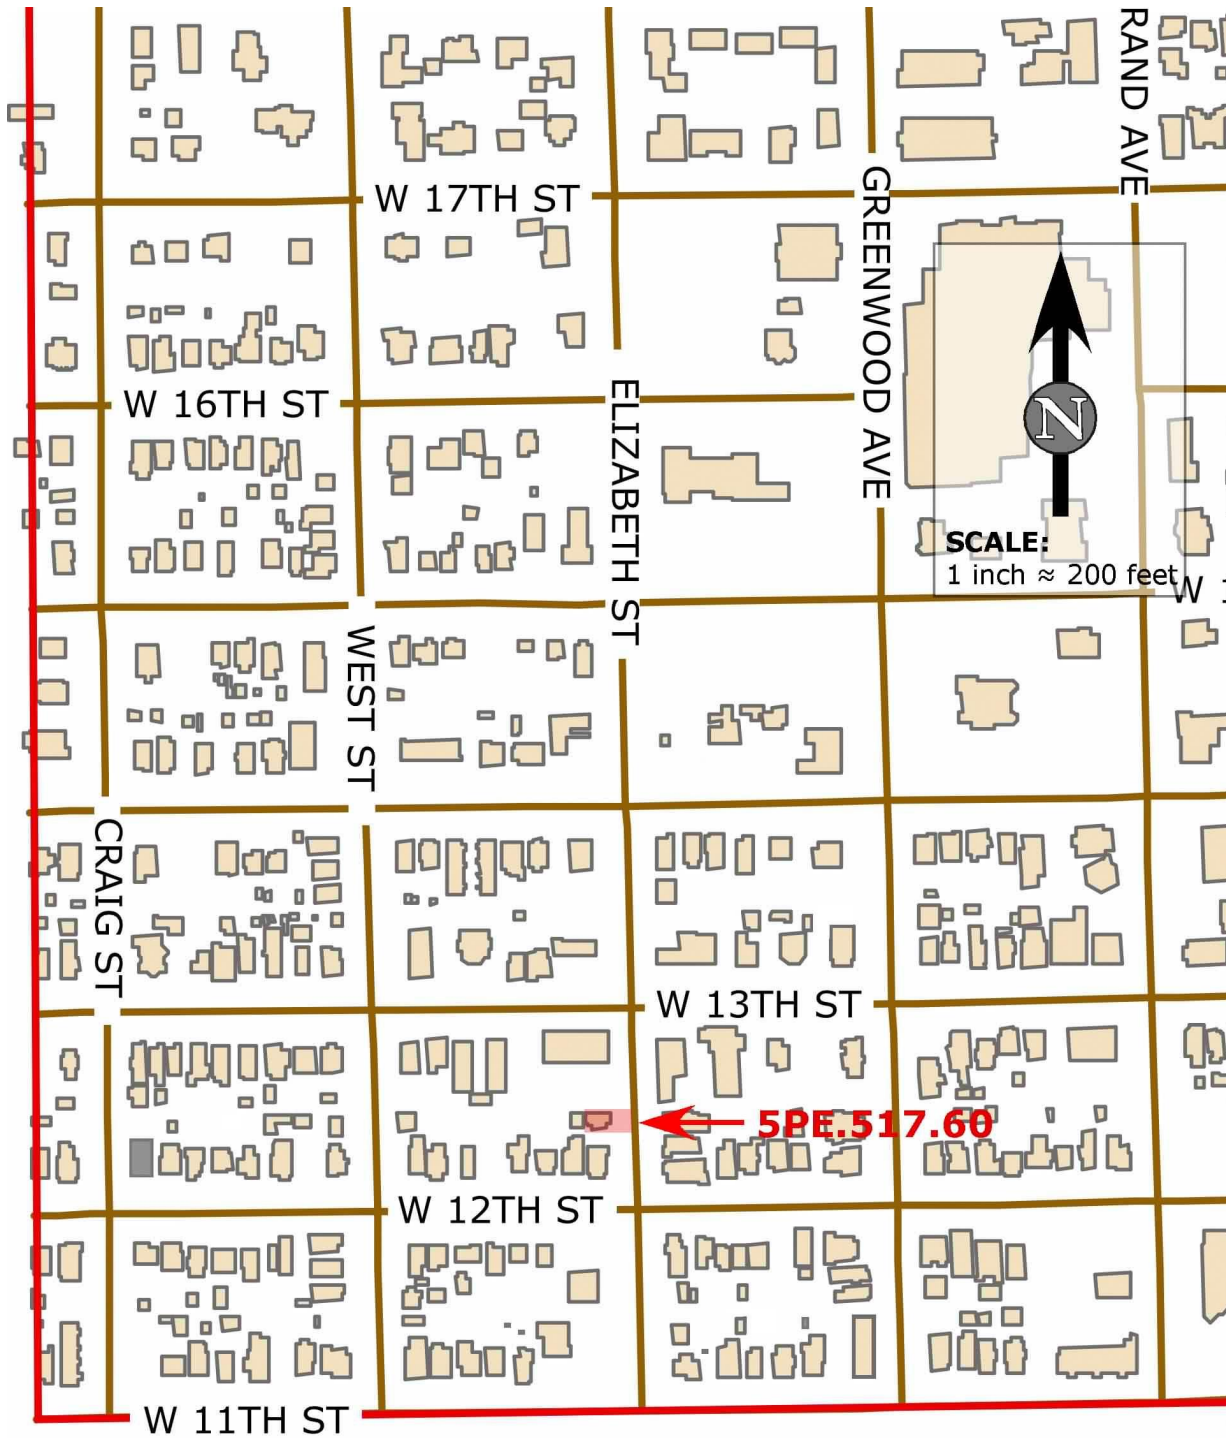
SITE SKETCH MAP

**This property is located on terrain sloping downward from northeast to southwest, with an elevation of around 4,700 feet above mean sea level. The neighborhood features modest one- and two-story houses. Setbacks from North Elizabeth Street are generally the same on this block. This property is situated on the west side of North Elizabeth Street, between 603 West 12th Street to the south and an east-west-oriented alley to the north. Separating the street from the pink sandstone sidewalk is a gravel strip. The property largely lacks planted grass and landscaping. A combination of wood picket and woven-wire fences delimit the southern and western sides of the property.**

Describe: **A small shed is located on the southwest corner of the lot. Oriented to the east, the building lacks a formal foundation. Red-painted, horizontal wood planks clad the exterior walls. Opening in the center of the front (east) elevation is a 4-panel wood door, painted red. Opening in the west end of the north elevation is a red-painted, vertical plank door. Gray asphalt shingles cover the front-gabled roof and the rafter ends are exposed.**
