COLORADO CULTURAL RESOURCE SURVEY

Architectural Inventory Form

- 1. Resource number: **5PE.5826** Parcel number(s):
- 2. Temporary resource number: **525419006**
- 3. County: **Pueblo**
- 4. City: **Pueblo**
- 5. Historic building name: **Pearson, Carter S., House**
- 6. Current building name: **1206 N Elizabeth Street**
- 7. Building address: **1206 N Elizabeth Street**
- 8. Owner name: **Russell H. Longgear, III**
- Owner organization:
- Owner address: **29376 Hardin Rd**
Pueblo, CO 81006

48. Report title: **Pueblo North Side Neighborhood Survey**

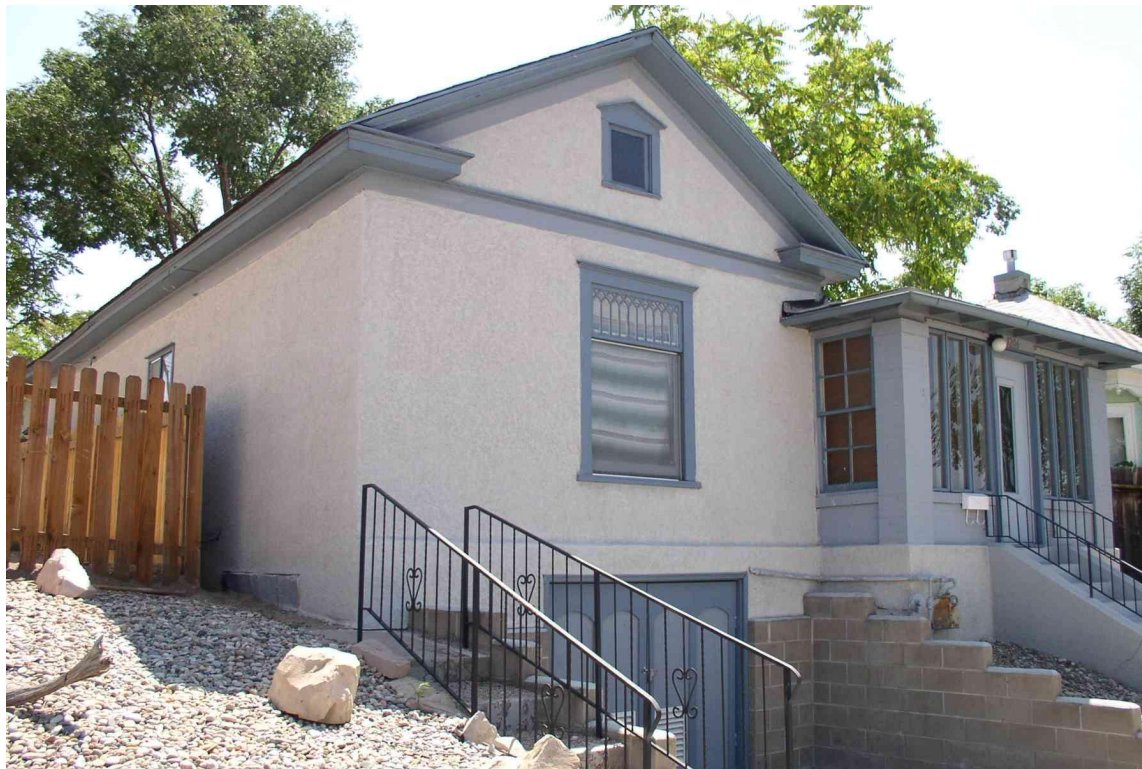
19. Primary external roof material: **Asphalt Roof/Composition Roof**
Other roof materials:
20. Special features: **Fence**
Chimney
Porch
21. General architectural description:
Oriented to the west, this house rests on a high, concrete foundation, largely obscured behind gray stucco. A doorway opens into the basement in the north half of the front (west) façade. It hosts paired, paneled wood doors, on metal strap hinges. Lining the well around the doorway are concrete blocks. Gray stucco clads the exterior walls. Windows are generally 1-beside-1-light sliding sash, with aluminum frames and blue-painted wood surrounds. Dominating the north side of the front (west) elevation is a 1-over-1-light, double-hung sash window, with a narrow upper sash containing cottage-style glazing. Above it, in the gable, is a single-light window, with a pedimented surround. A hipped-roof porch protrudes from the southwest corner. It has blue-painted brick piers. Enclosing the porch's side elevations are bands of 4-over-4-light windows. Across the front of the porch are single-light casements. The principal doorway opens in the center of the porch. It hosts a blue-painted, single-light slab door. Approaching the doorway are 10 concrete steps, flanked by wrought-iron railings. A shed-roof addition spans the rear (east) elevation and hosts a secondary doorway. Gray, interlocking asphalt shingles cover the gable-on-hip main roof and all other roof surfaces. The front-facing gable features eave returns. Blue-painted wood soffit and fascia, with projecting cornice, box the eaves. A red-brick chimney, with corbelled cap, protrudes near the roof's apex.

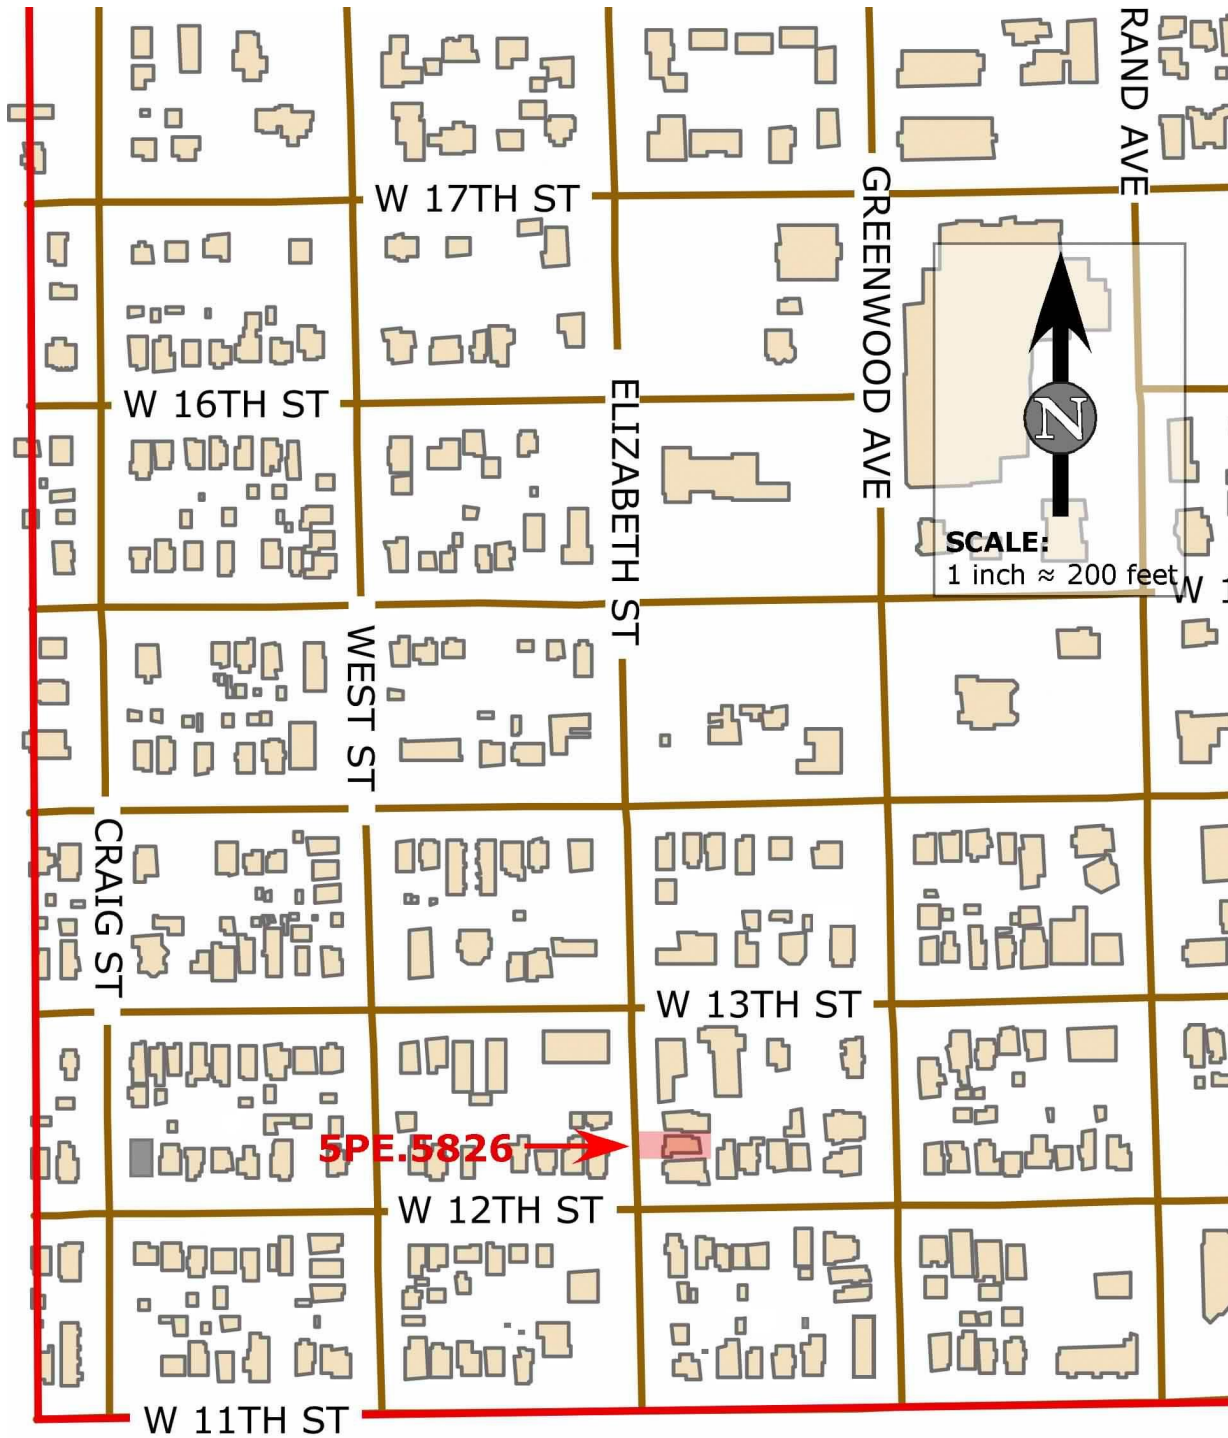
SITE SKETCH MAP

This property is located on terrain sloping downward from northeast to southwest, with an elevation of around 4,700 feet above mean sea level. The neighborhood features modest one- and two-story houses. Setbacks from North Elizabeth Street are generally the same on this block. This property is situated on the east side of North Elizabeth Street, between 1202 North Elizabeth Street to the south and 1210 North Elizabeth Street to the north. Separating the street from the sidewalk is a concrete-covered strip. A planted-grass yard, with mature landscaping, covers the lot. Cobblestones cover the slope in front (west of) the house. Surrounding the backyard is a wood privacy fence.
