COLORADO CULTURAL RESOURCE SURVEY

Architectural Inventory Form

- 1. Resource number: **5PE.5828** Parcel number(s):
- 2. Temporary resource number: **525420001**
- 3. County: **Pueblo**
- 4. City: **Pueblo**
- 5. Historic building name: **North Side Groceteria; Potter's Pharmacy; Bi-Rite Groceteria; North Side Arapahoe Grocery**
- 6. Current building name: **Hanger Prosthetics and Orthotics**
- 7. Building address: **1213 N Elizabeth Street**
- 8. Owner name: **Janelle Hall**
- Owner organization:
- Owner address: **3416 St Clair Ave**
Pueblo, CO 81005

48. Report title: **Pueblo North Side Neighborhood Survey**49. Date(s): **08/10/05**50. Recorder(s): **Adam Thomas**51. Organization: **Historitecture, L.L.C.**52. Address: **PO Box 419
Estes Park, CO 80517-0419**53. Phone number(s): **(970) 586-1165**

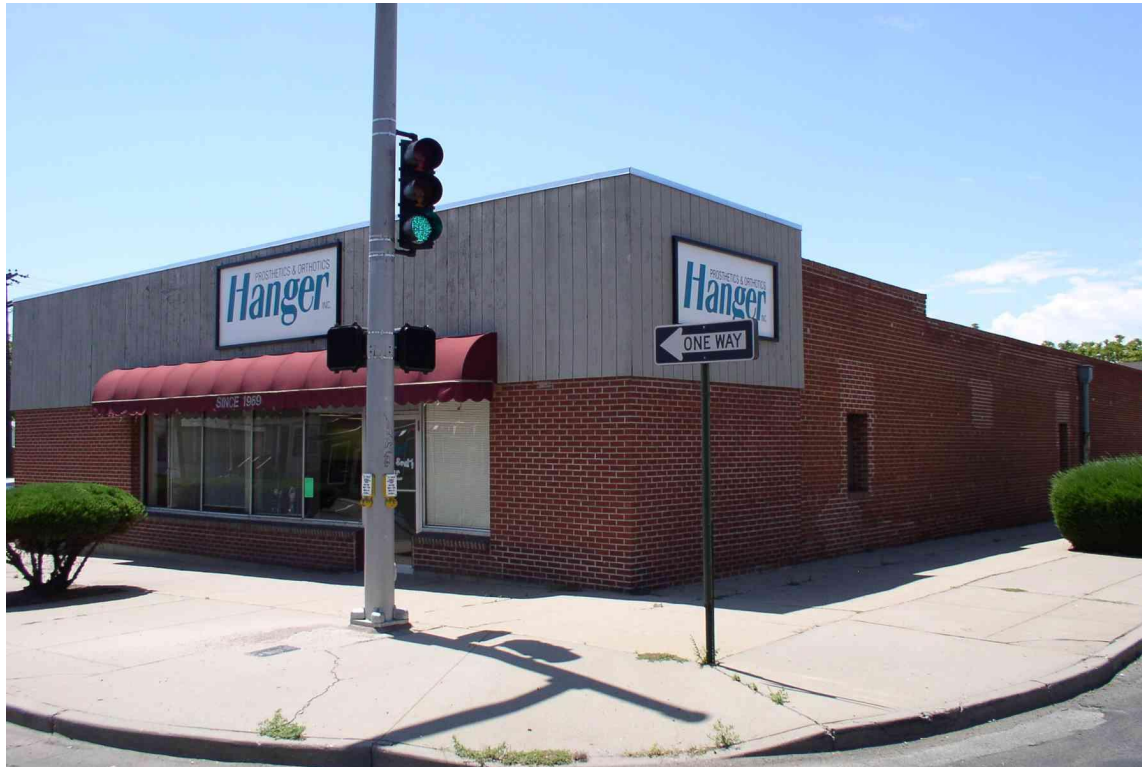
19. Primary external roof material: **Asphalt Roof**
Other roof materials:
20. Special features: **n/a**
21. General architectural description:
Oriented to the east, this building rests on a concrete foundation. The walls consist of red, raked bricks, except for the rear (west) elevation, which has red-painted concrete blocks. Gray-painted sheets of plywood cover the upper portions of the front (east) façade, wrapping around the northeast and southeast corners. The same material also covers a protruding bulkhead sheltering a doorway in the west end of the south elevation. Windows are generally 2-light casements, with aluminum frames. However, a band of single-light, plate-glass windows, sheltered beneath a red canvas awning, dominates the center of the façade, offset north of center. The principal doorway opens north of center within this band of windows. It hosts a plate-glass door. A khaki-painted metal slab door opens in the north end of the rear (west) elevation. The south elevation hosts 2 doorways. At the center of the elevation is a plate-glass door, with an aluminum frame. Approaching it is a concrete stoop, with steps along the south and a ramp ascending from the east. The west end of the same elevation has an identical door, but also features a sidelight to the north. A 2-step concrete stoop, with wrought-iron railing, approaches the doorway from the east. This doorway is sheltered by the bulkhead, which rests on steel supports. Asphalt covers the main flat roof.

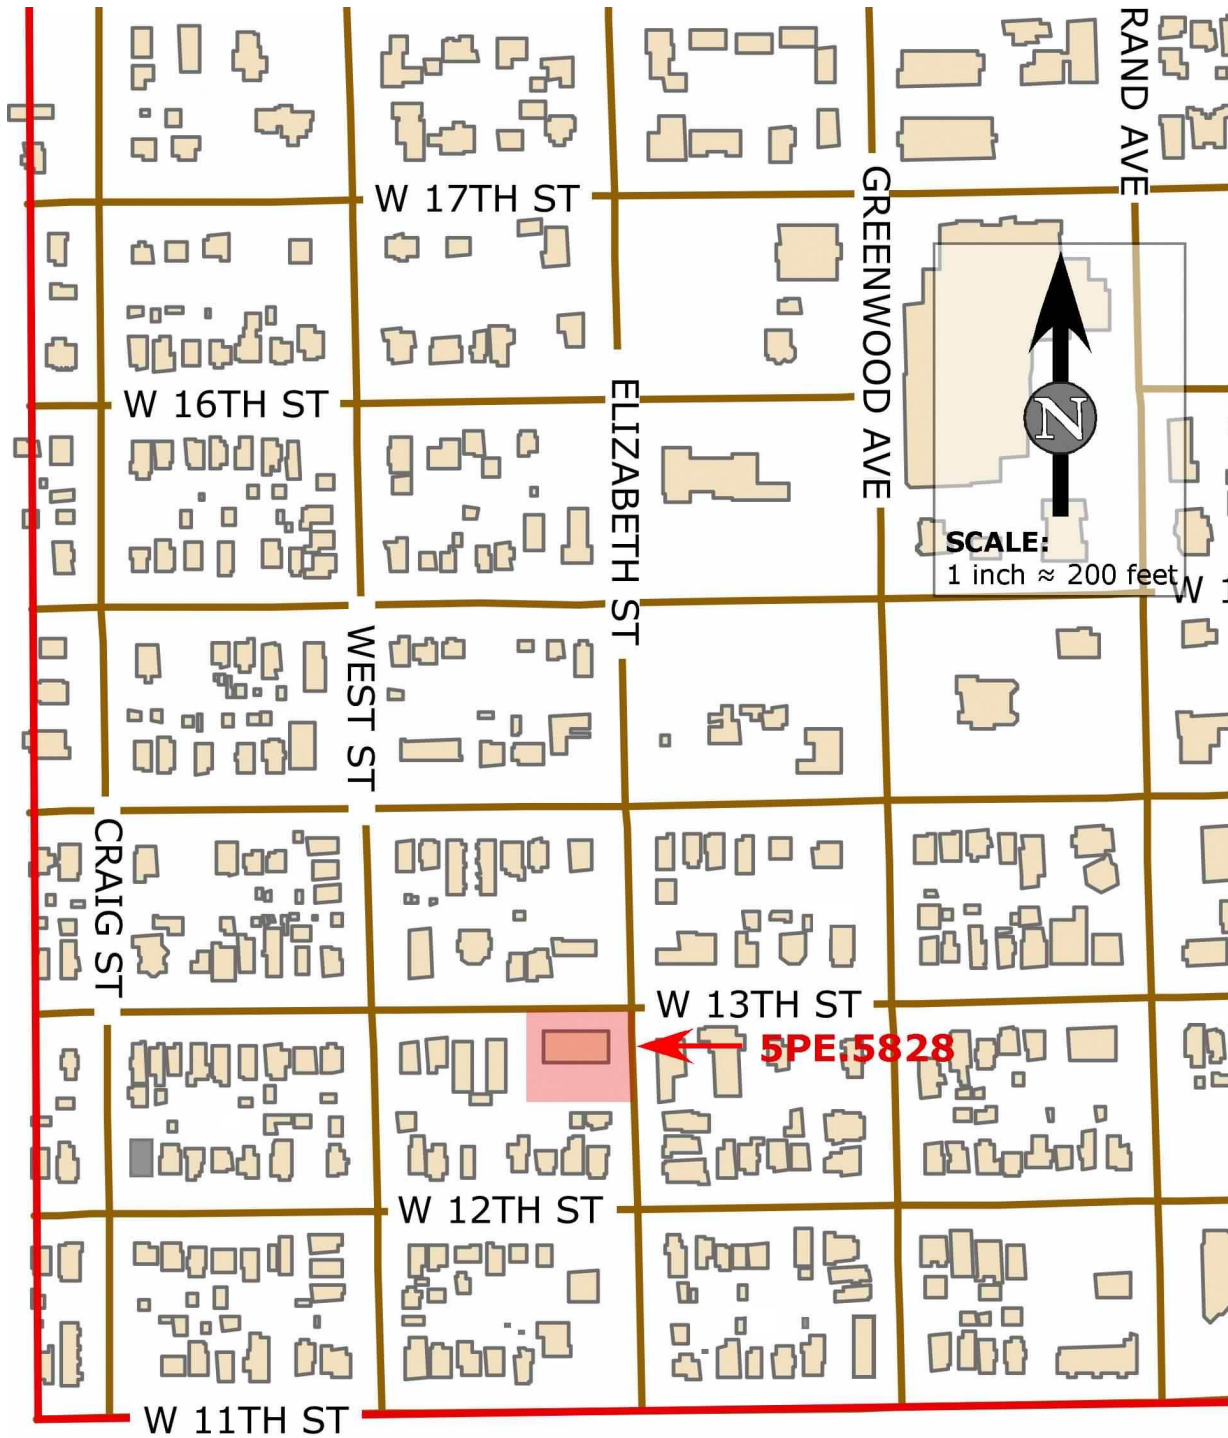
SITE SKETCH MAP

This property is located on terrain sloping downward from northeast to southwest, with an elevation of around 4,700 feet above mean sea level. The neighborhood features modest one- and two-story houses and a compact commercial district at the intersection of North Elizabeth and West 13th streets. Setbacks from North Elizabeth Street are generally the same on this block. This property is situated on the southwest corner of North Elizabeth and West 13th streets. Separating the streets from the sidewalks is a packed-earth strip, planted with junipers. A macadam parking lot dominates the southern and western portions of the parcel.
