COLORADO CULTURAL RESOURCE SURVEY

Architectural Inventory Form

- 1. Resource number: **5PE.5830** Parcel number(s):
- 2. Temporary resource number: **525410007**
- 3. County: **Pueblo**
- 4. City: **Pueblo**
- 5. Historic building name: **Curtis & Roller Texaco Station; Bassi Texaco Gas Station; Bob's Texaco; Harold's Texaco Service Station**
- 6. Current building name: **Believers Realty**
- 7. Building address: **1300 N Elizabeth Street**
- 8. Owner name: **Mary A. Highline**
- Owner organization:
- Owner address: **11 Reservoir Dr**  
**Pueblo, CO 81005**

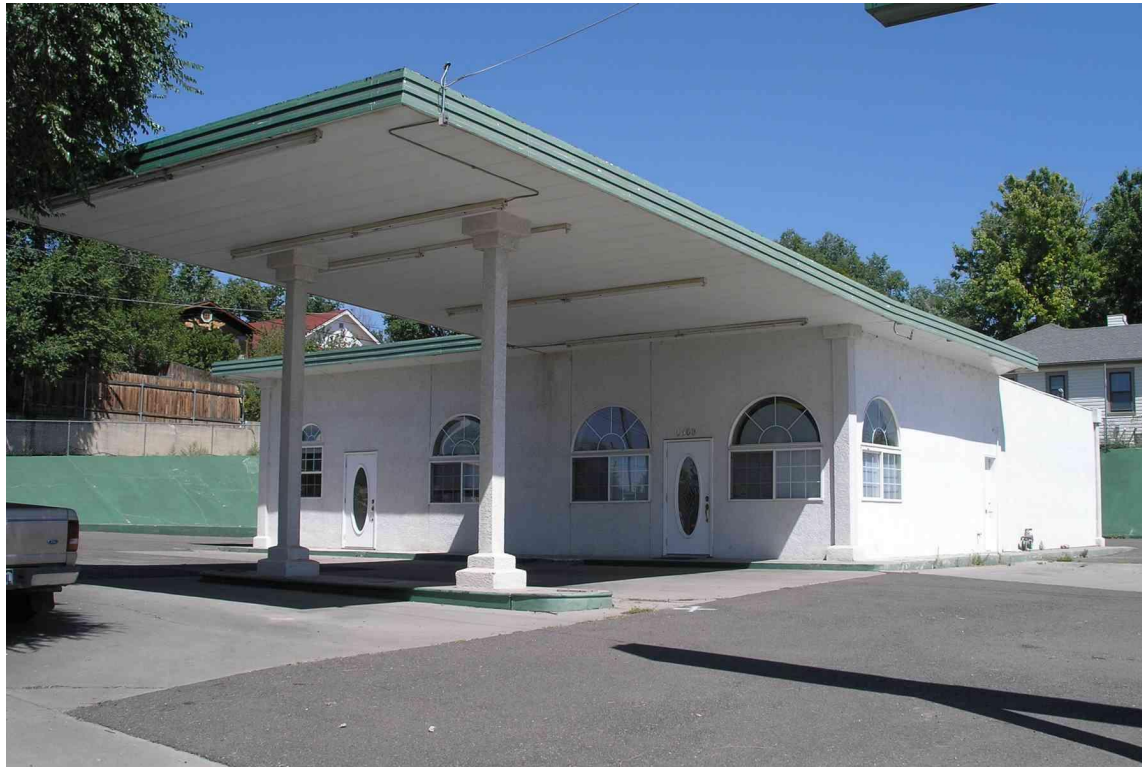
**Oriented to the west, this building rests on a concrete foundation. White stucco clads the exterior walls. Windows vary from 6-over-6-light, double-hung sash, to 6-beside-6-light and 9-beside-9-light sliding sash. They all have white vinyl frames. Above all of the windows in the front (west) façade and the westernmost windows in the side elevations are round-arch transoms. Doorways open in center of the southern half and northern half of the façade. Both host vinyl doors with oval glazing. A rubber membrane covers the flat roof, which extends westward from the southern half of the façade. Square, stucco-covered columns support this canopy, which shelters a former gas pump island.**
