COLORADO CULTURAL RESOURCE SURVEY

Architectural Inventory Form

- 1. Resource number: **5PE.5832** Parcel number(s):
- 2. Temporary resource number: **525410012**
- 3. County: **Pueblo**
- 4. City: **Pueblo**
- 5. Historic building name: **Larson, Howard, House**
- 6. Current building name: **Vigil, Soriada, House**
- 7. Building address: **1312 N Elizabeth Street**
- 8. Owner name: **Soraida Vigil**
- Owner organization:
- Owner address: **PO Box 4616**
Pueblo, CO 81003

47. Photograph numbers): **CD-ROM Photo Disc: North Side Photos**
File Name(s): elizabethstn1312
 Negatives filed at: **Special Collections**
Robert Hoag Rawlings Public Library
100 East Abriendo Avenue
Pueblo, CO 81004-4290
 48. Report title: **Pueblo North Side Neighborhood Survey**
 49. Date(s): **08/30/05**
 50. Recorder(s): **Adam Thomas**
 51. Organization: **Historitecture, L.L.C.**
 52. Address: **PO Box 419**
Estes Park, CO 80517-0419
 53. Phone number(s): **(970) 586-1165**

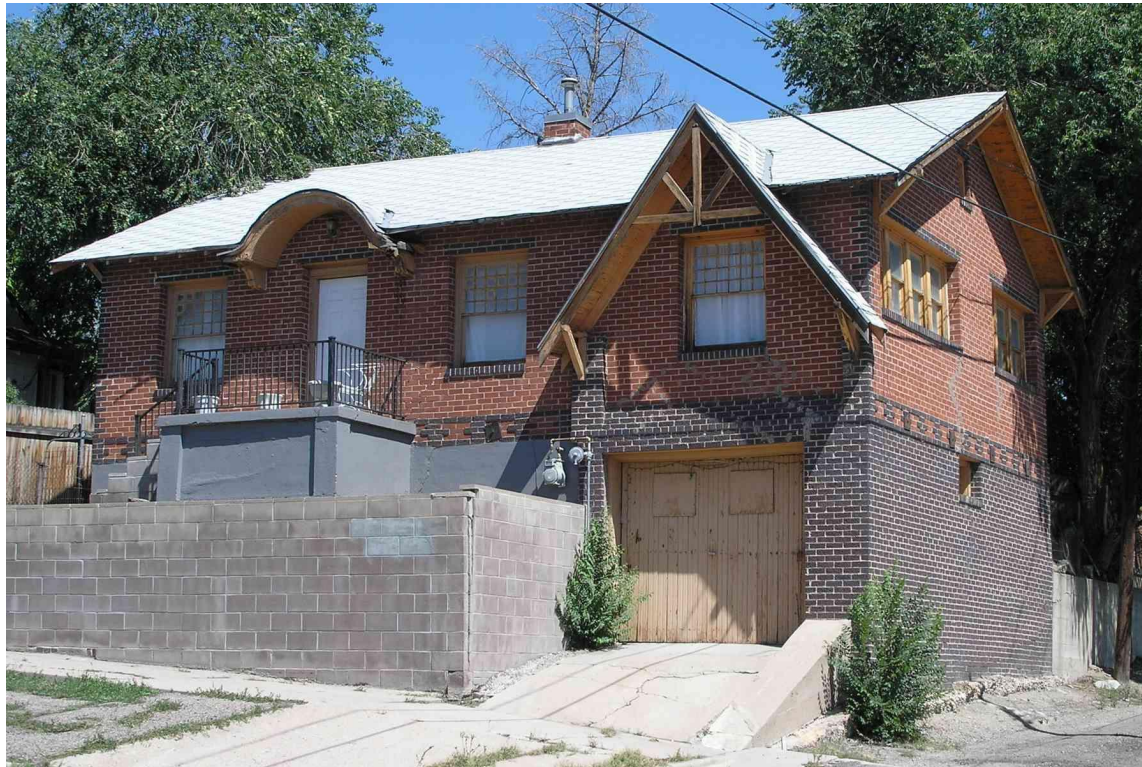
19. Primary external roof material: **Asphalt Roof/Composition Roof**
Other roof materials:
20. Special features: **Chimney**
Fence
Garage
21. General architectural description:
Oriented to the west, this house rests on a concrete foundation, largely veneered in a dark-brown brick. Piercing the south end of the foundation's west elevation is a single-car, beadboard, overhead pivot-type garage door, painted yellow. Sheltering the doorway is a large, front-gabled hood, on knee brackets. A red-brick veneer, with a dark-brown-brick watertable, windows sills and headers, and corners, clads the exterior walls. Most windows are 24-over-1, double-hung sash, with yellow-painted wood frames. However, smaller windows are 6- and 9-over-1-light and, in both faces of the southeast corner, are bands of 1-over-1-light windows. The principal doorway opens north of center in the asymmetrical front (west) façade, sheltered beneath a barrel-roofed hood on scroll brackets. It hosts a 6-panel metal door, painted white. Approaching the doorway from the north is a high, 5-step concrete stoop, with a wrought-iron railing. Another doorway opens in the north end of the rear (east) elevation. Gray asphalt shingles cover the side-gabled roof, and the rafter ends are exposed. Knee brackets appear in the gables.

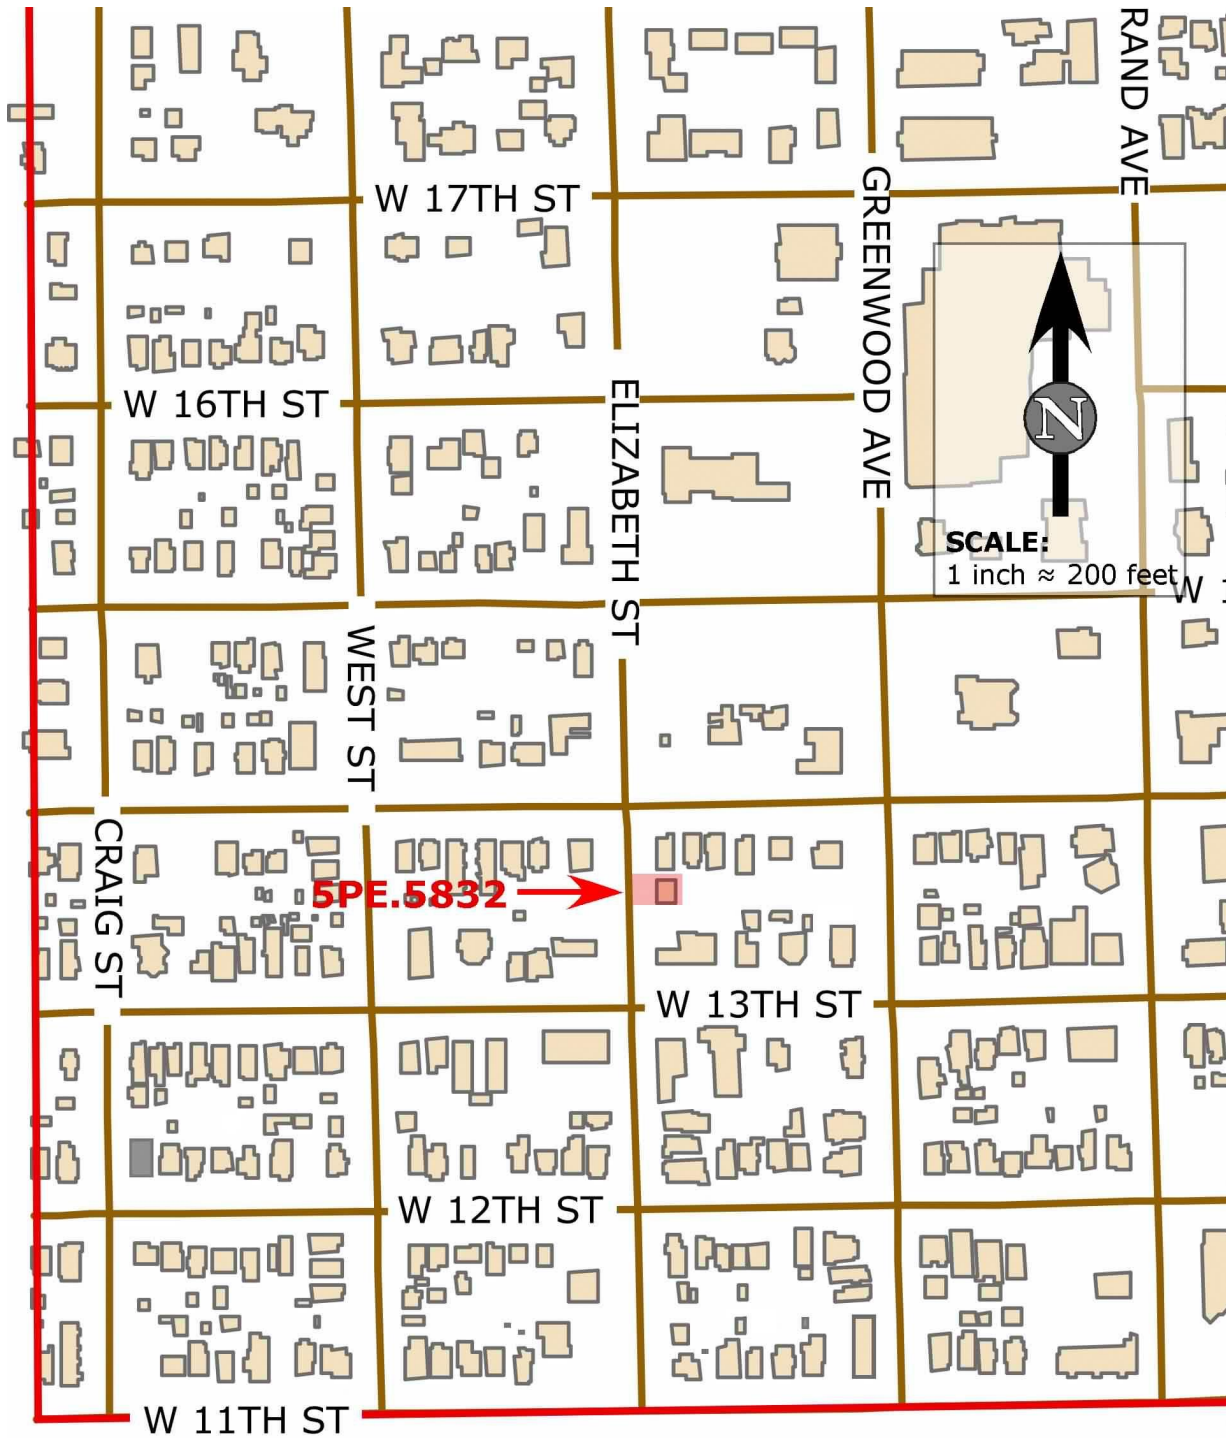
SITE SKETCH MAP

This property is located on terrain sloping downward from northeast to southwest, with an elevation of around 4,700 feet above mean sea level. The neighborhood features modest one- and two-story houses. Setbacks from North Elizabeth Street are generally the same on this block. This property is situated on the east side of North Elizabeth Street, between an east-west-oriented alley to the south and 516 North Elizabeth Street to the north. Separating the street from the sidewalk is a macadam strip. A planted-grass yard, with mature landscaping, covers the lot. High, concrete block retaining walls line the west and south sides of the property. A woven-wire fence caps the southern retaining wall and encloses the back yard.
