COLORADO CULTURAL RESOURCE SURVEY

Architectural Inventory Form

- 1. Resource number: **5PE.5833** Parcel number(s):
- 2. Temporary resource number: **525409001**
- 3. County: **Pueblo**
- 4. City: **Pueblo**
- 5. Historic building name: **Smith, Dr. Dean B., Building**
- 6. Current building name: **Smith, Judith Virginia, Building**
- 7. Building address: **1321-25 N Elizabeth Street**
- 8. Owner name: **Judith Virginia Smith**
- Owner organization:
- Owner address: **1325 N Elizabeth St**  
**Pueblo, CO 81003**

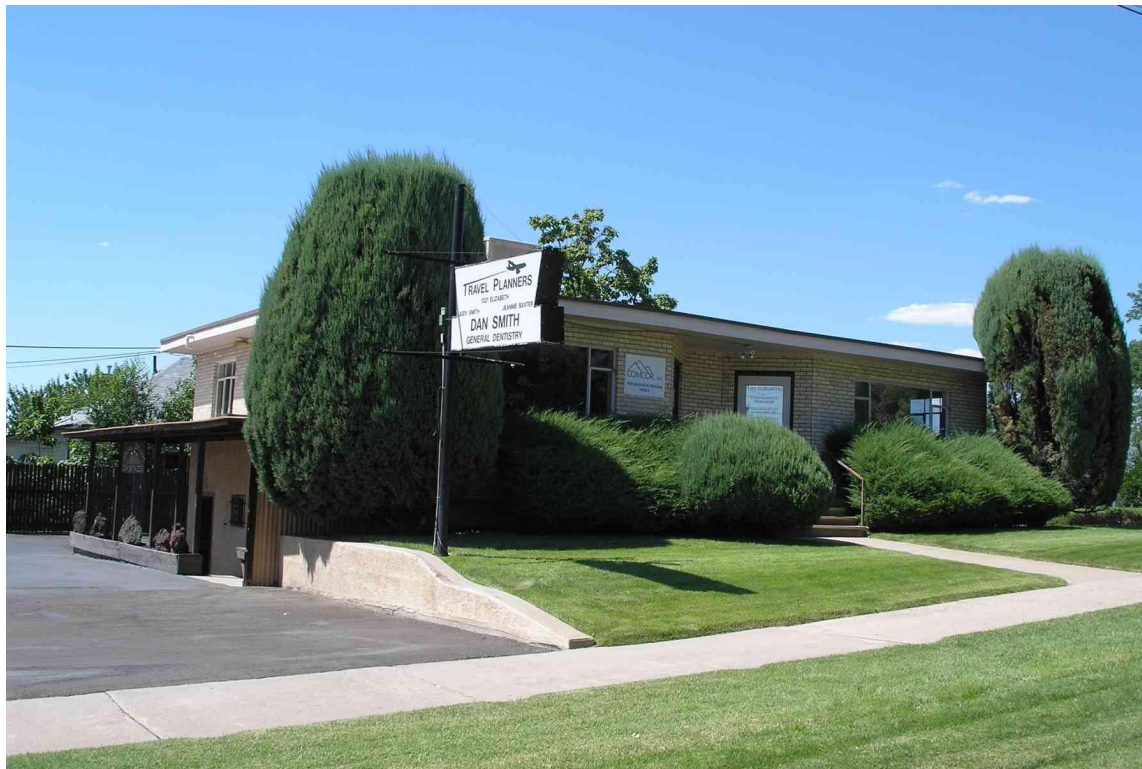
**Oriented to the east, this office building rests on a concrete foundation, covered in buff-colored stucco. Basement windows are 1-beside-1-light, sliding sash, with aluminum frames. A doorway pierces the west end of the south elevation, providing access to the dental clinic of Dr. Dan Smith. Approaching the doorway is a concrete-lined well, spanning the entire south elevation. It hosts steps descending from the west and a ramp descending from the north. Sheltering this well is a flat-roofed porch, with square wood supports and a corrugated sheet metal roof. A buff-colored brick veneer clads the exterior walls. Windows are generally tripartite, consisting of single-light casements flanking a central, fixed frame. The windows have white-painted steel frames and corresponding transoms. Either end of the symmetrical front (east) façade hosts similar windows, but with a single, large picture window in the center. Smaller window openings have single-light casements. A pair of doorways opens in a canted recess at the center of the façade. The south door is painted brown and the north door white. Each hosts a single light. A pair of wood slab doors also opens in the rear (west) elevation, providing access to an unsheltered wood deck and steps. Rubber membrane covers the flat roof, and cream-painted wood fascia and soffit box the broadly overhanging eaves.**

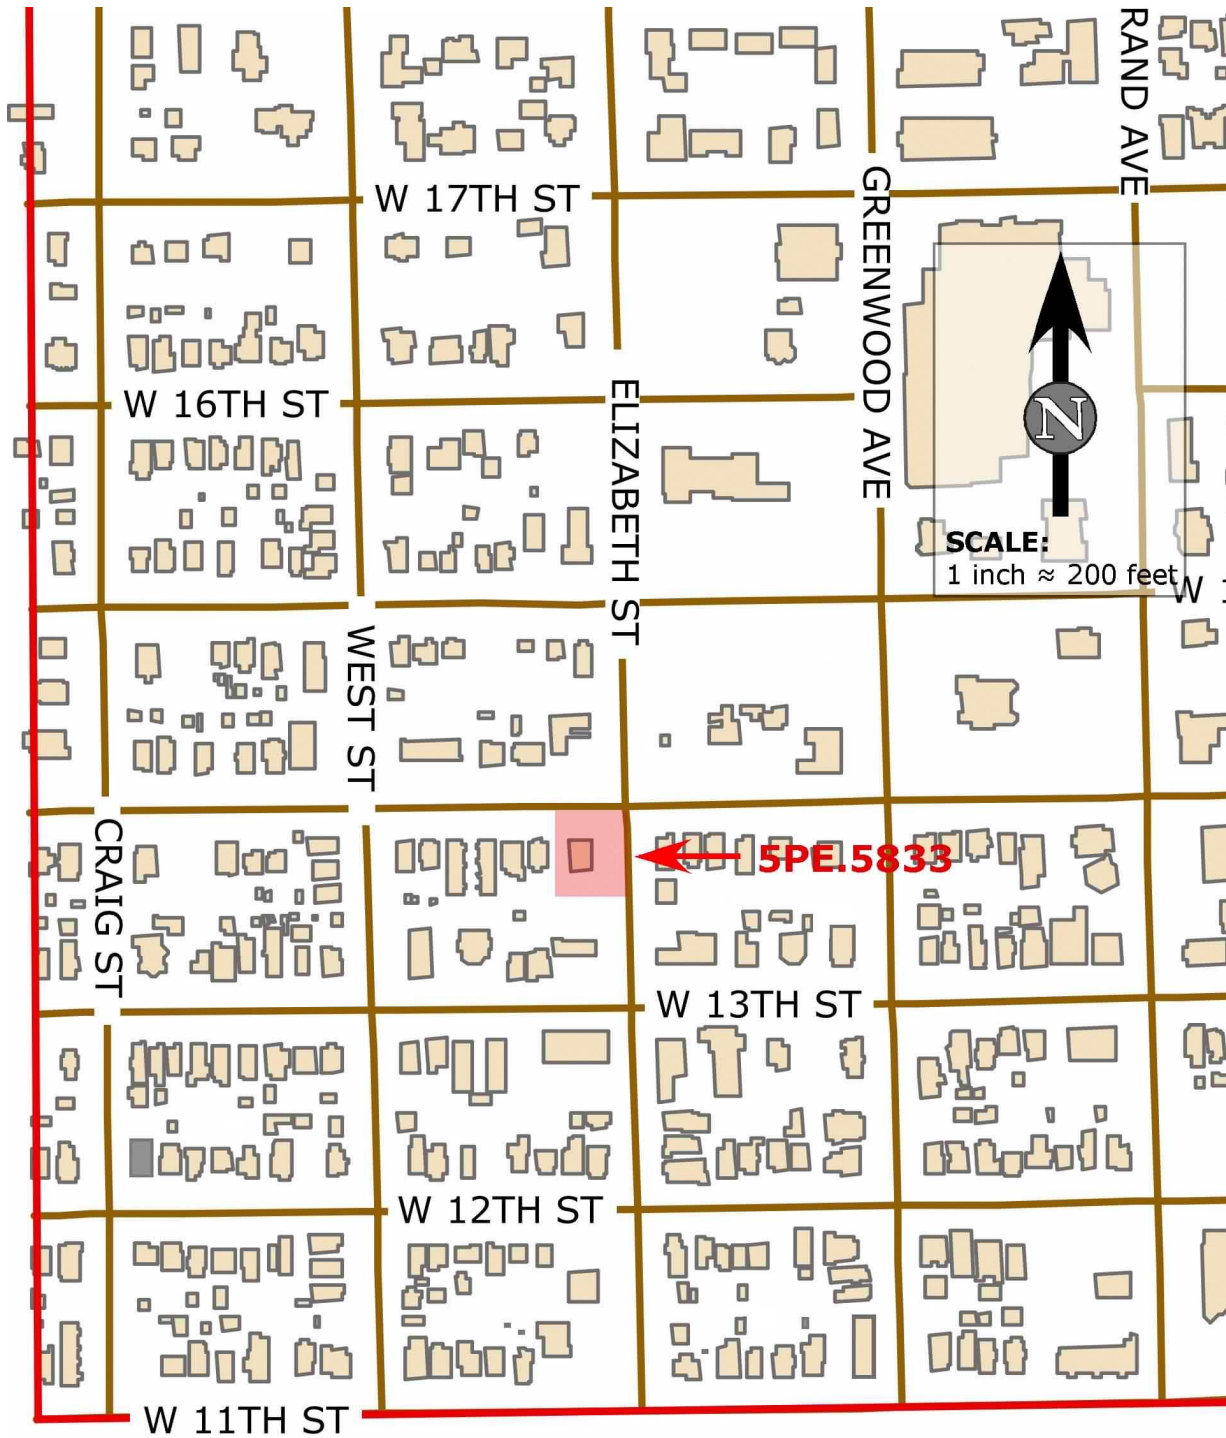
SITE SKETCH MAP

This property is located on terrain sloping downward from northeast to southwest, with an elevation of around 4,700 feet above mean sea level. The neighborhood features modest one- and two-story houses. Setbacks from North Elizabeth Street are generally the same on this block. This property is situated on the southwest corner of North Elizabeth and West 14th streets. Separating the streets from the sidewalks is a grass strip. A planted-grass yard, with mature landscaping, covers the lot. A macadam parking lot wraps around the south and west sides of the building.
