COLORADO CULTURAL RESOURCE SURVEY

Architectural Inventory Form

I. IDENTIFICATION

- 1. Resource number: **5PE.5836**
- 2. Temporary resource number:
- 3. County: **Pueblo**
- 4. City: **Pueblo**
- 5. Historic building name: **Tapia, Abel, Apartments**
- 6. Current building name: **Tapia, Abel, Apartments**
- 7. Building address: **1509-11 N Elizabeth Street**
- 8. Owner name: **Abel J. Tapia**
- Owner organization:
- Owner address: **1827 N Elizabeth St**
Pueblo, CO 81003

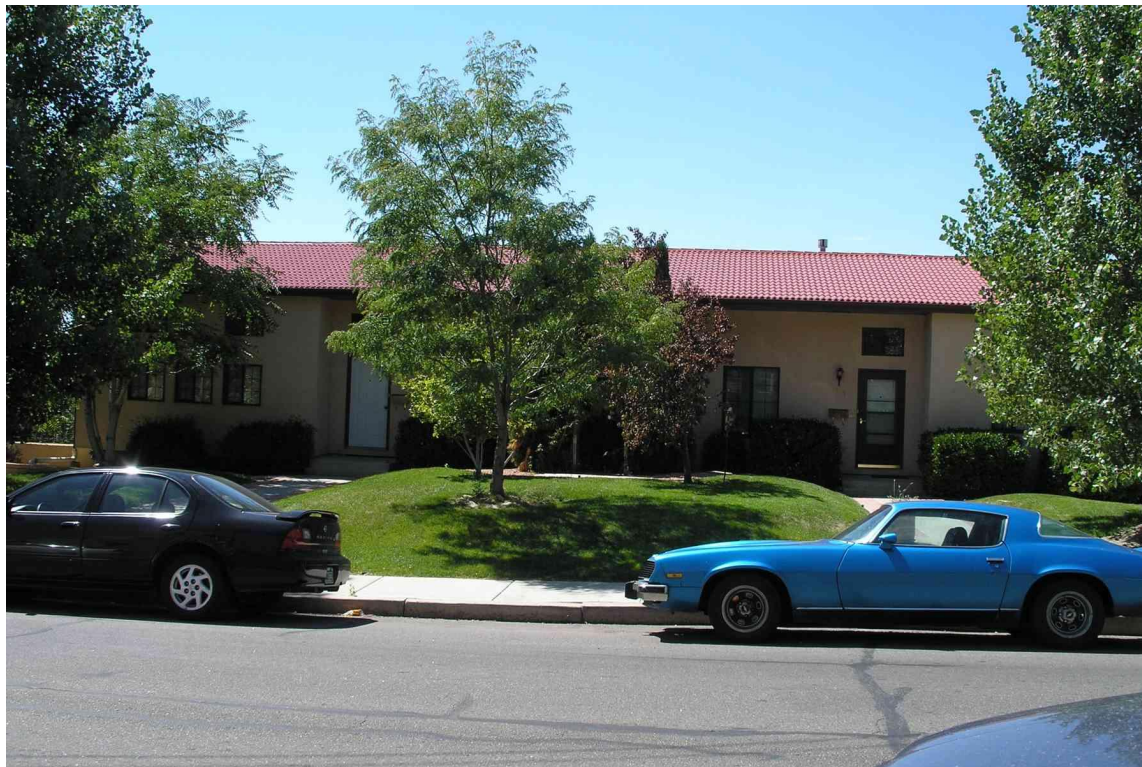
19. Primary external roof material: **Terra Cotta Roof**
Other roof materials:
20. Special features: **Porch**
21. General architectural description:
Oriented to the east, this building rests on a concrete foundation. Because of the severe slope of the lot, descending from east to west, the basement is fully exposed across the rear (west) elevation. Thus doorways into basement apartment units open in the western ends of the side elevations and across the rear elevation. The first story of the west elevation protrudes over the foundation, creating a sheltered porch. Tan stucco clads the exterior walls. Windows are generally 8-beside-8-light, sliding sash, with brown aluminum frames. Four-light clerestory windows appear at either end of the symmetrical front (east) façade and above the doorways in the façade. Wrapping around the front-gabled bay protruding from the north end of the west elevation are single-light, fixed frame windows. Doorways open in each half of the façade. They host white-painted metal doors. Doorways in the rear (west) elevation provide access to a large, partially sheltered deck spanning nearly the entire elevation. It has a wrought-iron railing. Red terra cotta tiles cover the cross-gabled roof, and brown-painted wood fascia and soffit box the eaves.
