COLORADO CULTURAL RESOURCE SURVEY

Architectural Inventory Form

- 1. Resource number: **5PE.5816** Parcel number(s):
- 2. Temporary resource number: **525419015**
- 3. County: **Pueblo**
- 4. City: **Pueblo**
- 5. Historic building name: **Hall, Eugene C., Duplex; 503 West 13th Street**
- 6. Current building name: **Pueblo Community Services**
- 7. Building address: **1217 N Greenwood Street**
- 8. Owner name: **Duncan C. and Maria E. McAuliffe**
- Owner organization:
- Owner address: **1217 N Greenwood St**
Pueblo, CO 81008

48. Report title: **Pueblo North Side Neighborhood Survey**

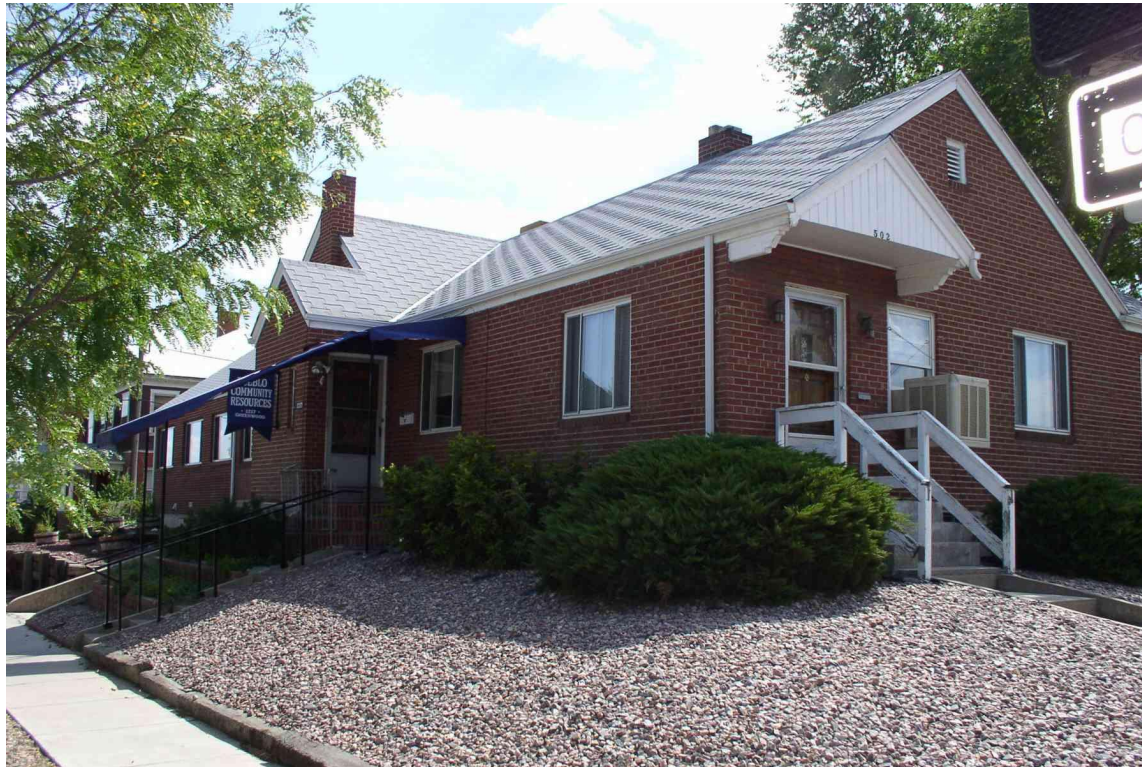
19. Primary external roof material: **Asphalt Roof**
Other roof materials:
20. Special features: **Window/Glass Block**
Garage/Attached Garage
Chimney
21. General architectural description:
Oriented to the east, this house rests on a concrete foundation, with 3-light, hopper basement windows. A garage door opens into the basement, near the center of the front (east) façade. It hosts a 24-panel, wood, overhead-retractable garage door, painted white. A red-brick veneer clads the exterior walls. An addition to the south elevation has raked brick. Windows are generally tripartite, white vinyl-frame sliding sash, with the central light fixed. Other windows are 1-over-1-light, double-hung sash or single-light, fixed-frame picture windows. The principal doorway opens in the north elevation of a front-gabled foyer protruding from the north side of the façade. Approaching the doorway are 3, round, brick and concrete steps, flanked by a silver-painted, decorative wrought-iron railing. A blue canvas awning shelters the stoop and the concrete steps approaching it. The east elevation of the foyer hosts a pair of openings with glass blocks. The doorway hosts an 8-panel, 1-light wood door, opening behind an aluminum-frame storm door. An identical door combination occupies a doorway at the east end of the north elevation. A front-gabled hood, on shaped perlints, shelters the concrete stoop. Doorways open beneath both west-facing gables. They host 3-panel, 6-light, wood doors, painted white, opening behind aluminum-frame storm doors. Paired, 10-light metal doors open in the west face of the inside (southeast-facing) corner. They provide access to a wood deck, partially sheltered beneath a blue canvas awning. Gray, interlocking asphalt shingles cover the cross-gabled roof, and the building lacks overhanging eaves. A brick hearth and chimney is engaged to east-facing gable. Another chimney protrudes from the

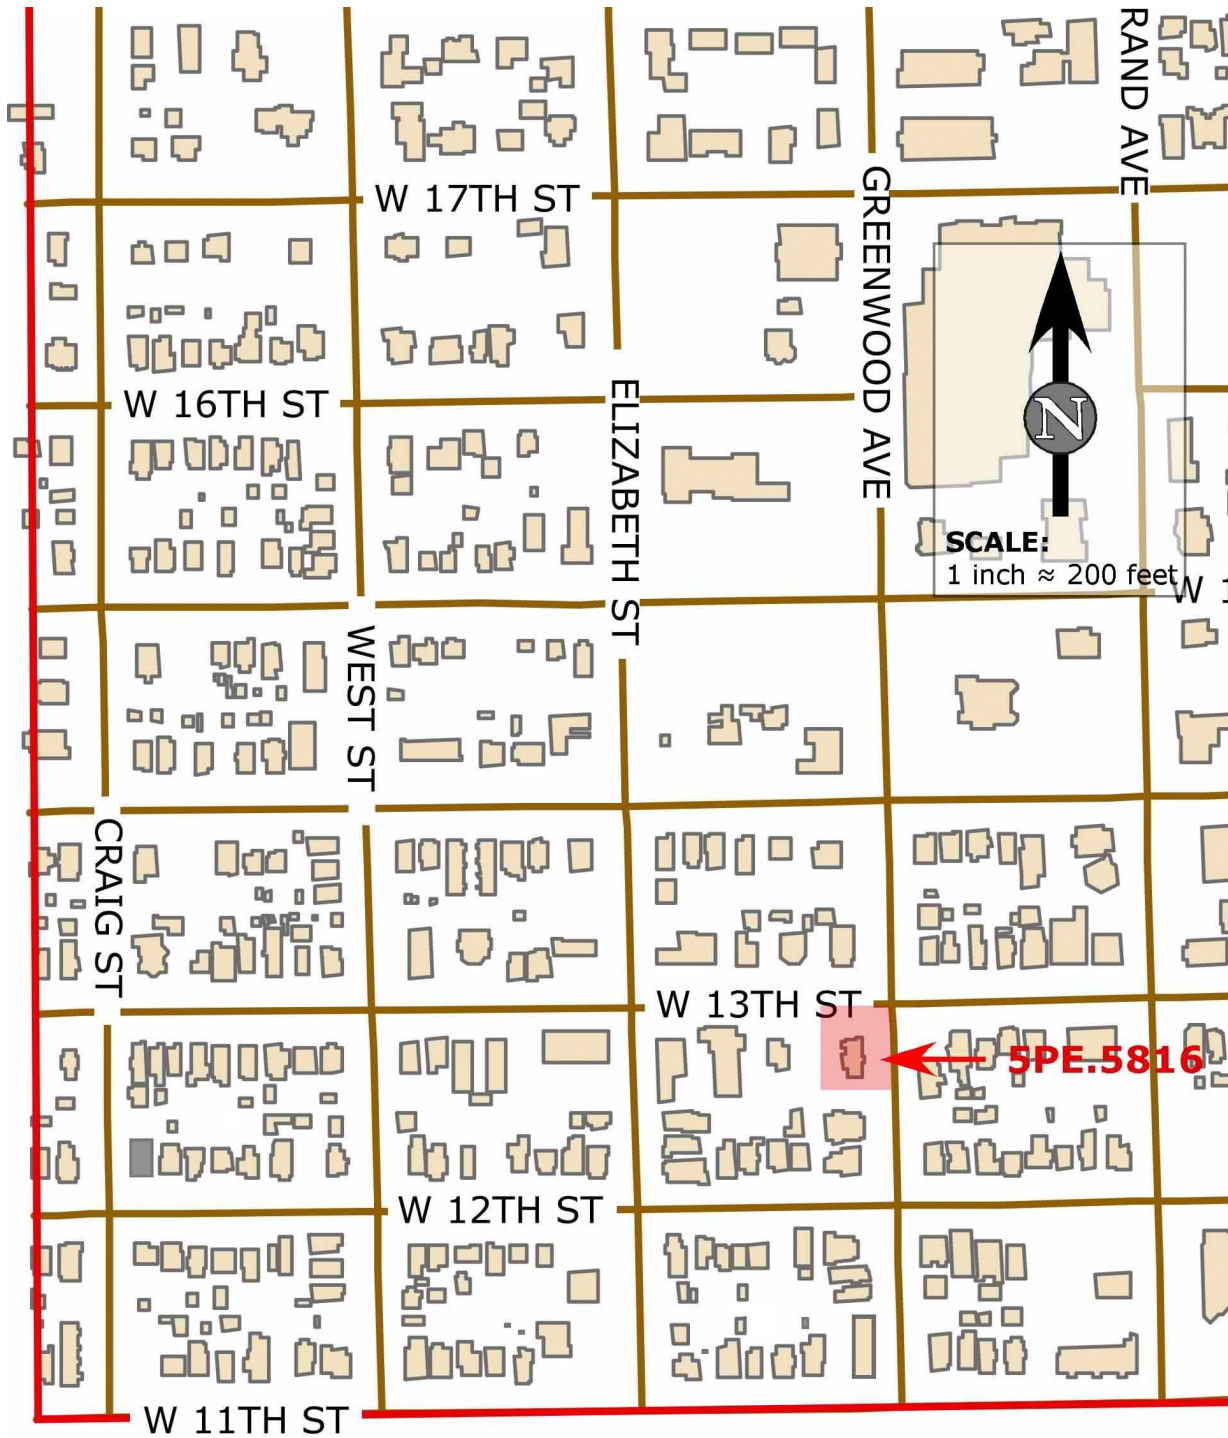
SITE SKETCH MAP

This property is located on terrain sloping downward from north to south, with an elevation of around 4,700 feet above mean sea level. The neighborhood features modest one- and two-story houses and commercial buildings. Setbacks from North Greenwood Street are generally the same on this block. This property is situated on the southwest corner of North Greenwood and West 13th streets. Separating the streets from the sidewalks is a gravel-covered strip. Gravel also covers much of the rest of the property, but a small planted-grass yard is located northeast of the house, surrounded by a chain-link fence. Along the east side of the property are concrete block and railroad-tie retaining walls. A cobblestone retaining wall flanks the south side of the property. Southwest of the house is an asphalt parking area.
