COLORADO CULTURAL RESOURCE SURVEY

Architectural Inventory Form

- 1. Resource number: **5PE.5817** Parcel number(s):
  - 2. Temporary resource number: **525410010**
  - 3. County: **Pueblo**
  - 4. City: **Pueblo**
  - 5. Historic building name: **Saunders, Miles G., House**
  - 6. Current building name: **Mullans, Piersel and Reed, P.C., Attorneys at Law**
  - 7. Building address: **1311 N Greenwood Street**
  - 8. Owner name: **Thomas J. Mullans, Douglas D. Piersal, and Shannon Reed**
- Owner organization:
- Owner address: **301 W Mangrum Dr  
Pueblo West, CO 81007**

48. Report title: **Pueblo North Side Neighborhood Survey**

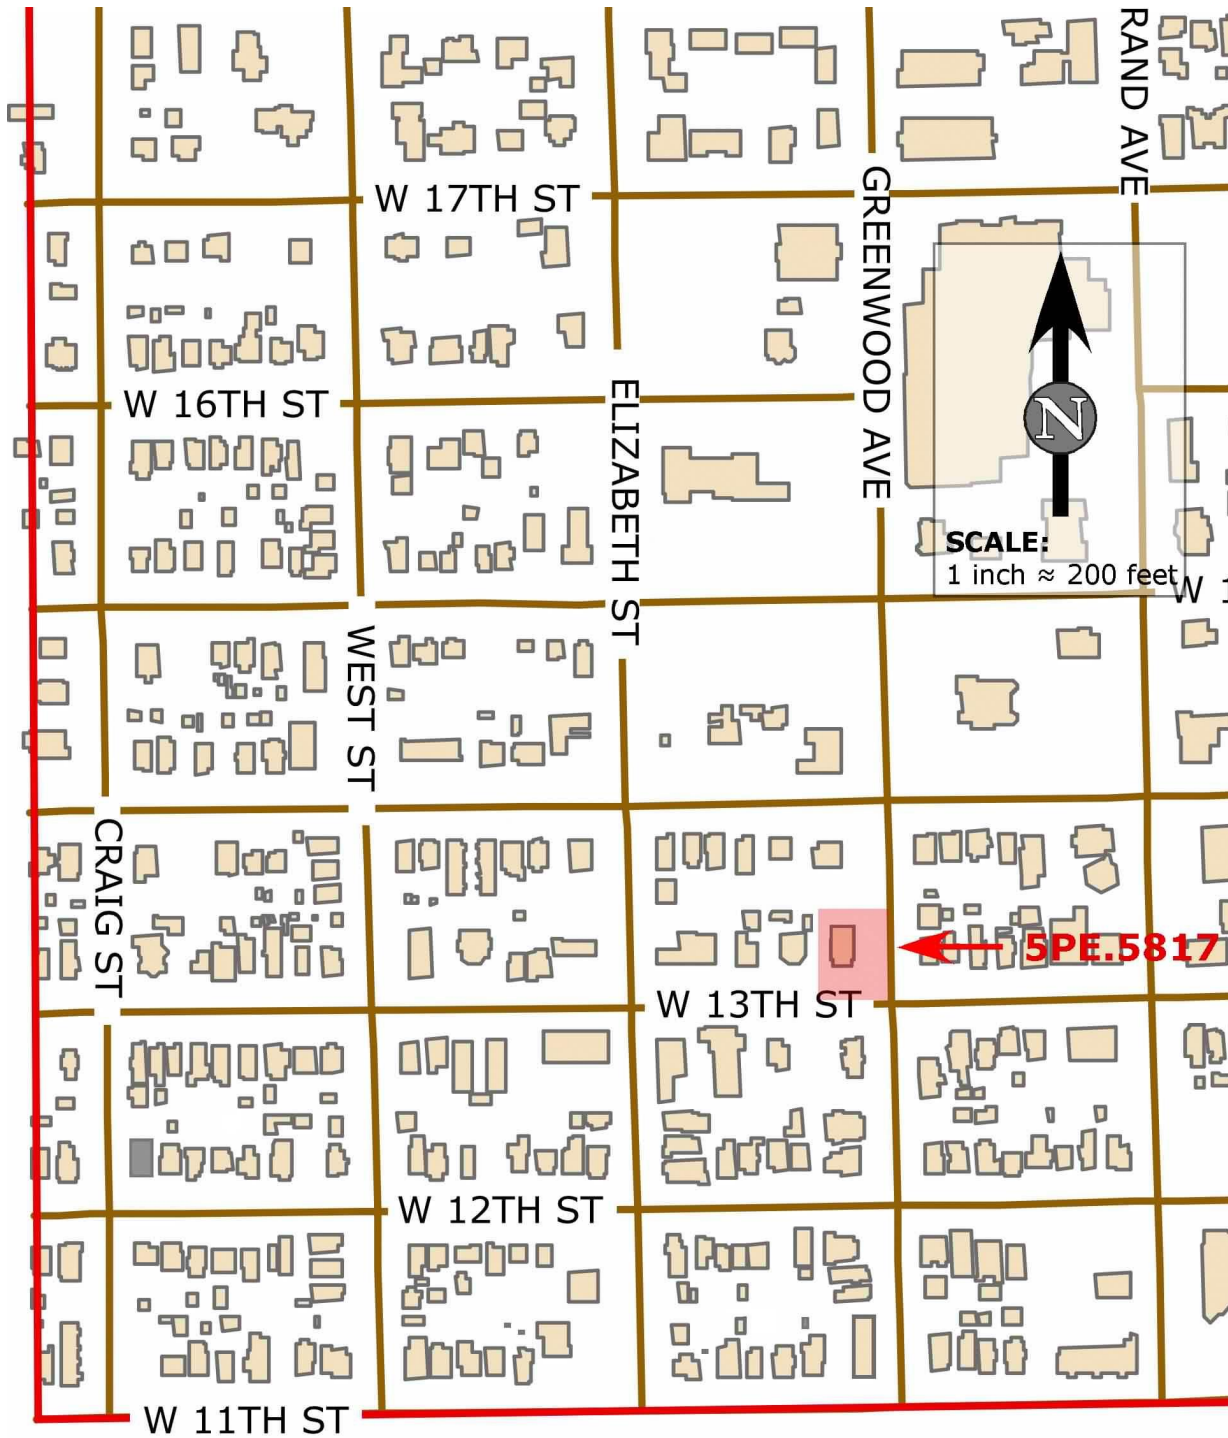
#### SITE SKETCH MAP

**This property is located on terrain sloping downward from north to south, with an elevation of around 4,700 feet above mean sea level. The neighborhood features modest and large one- and two-story houses. Setbacks from North Greenwood Street are generally the same on this block. This property is situated on the northwest corner of North Greenwood and West 13th streets. Separating the streets from the sidewalks is a gravel-covered strip, planted with shady elm trees. A planted-grass yard, with mature landscaping, covers the lot. Enormous pink sandstone slabs approach the front porch, and a concrete parking lot is located along the northern edge of the property.**
