COLORADO CULTURAL RESOURCE SURVEY

Architectural Inventory Form

| 5. Historic building name: | Hinshaw Cabin | | |

48. Report title: **Eldora Historical and Architectural Survey, 2007-08**

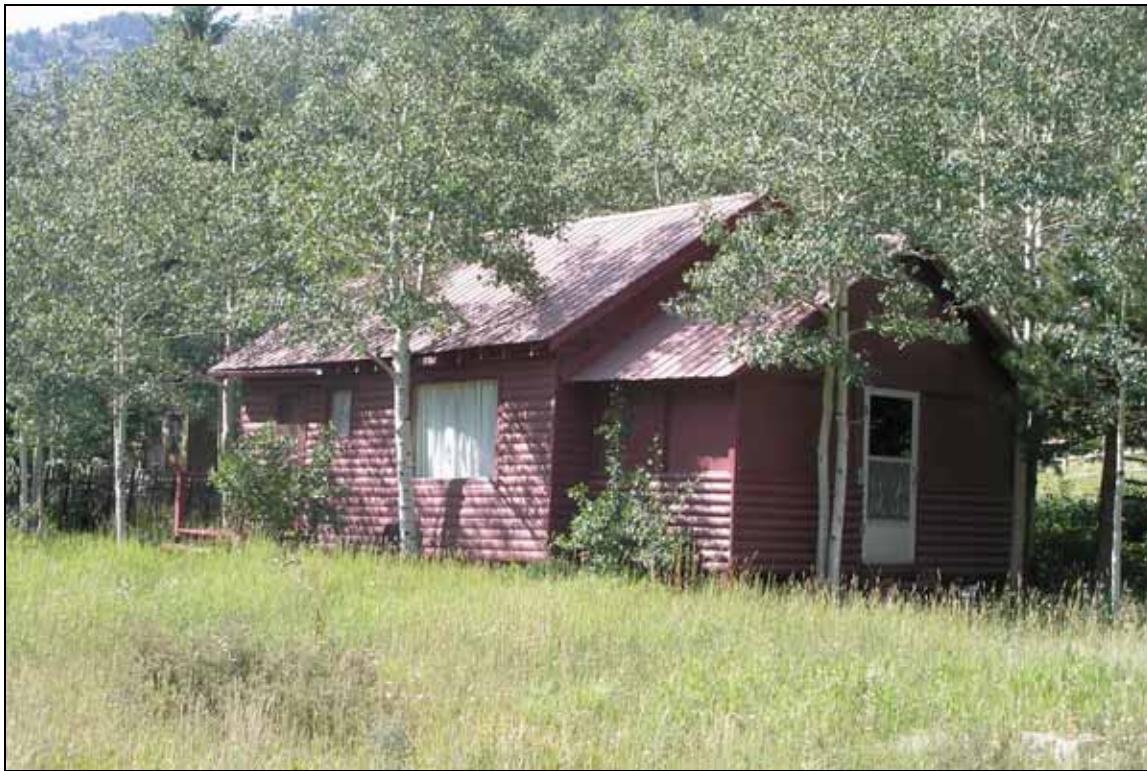
19. Primary external roof material: **Asphalt Roof/Composition Roof**
Other roof materials:
20. Special features: **Porch**
Fence
21. General architectural description:
Oriented to the east (toward 8th Street), this cabin appears to lack a formal foundation. Red-painted, simulated log siding clads the exterior walls. Windows are generally 4-light casement, with red-painted wood frames and surrounds. The south end of the rear (west) elevation hosts a 4-beside-4-light, sliding-sash window, with a red-painted wood frame. An opening in the north end of the same elevation is covered by a hinged wood hatch or cover. A large, single-light picture window dominates the east end of the south elevation. A large, front-gabled porch spans most of the east elevation. It has been enclosed with red-painted sheets of plywood. The principal doorway opens in the center of the porch and appears to host only an aluminum-frame storm door. Approaching it are wood steps. Another doorway opens in the west end of the south elevation. It provides access to an unsheltered wood stoop. Red-painted sheets of aluminum, with standing seams, cover the front-gabled main and porch roofs.

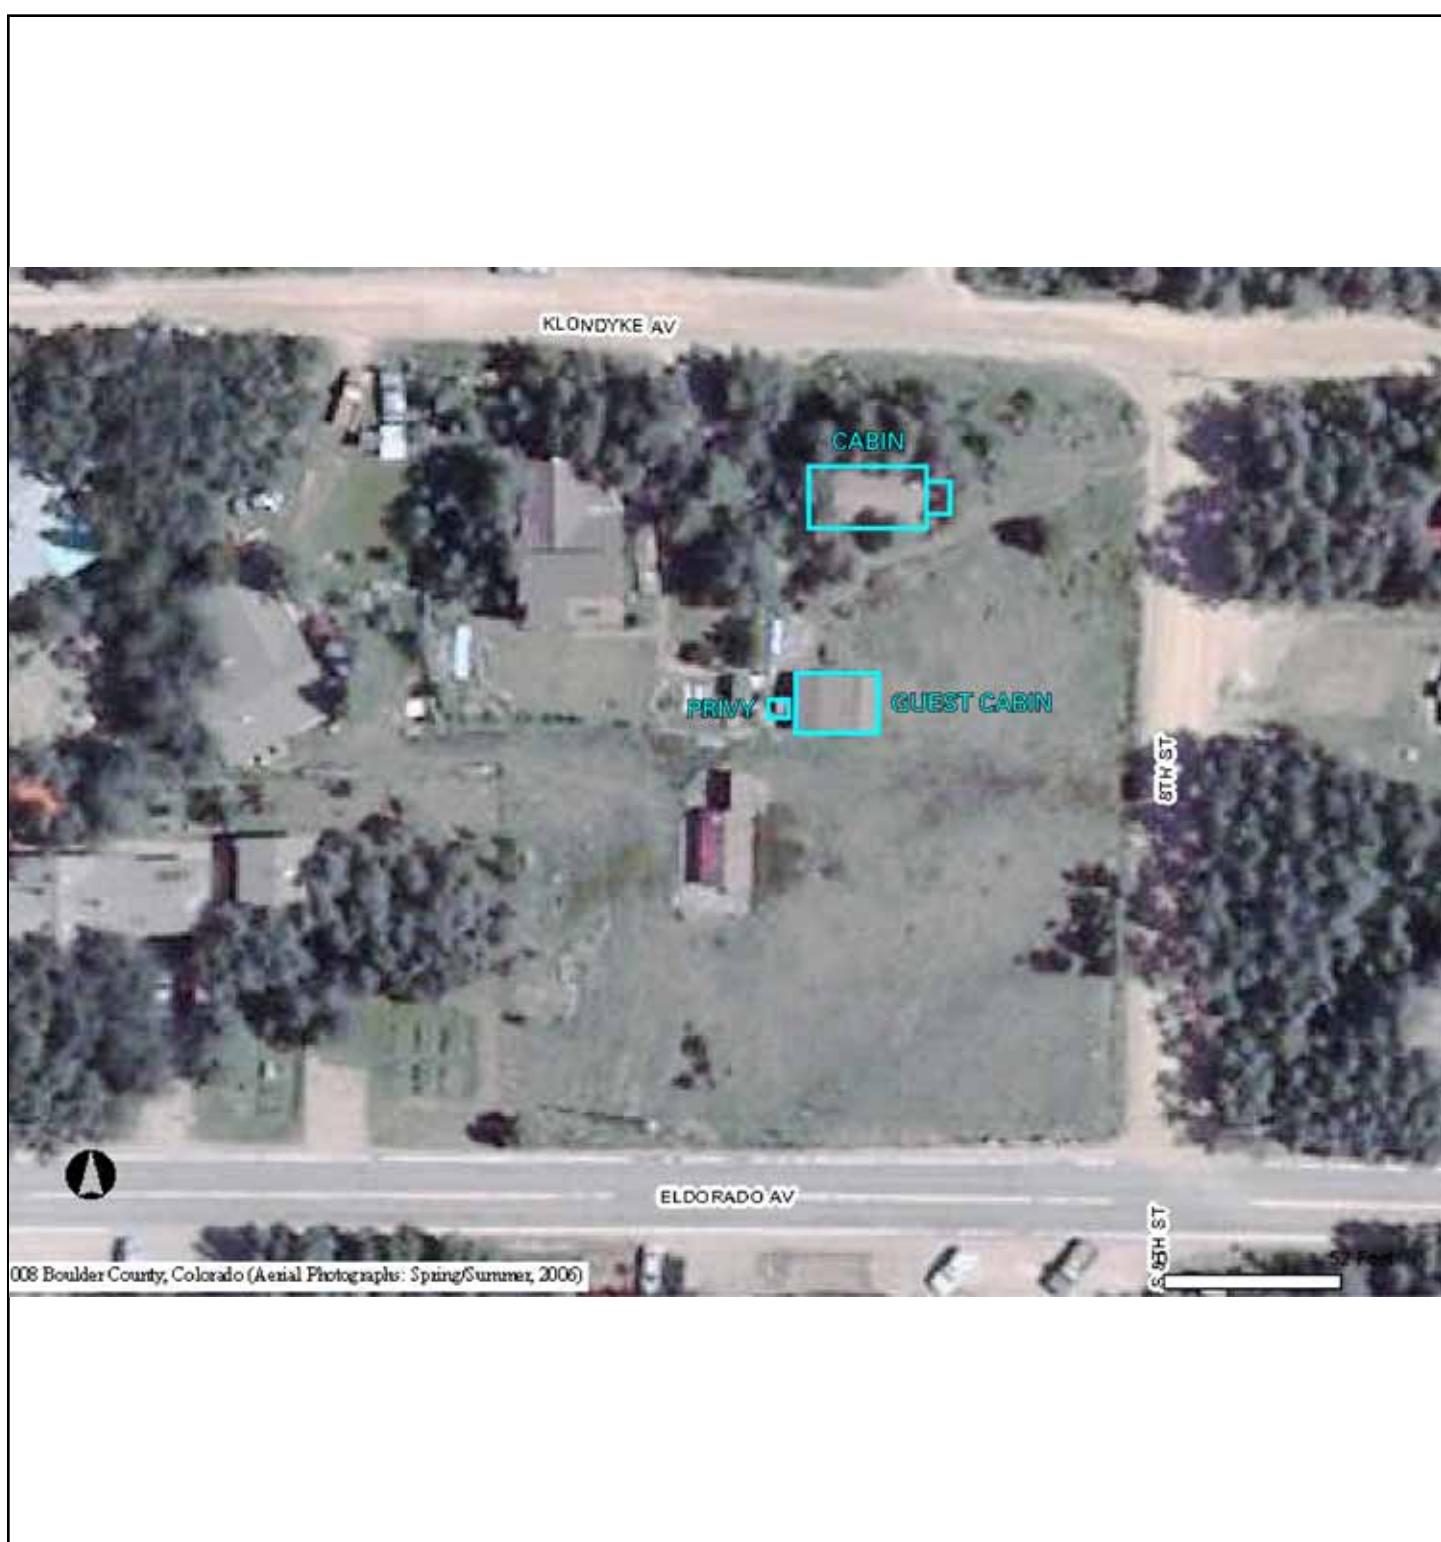
SKETCH MAP

24. Associated building, features or objects:
GUEST CABIN
A guest cabin or bunk house is located directly south of the main house. It appears to have been a modular or kit-built building. Oriented to the east, the building lacks a formal foundation. Red-painted, horizontal wood weatherboard, with cornerboards, clads the exterior walls. Red-painted battens cover the seams in the weatherboard, dividing the east and west elevation into two bays and the north and south elevations into three bays. All of the window openings have been

A privy or small storage shed is located just west of the guest cabin. Oriented to the north, the building appears to lack a formal foundation. Unpainted, vertical wood planks clad the exterior walls. The only doorway opens in the north elevation. Brown and red sheets of asphalt cover the shed roof.
