COLORADO CULTURAL RESOURCE SURVEY

Architectural Inventory Form

- 1. Resource number: **5WL.5610** Parcel number: **080716308018**
- 2. Temporary resource number: **Not Applicable**
- 3. County: **Weld**
- 4. City: **Windsor**
- 5. Historic building name: **Windsor Mercantile Company; Windsor Odd Fellows Hall**
- 6. Current building name: **Manweiler Appliance Company; My Favorite Things**
- 7. Building address: **414 Main Street**
- 8. Owner name: **Manweiler & Hess, LLC**
- Owner organization:
- Owner address: **10625 Weld County Rd 72
Windsor, CO 80550**

Touting "everything for the family, home, car, and farm," Gambles was a national franchise of hardware and furniture stores. The business in Windsor dated to at least 1940, when R.W. Turner owned it. It later became a Western Auto franchise until Krise purchased it in the late 1950s and returned it to Gambles. Krise originally operated the store at 419 Main Street (5WL.5614) before moving here in 1960. At the time, Krise undertook the most radical remodeling project in the building's history. He constructed a single-story addition to the west of the original building, on lot 17, which was then vacant but had previously hosted

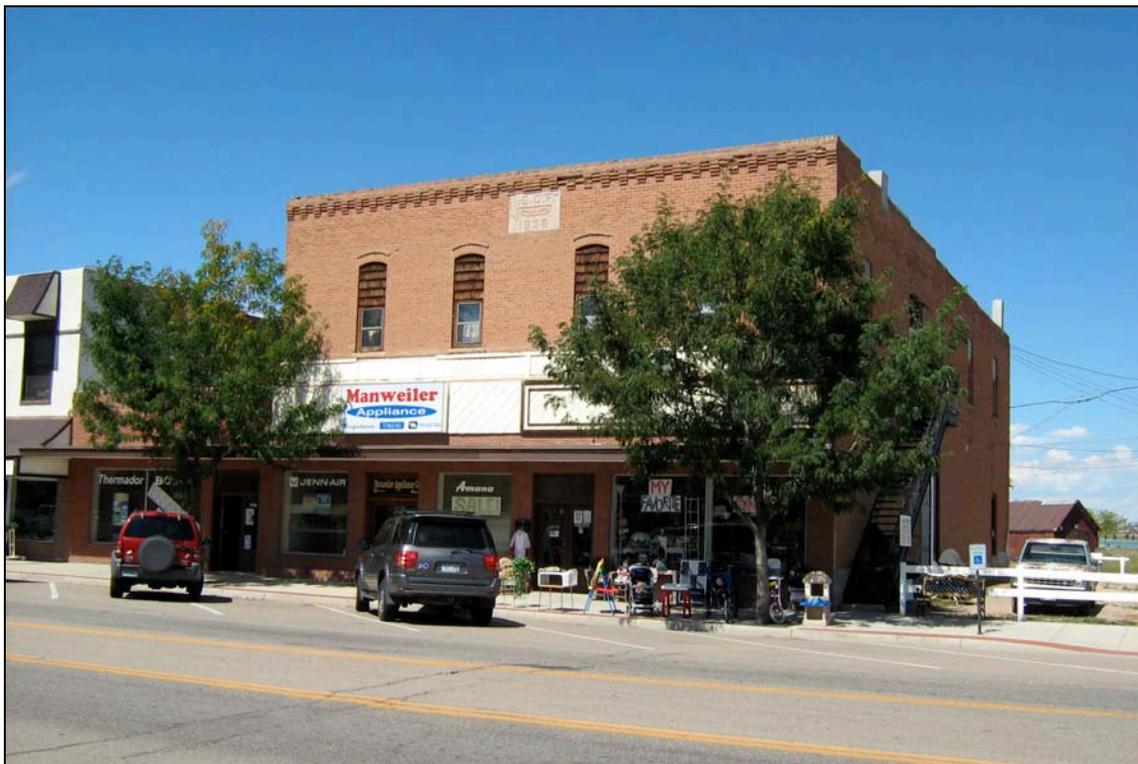
19. Primary external roof material: **Asphalt Roof/Composition Roof**
Other roof materials:
20. Special features: **Window/Segmental Arch**
Chimney
21. General architectural description:
Oriented to the south, this building rests on rock-faced, regular-coursed, sandstone ashlar foundation, largely concealed behind concrete stucco. The walls consist of red, pressed brick, set in a 7-over-1 common bond. Spanning the first story of the front (south) façade is a veneer of red Roman bricks, integrating the façade of the original 2-story building with the single-story 1948 addition to the west. Stucco covers the rear (north) elevation. Windows in the first story of the façade are plate-glass, with aluminum frames. Three doorways open in the façade. Each hosts paired doors beneath a single transom. The east and west doorways have brown-painted, single-light doors. The central doorway hosts paneled, single-light wood doors. A flat-roofed awning spans the entire façade. Cream-painted wood panels cover the area between the top of the awning and the sills of the second-story windows. The façade's second story windows have been replaced with small, 1-over-1-light sash windows, with aluminum frames. Filling the remainder of the window openings, between the rock-faced sandstone sills and segmental arches, are square-cut wood shingles. In the center of the façade, beneath the corbelled brick cornice, is a sandstone panel inscribed "I.O.O.F / 1898," with the image of three interlocking circles. Windows in the second story of the secondary elevations have been replaced with 1-beside-1-light, sliding sash windows, with 9-light transoms. Filling the areas between the tops of the windows and the bottoms of the segmental arches is wooden composition siding. A doorway opens in the south side of the east elevation's second story. A steel staircase approaches the doorway from the south. A doorway in the north end of the east elevation's first story has been enclosed. Other doorways open in the east end of the rear elevation and in the east and north elevations of a single-story rear addition. The rear elevation of the 1948 addition has concrete block walls and 8-light, steel-frame windows, with integral casements. Windows in the second story of the rear elevation are generally 1-over-1-light, double-hung sash, with white vinyl frames. Filling the rest of the window openings is white, wooden composition siding. The roof consists of two separate planes. Lining the eastern and southern portions is a shed roof. Raised above the remainder of the surface is a barrel roof, containing the trusses that provided clear-span space for the lodge hall below. (This feature is not visible from street level, but is clear on aerial photographs.) Sheets of rolled asphalt cover all roof surfaces. A stucco-covered chimney protrudes from the northeast corner of the building.
