COLORADO CULTURAL RESOURCE SURVEY

Architectural Inventory Form

- 1. Resource number: **5WL.5615** Parcel number: **080721203017**
- 2. Temporary resource number: **Not Applicable**
- 3. County: **Weld**
- 4. City: **Windsor**
- 5. Historic building name: **S.G. Fuller & Company General Mercantile; Olson's Clothing Store**
- 6. Current building name: **Starck Building**
- 7. Building address: **421 Main Street**
- 8. Owner name: **Edward R. and Jo Ann Starck**
- Owner organization:
- Owner address: **505 Chestnut St
Windsor, CO 80550**

Downtown Windsor Survey

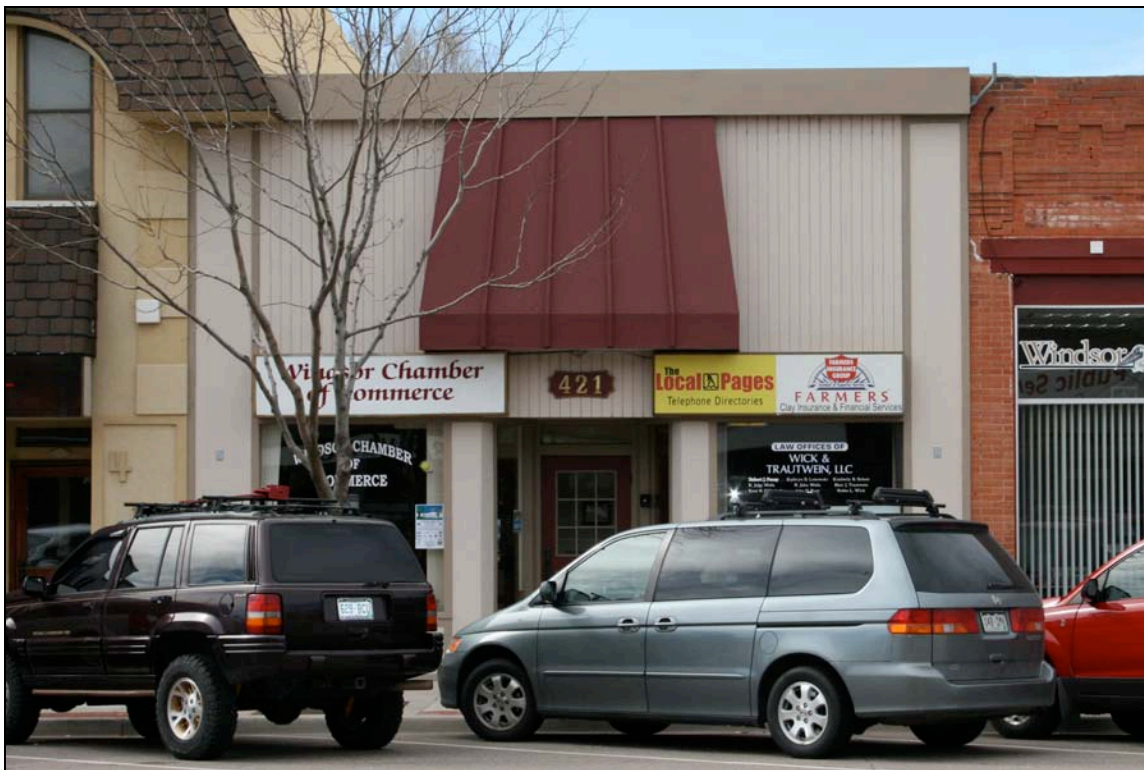
20. Special features: **Chimney**
21. General architectural description:
This building is oriented to the north. The nature of the foundation could not be determined. Tan stucco clads the exterior walls, except for the area above the windows and doorway in the front (north) façade, which is covered in tan-painted sheets of plywood scored to resemble vertical boards. Dominating the façade are plate-glass windows, with khaki-painted wood frames. The principal doorway opens within a canted recess at the center of the symmetrical façade. It hosts a red-painted metal door consisting of 9 lights and 4 raised panels with a flower pattern. Above the doorway, extending to just below the bulkhead parapet cap, is a pent roof awning consisting of red-painted boards and battens. A secondary doorway opens in the west end of the rear (south) elevation. It hosts a cream-painted steel slab door, with a single light. Sheltering the doorway is a small, pent-roof hood, with asphalt shingles. A black rubber membrane covers the nearly flat roof, and a low chimney protrudes near the south end of the east elevation.

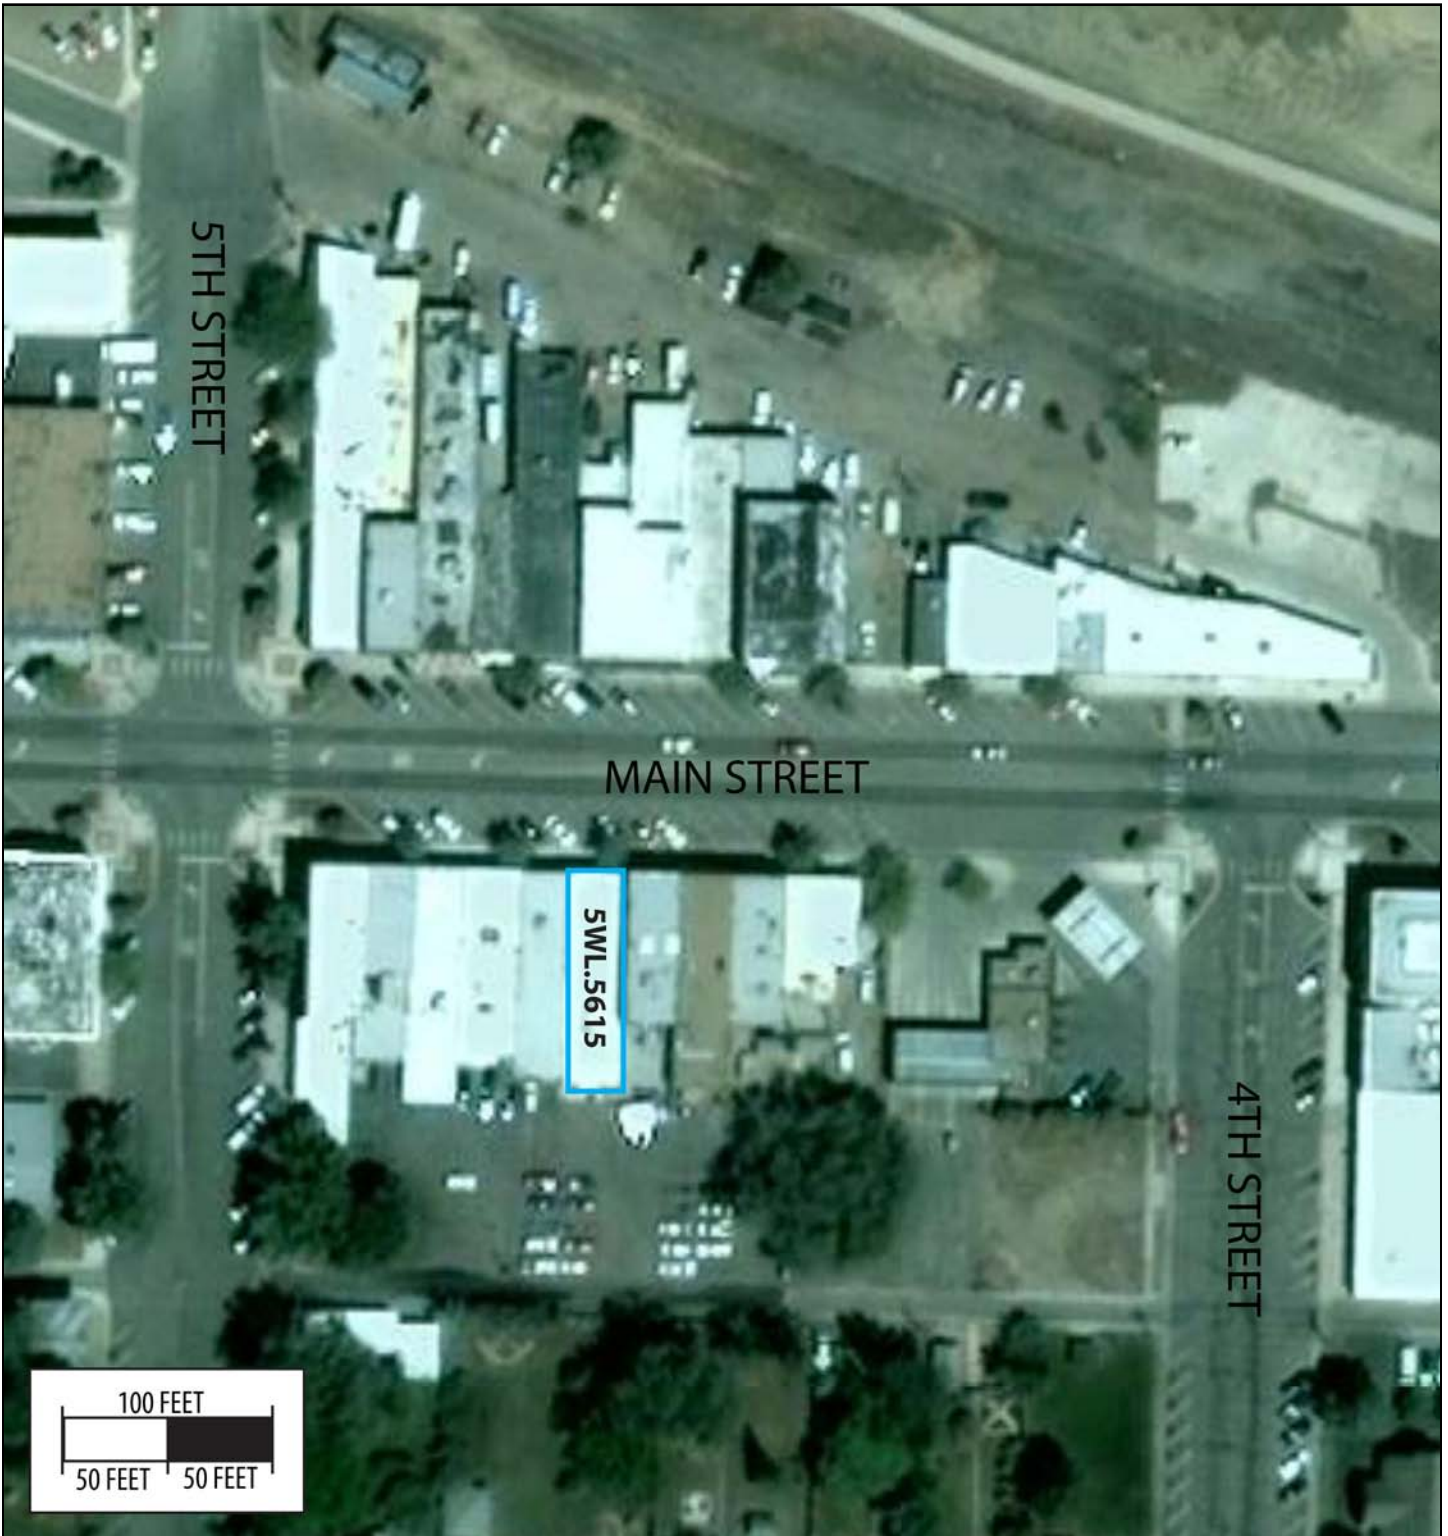
SKETCH MAP

22. Architectural style: **Other Style**
Other architectural style: **Windsor German Old-World Motif**
Building type:
23. Landscape or special setting features:
This commercial building is located on Main Street, the principal east-west thoroughfare through downtown Windsor. It is situated on the south side of the street, between 419 Main Street to the east and 423 Main Street to the west. Separating the building's front (north) facade from the street is a concrete sidewalk. Macadam covers a parking area behind (south of) the building.
