COLORADO CULTURAL RESOURCE SURVEY

Architectural Inventory Form

- 1. Resource number: **5WL.5617** Parcel number: **080721203018**
- 2. Temporary resource number: **Not Applicable**
- 3. County: **Weld**
- 4. City: **Windsor**
- 5. Historic building name: **J.T. Perkins Merchandise Company; United States Post Office; Darnell & Sons Market; Lorenz Market**
- 6. Current building name: **Windsor Now**
- 7. Building address: **423 Main Street**
- 8. Owner name: **Greeley Publishing Company, Inc.**
- Owner organization:
- Owner address: **500 Double Eagle Court
Reno, NV 89511**

48. Report title: **Downtown Windsor Survey Report**
49. Date(s): **4/15/2008**
50. Recorder(s): **Adam Thomas, Jeffrey DeHerrera, and Rachel Kline**
51. Organization: **Historitecture, LLC**
52. Address: **PO Box 419
Estes Park, CO 80517-0419**
53. Phone number(s): **(970) 586-1165**

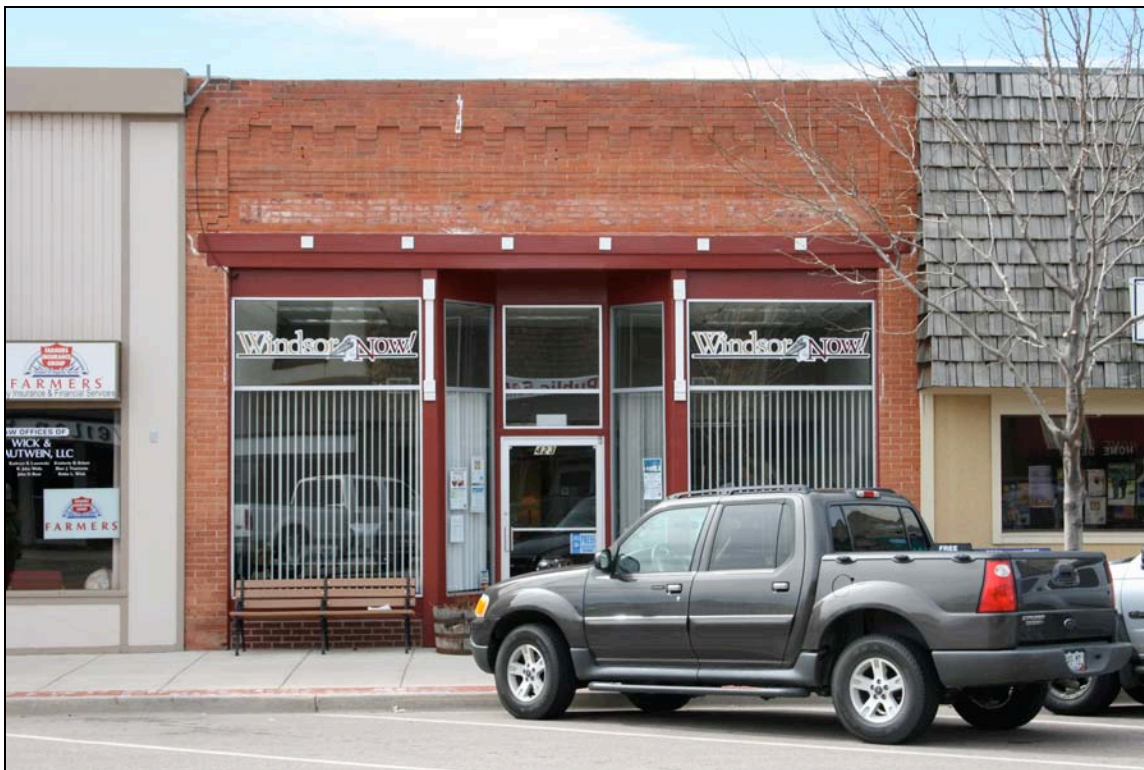
21. General architectural description:
Oriented to the north, this building rests on a sandstone foundation. Cladding the front (north) façade is a red, pressed-brick veneer, with thin, white mortar. The brickwork features a corbelled cornice. Beneath the windows, the kickplates have been replaced with red, raked bricks. An addition to the rear (south) elevation consists of white-painted, concrete blocks. White-painted, vertical board-and-batten siding covers a recess at the east end of the rear elevation. Large, plate-glass windows, with corresponding transoms, dominate the façade. They have aluminum frames. The principal doorway opens within a canted recess at the center of the symmetrical façade. It hosts a plate-glass door with an aluminum frame. Above it is a transom. The beam spanning the windows and doorway features white-painted, cast-iron rosettes. A secondary doorway opens in the south face of the rear recess. It hosts a blue-painted metal door, with a single light. A doorway opening in the west side of the recess also hosts a blue-painted metal door, with 6 panels. Gray sheets of asphalt cover the nearly flat roof. Protruding near the north end of the west elevation is a red-brick chimney.
