COLORADO CULTURAL RESOURCE SURVEY

**Architectural Inventory Form**

- 1. Resource number: **5WL.5618** Parcel number: **080716308005**
- 2. Temporary resource number: **Not Applicable**
- 3. County: **Weld**
- 4. City: **Windsor**
- 5. Historic building name: **Weld County Bank; Farmers State Bank**
- 6. Current building name: **Blushing Bride**
- 7. Building address: **424 Main Street**
- 8. Owner name: **Golden Deleaney, LLC**
- Owner organization:
- Owner address: **201 Cattail Bay  
Windsor, CO 80550**

Downtown Windsor Survey

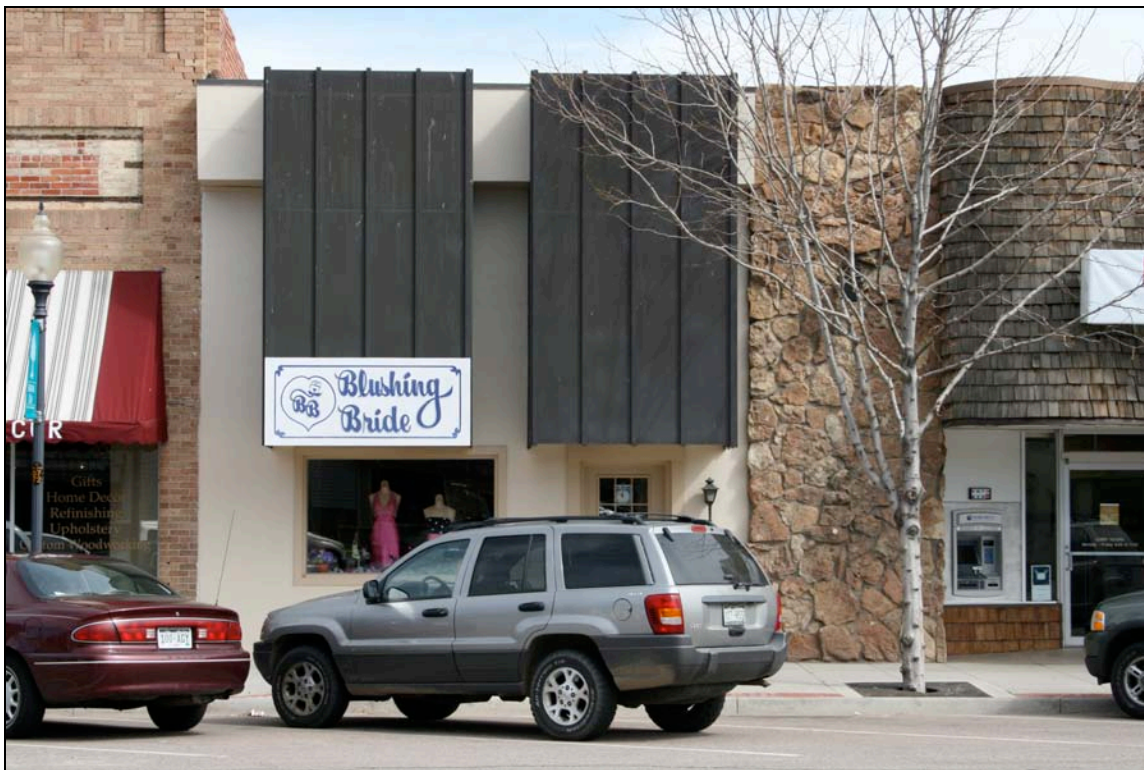
20. Special features: **Chimney**  
**Window/Glass Block**
21. General architectural description:  
**This building is oriented to the south. The nature of the foundation could not be determined. Cream-colored stucco clads the exterior walls. Extending from the top of the window and door openings in the front (south) façade are brown, sheet metal-covered bulkheads. A plate-glass window, with tan-painted wood surrounds, pierces the asymmetrical façade west of center. The principal doorway opens in the eastern half of the façade. It hosts a two-panel, nine-light metal door, painted tan. Glass-block windows open in the eastern and western ends of the rear (north) elevation. Between them opens a secondary doorway, sheltered beneath a wood-framed porch, with a corrugated, translucent fiberglass shed roof. A rubber membrane covers the nearly flat roof and a tall, stucco-covered chimney protrudes from the rear elevation, east of center.**

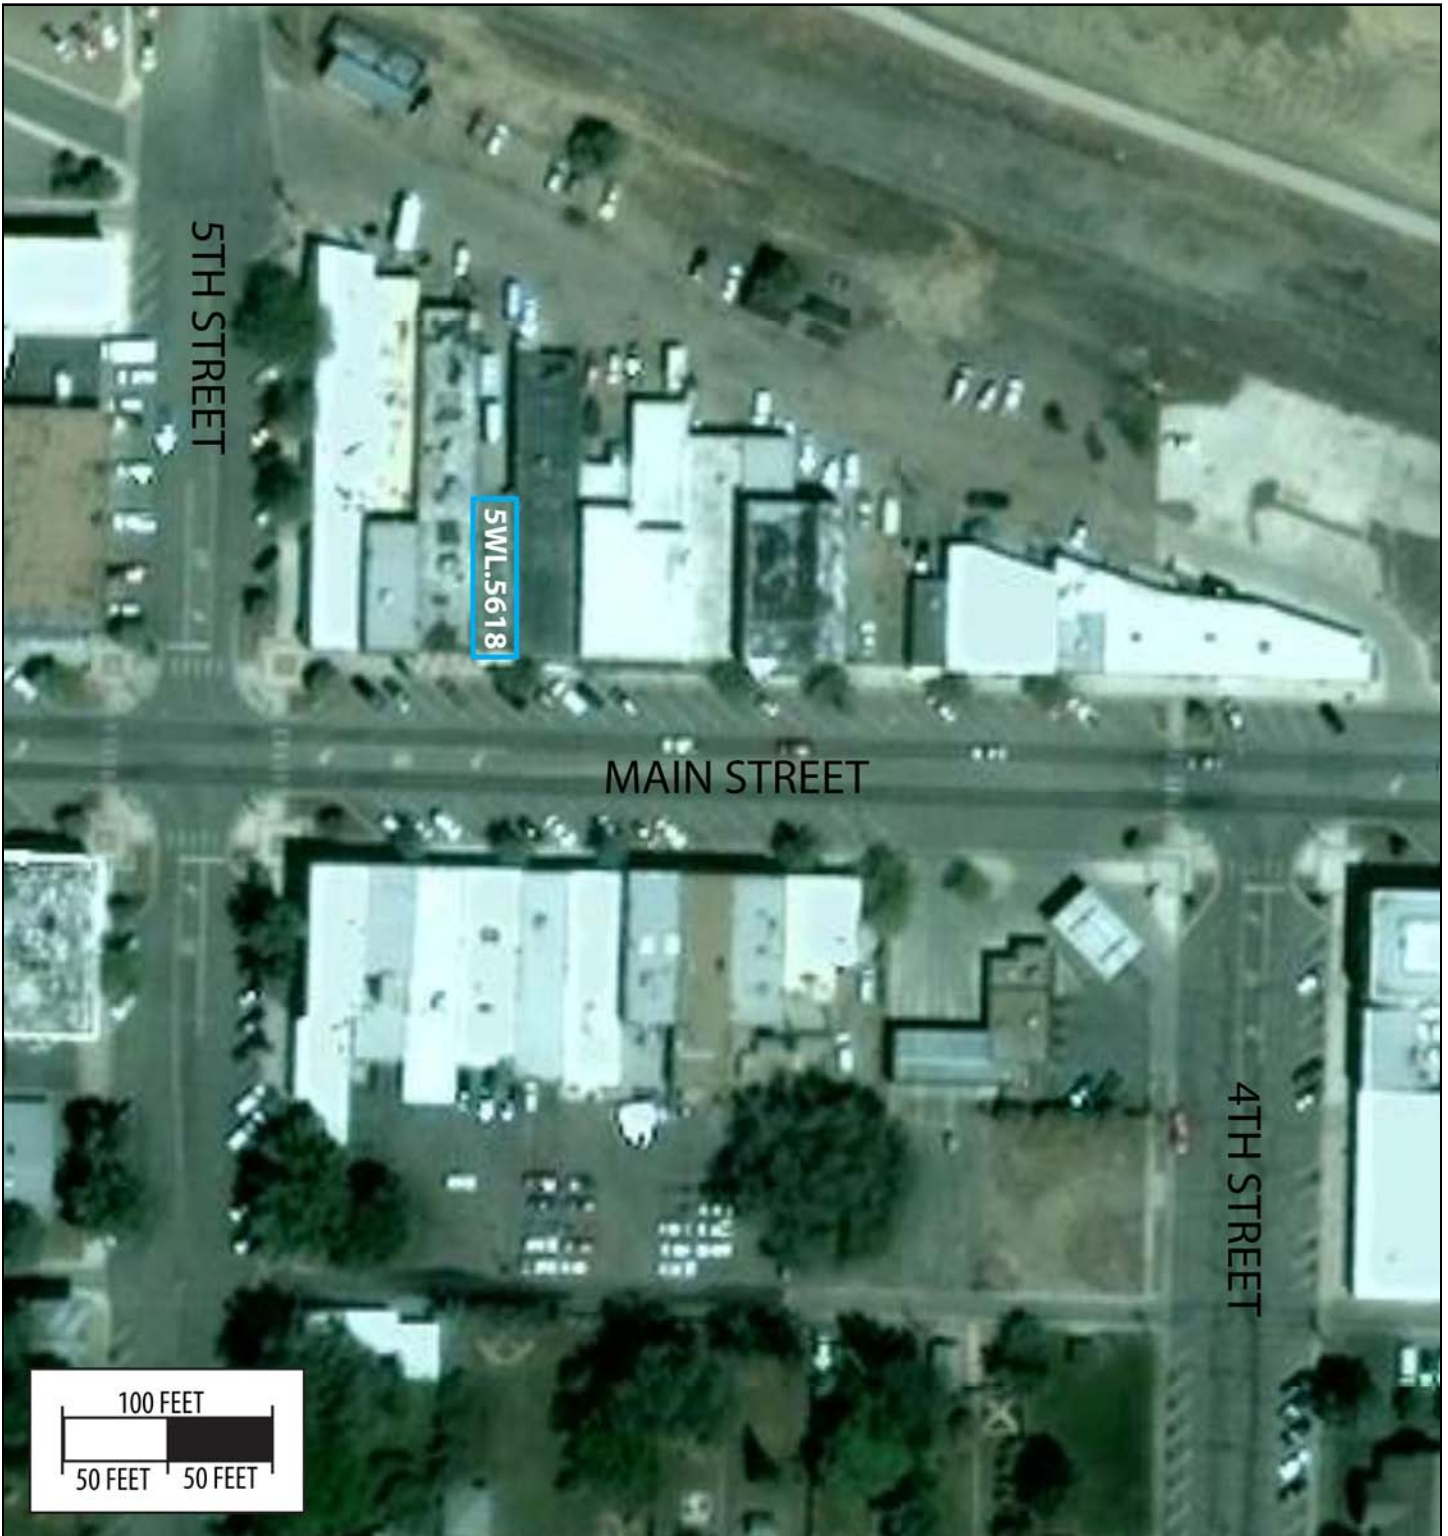
SKETCH MAP

**This commercial building is located on Main Street, the principal east-west thoroughfare through downtown Windsor. It is situated on the north side of the street, between 422 Main Street to the east and 426 Main Street to the west. Separating the building's front (north) facade from the street is a concrete sidewalk. Macadam covers a parking area behind (north of) the building.**
