COLORADO CULTURAL RESOURCE SURVEY

**Architectural Inventory Form**

- 1. Resource number: **5WL.5620** Parcel number: **080716308004**
- 2. Temporary resource number: **Not Applicable**
- 3. County: **Weld**
- 4. City: **Windsor**
- 5. Historic building name: **Schwalm Building; Cable Brothers Merchandise Company; Cory Store; Koehler Supply Company; Windsor Bowling Alley; Teller's Grocery & Market; S&M Market**
- 6. Current building name: **Memory Lane Antiques & Refinishing**
- 7. Building address: **426 Main Street**
- 8. Owner name: **Golden Deleaney, LLC**
- Owner organization:
- Owner address: **201 Cattail Bay  
Windsor, CO 80550**

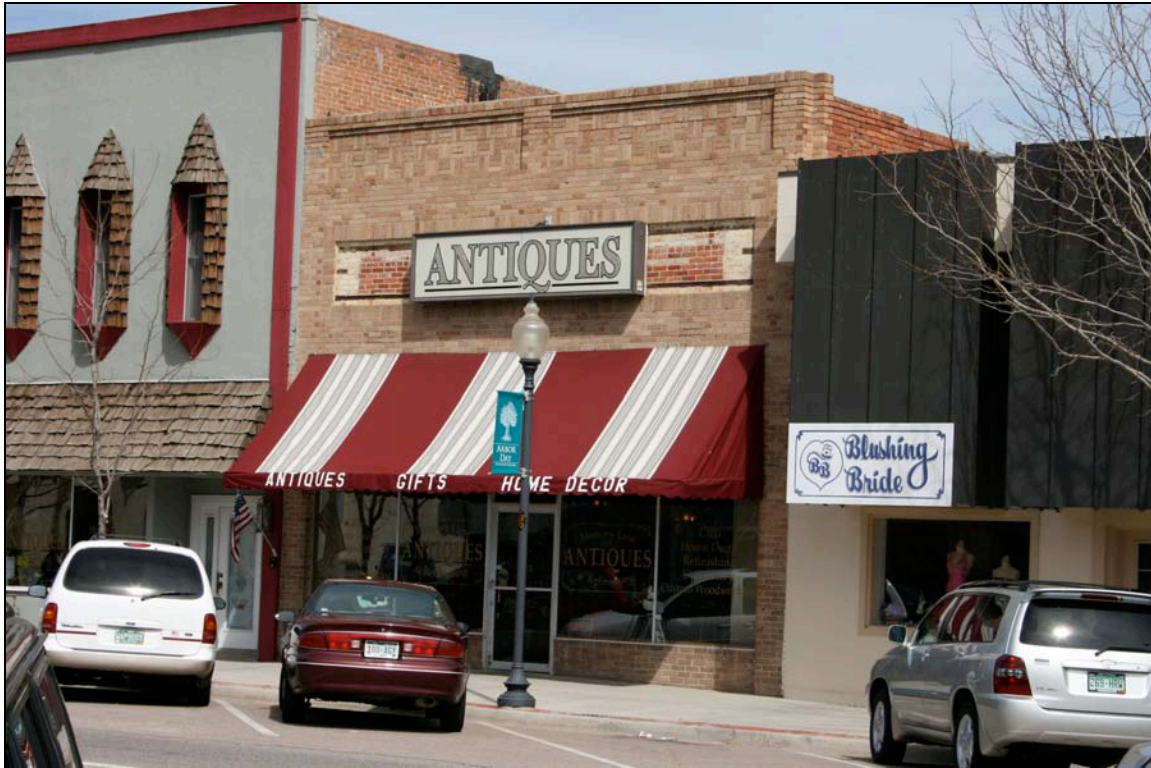
20. Special features: **None Applicable**
21. General architectural description:  
**Oriented to the south, this building rests on a concrete foundation. The exterior walls consist of red, pressed bricks, set in a 6-over-1 common bond. Iron tie-rod plates punctuate the side elevations, near the parapet. Cladding the front (south) façade is a veneer of tan pressed bricks. They form a frame around the signband and are set in alternating squares in two panels beneath the corbelled cornice. Dominating the façade are plate-glass windows, with aluminum frames. The principal doorway opens in the center of the symmetrical façade, and hosts a plate-glass door with an aluminum frame. Above it is a single-light transom. Spanning the windows and doorway is a frosted-light transom, shaded beneath a red-and-white striped, canvas awning. Opening in the east elevation's first story are single-light awning windows, each protected behind a single, iron band. In the second story of the same elevation is a 1-beside-1-light, sliding-sash windows, with white-painted wood frames. Opening in the west end of the rear (north) elevation is a 1-over-1-light, double-hung sash window, protected behind an iron grille. East of this window, near the center of the elevation, is an unusually wide, gray-painted, steel slab door. The second story of the rear elevation hosts three, 1-over-1-light, double-hung sash windows, with white vinyl frames. Opening in the east end of the rear elevation's second story, beneath a stair tower or penthouse, is a doorway. It hosts a white-painted, 6-panel steel door, opening behind a white, vinyl-frame storm door. It provides access to a small, unsheltered steel porch, with steps descending to the north. A rubber membrane covers the nearly flat roof.**
