COLORADO CULTURAL RESOURCE SURVEY

Architectural Inventory Form

- 1. Resource number: **5WL.5628** Parcel number: **080721204013**
- 2. Temporary resource number: **Not Applicable**
- 3. County: **Weld**
- 4. City: **Windsor**
- 5. Historic building name: **Benton Motor Company**
- 6. Current building name: **Fil Pete Building**
- 7. Building address: **503-507 Main Street**
- 8. Owner name: **Fil Pete, LLC**
- Owner organization:
- Owner address: **2880 41st Ave
Greeley, CO 80634**

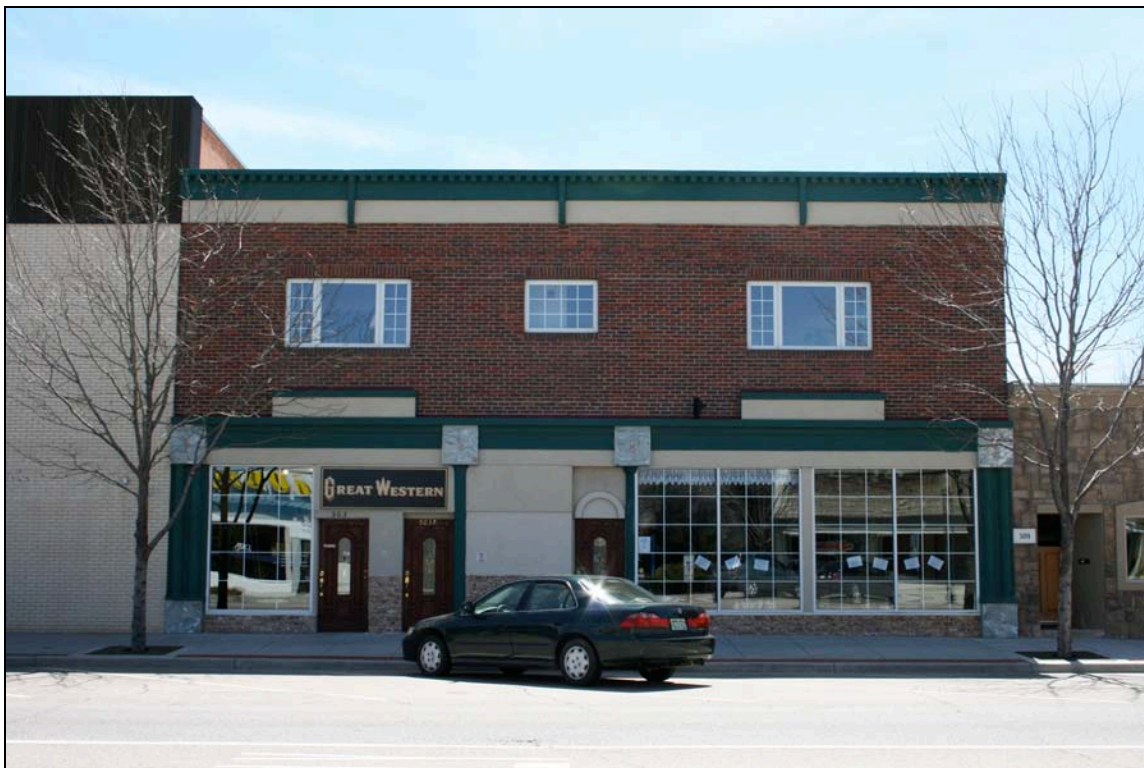
20. Special features: **Chimney**
Roof Treatment/Decorative Cornice
21. General architectural description:
This building is oriented to the north. The nature of the foundation could not be determined. Stucco covers much of the building. Most of it is off-white or buff color; however, the second story of the rear (south) elevation has tan stucco. A faded, painted wall sign occupies the top corner of the west elevation. It reads "CHRYSLER / PLYMOUTH/ SALES & SERVICE." Cladding the second story of the front (north) façade is a red, raked-brick veneer. Pink, hammered Roman bricks cover the lower third of the façade's first story. Covering the remainder of the façade is buff-colored stucco. Green-painted, engaged Tuscan columns divide the first story of the façade into three, unevenly spaced bays. The columns span between marble tiles. Crowning the façade is a green-painted cornice, with three, evenly spaced brackets. Windows are generally 6- to 8-light sliding-sash, with white vinyl frames. Those opening in either end of the façade's second story flank single-light picture windows. Piercing the center of the façade's second story is a 12-light, fixed-frame window. Dominating the first story of the façade are 15-light windows. A single window of this type opens in the eastern half of the eastern bay. Two pairs of the same window dominate the western bay. Opening in the second story of the west elevation are 6- to 8-light sliding-sash windows. The west end of the rear elevation's first story hosts single-light, sliding sash windows flanking a larger, fixed-frame window. Second-story windows in this elevation have brown, stucco surrounds, with projecting keystones. Windows also open into an atrium dividing the rear elevation's second story into two halves. Two doorways open in the western half of the easternmost bay. A third opens in the western end of the central bay. Each hosts paneled wood doors, with round-arch lights of leaded glass. Above the westernmost door is a round-arch, stuccoed pediment. Opening in the west end of the rear elevation is a secondary doorway. It hosts a white-painted slab door. Another doorway opens in the eastern half of the rear elevation's second story. It provides access to an unsheltered wood deck, with a staircase descending from east to west. Red-brick chimneys are engaged to the center of the west elevation and to the west end of the rear elevation, and protrude near the center of the building. A rubber membrane covers the nearly flat main roof and all other roof surfaces.
